Phase II Final Report

Cooks Run Watershed Assessment

June 30, 2008

**Aqua Link, Inc.**

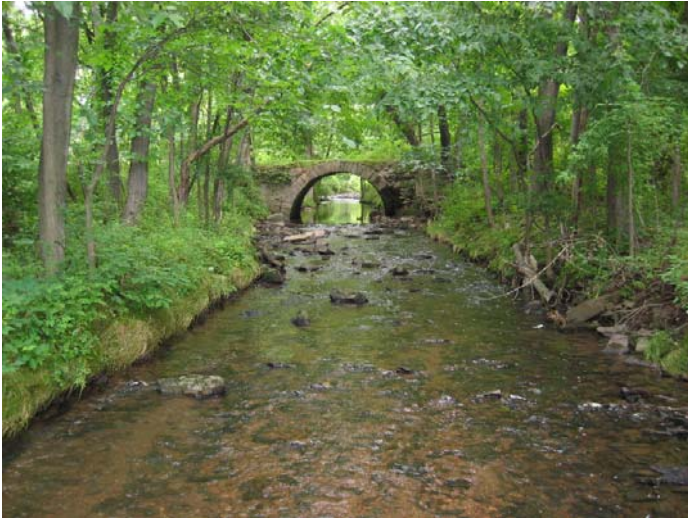
Segment 16-17

Problem description: minor streambank erosion due to the lack of a good riparian buffer containing woody vegetation. The adjacent lawn is maintained (mowed) right up to the streambank.

Stream Name:	Cooks Run
Stream Segment:	16-17
Level of Impairment:	2
Dimensions of NPS Problem:	200 feet occurring along right bank
Location of NPS Problem:	Between North Shady Retreat Road & Route 611 Bypass

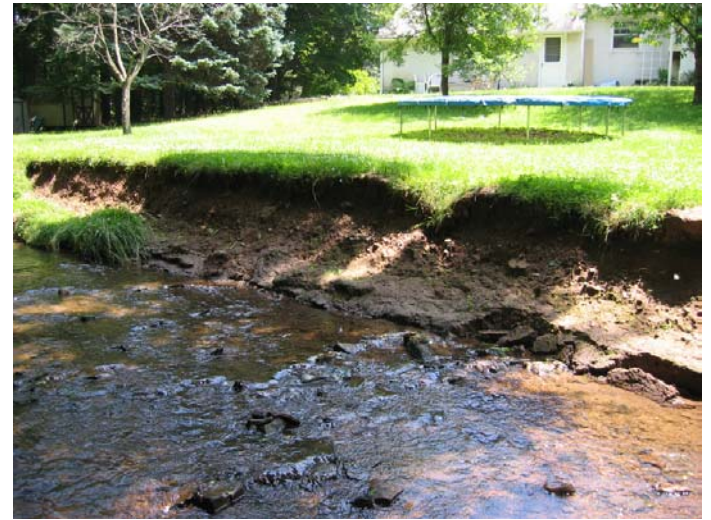
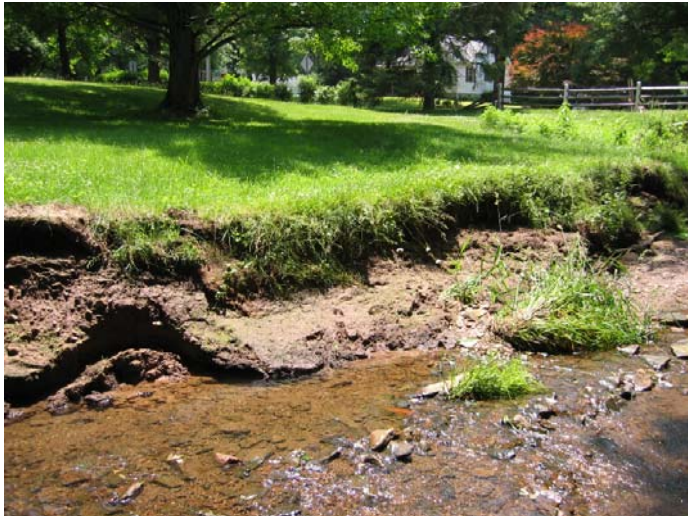
NPS Problem 15 (First View)

NPS Problem No. 15

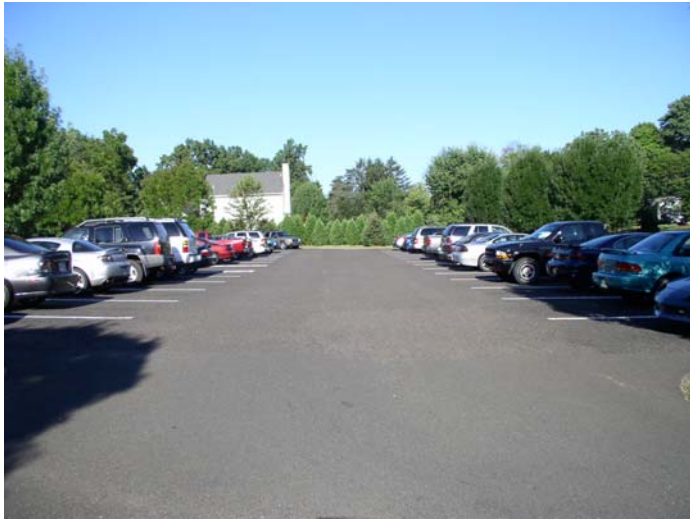
SWM 18 – Gilmore & Associates, Inc.

The offices for Gilmore & Associates Inc. are located within the Cooks Run Watershed. Constructed in 1999, the parking area along Butler Avenue utilizes porous asphalt with infiltration bed for stormwater management. The parking area is vacuum swept twice yearly to minimize pore clogging—once in the fall after all the leaves have fallen and again in the spring to remove any sand or cinders that have been carried into the site from elsewhere. After six years, the system still functions as intended and shows no visible degradation.

This structure was well conceived and the site owner is maintaining it as recommended in the newly issued draft BMP Handbook. Therefore there are no recommended improvements for this facility.

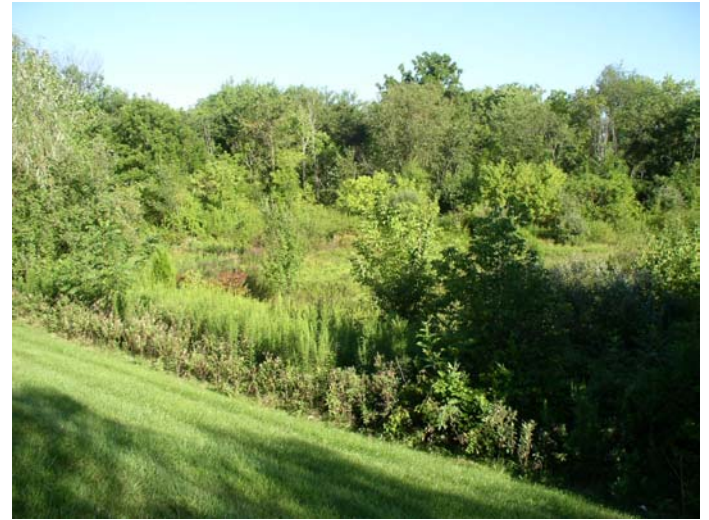
SWM 19 – Stonington Farm

The Stonington Farms detention basin is a dry basin that is ‘maintained’ in a meadow condition. As shown in the photograph, this means that there is little or no maintenance performed. Although this basin provides superior vegetative filtration, the presence of young trees within the basin could be cause for concern. The basin should be inspected to confirm that the vegetation has not compromised the outlet structure of this basin. Also, the location and size of the trees should be identified, and any trees on or in close proximity to the berm should be removed to protect its integrity.

The basin is maintained in a well-vegetated condition, however periodic inspections should be made to insure that outlet structure is clear of obstruction. Also, there are several young trees within the basin, which should be evaluated to determine whether they threaten the integrity of the detention facility and the berms.

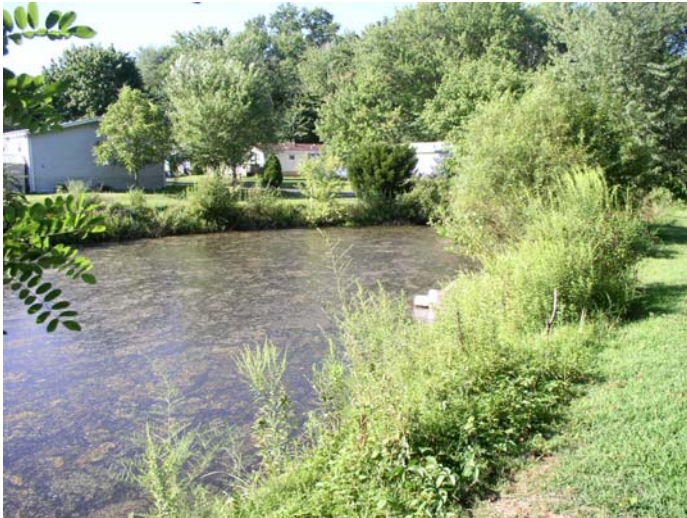
SWM 20 – Trailer Park – Pond No. 1

There are two retention basins within the trailer park. Pond No. 1 is located adjacent to Burpee Road and demonstrates significant degradation. This is readily apparent in the algae growth within the pond. The second pond, Pond No. 2, is located adjacent to Sandy Ridge Road. Although it does not have significant algae growth, this pond appears ‘murky’ which is indicative of sediment build up within the pond. Both ponds have a naturalized perimeter to provide vegetative filtration of overland flow into the ponds. These facilities would benefit from sediment forebays at basin inlets and water aeration.

Pond No. 1 along Burpee Road is significantly compromised from a water quality viewpoint with the excessive growth of algae. It is recommended that the pond be treated to remove the algae and an aeration system be installed to prevent future blooms. Both ponds appear to have significant sediment deposition, therefore it is recommended that sediment forebays be installed at the inflows to these basins. As an alternative, water quality devices may be installed in the storm inlets, which

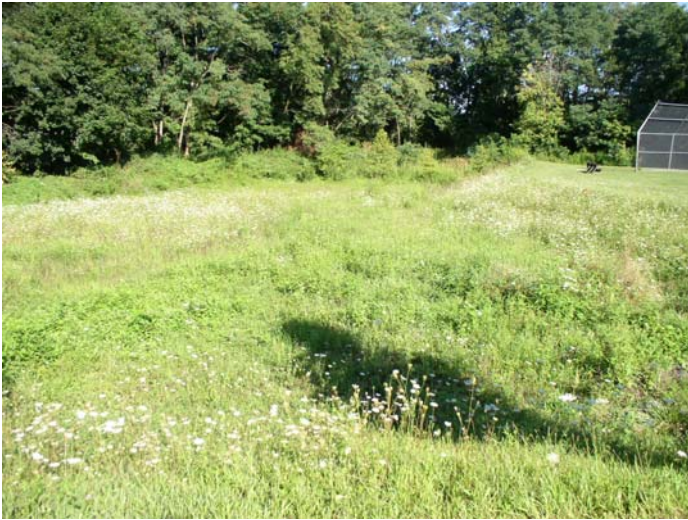
SWM 22 – Foundations Behavioral Health

The stormwater management facility is designed as a dry detention facility and is being maintained in a meadow condition. The basin is well vegetated and apparently does not contain any invasive herbaceous plants or trees. There are no recommendations for this facility.

In general, this facility is well conceived and built. The plantings appear to be thriving and there are no recommended improvements offered at this time.

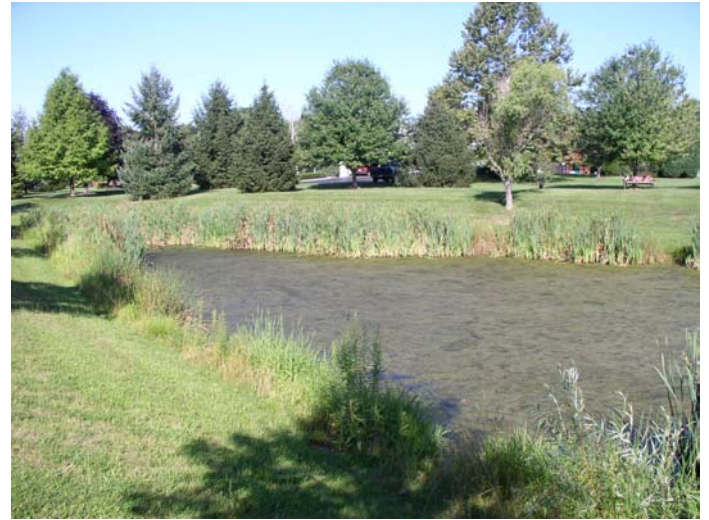
SWM 23 – Fabia Court

Fabia Court is a residential subdivision consisting of single-family homes. The stormwater management facility is designed as a wet pond. There are two ways in which this basin could be modified to improve water quality. First, although there is a vegetated perimeter, the vegetation is being overrun with cattails. These plants are known to be an invasive species, which will take over the pond in time. It is strongly recommended that they be removed and replaced with other aquatic or semi-aquatic vegetation. The second problem with this pond is the dense growth of filamentous algae. Overall, this pond should be treated to control the growth of nuisance algae and preventative measures taken to avoid future algal blooms. These measures would include aeration of the pond and reduction of nutrient pollution to the pond such as the excessive use of lawn fertilizers.

There are two recommendations for this facility. First the invasive plants should be totally removed and then replaced with native wetland plant species. The second recommendation is to install some form of aeration device to prevent stagnation and reduce the frequency of algal blooms. Although more difficult to enforce, an additional recommendation is to reduce the nutrient loadings (i.e., lawn fertilizers) to the pond, which are contributing to the excessive growth of algae.

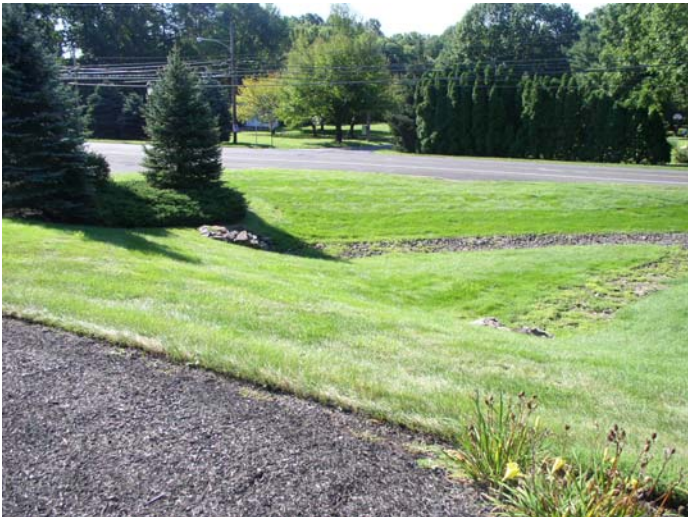
SWM 24 – Fluehr Funeral Home

The basin in front of the Fluehr Funeral home is a low profile, dry detention basin. The inflow pipes directly discharge to the low flow, stone channel, which minimize soil erosion and improves the conveyance of runoff during smaller rain events, without compromising potential infiltration. The owner maintains this basin as a well-manicured lawn. Although water quality may be improved by more naturalized vegetation, this would detract from the aesthetics of the site. Therefore, in light of the well-maintained appearance and function of the basin, there are no recommended improvements to this site.

This structure was well conceived and the site owner is maintaining it as a well-manicured lawn. Therefore, there are no recommended improvements for this facility.
