Lake Galena Northern Shoreline Stabilization Project PALMS Lake BMP Mini Grant Final Report

May 31, 2012

Prepared By: Bucks County Conservation District 1456 Ferry Road, Suite 704 Doylestown, PA 18901

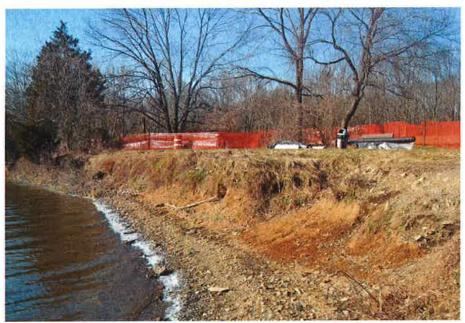
Photo 1. Project area immediately before start of construction

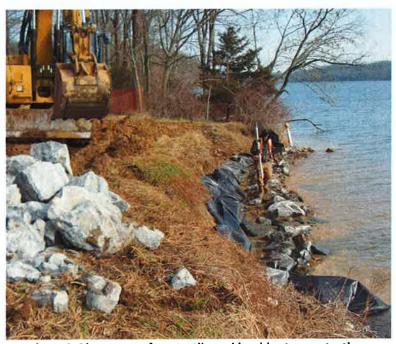
Photo 2. Placement of geotextile and boulder toe protection.

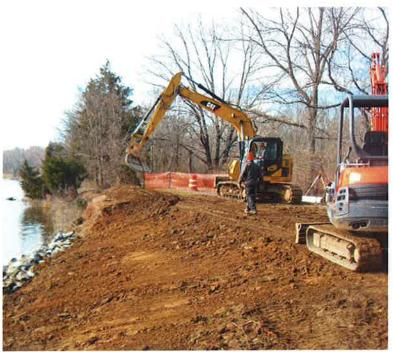
Photo 3. Enviroscapes, Inc. crew regrading bank

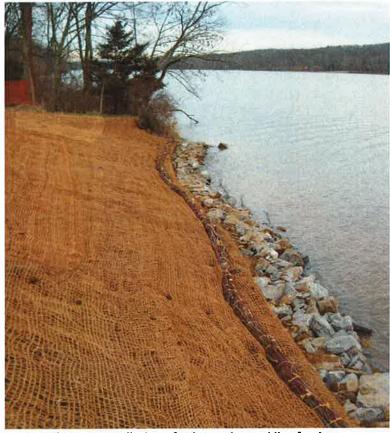
Photo 4. Installation of coir matting and live fascines.

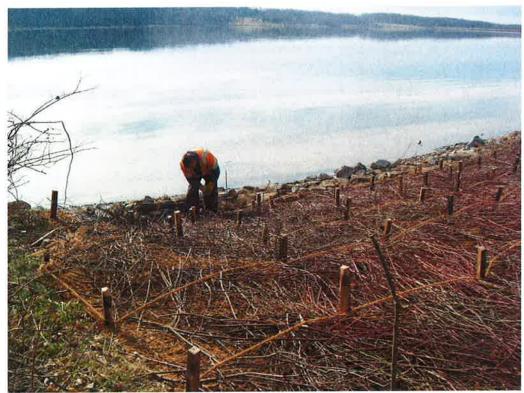
Photo 5. The crew secures the brush mattresses and installs live stakes

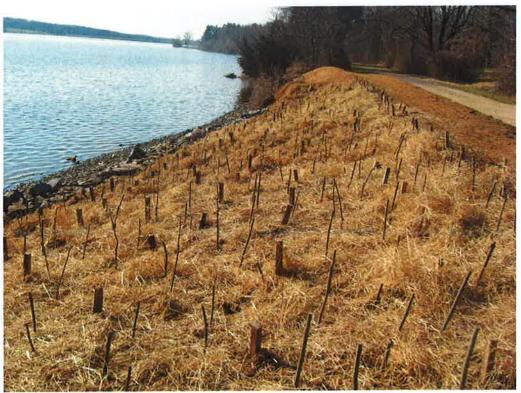
Photo 6. Newly restored bank after final stabilization
