# FINAL REPORT

## *North Branch Neshaminy Creek & Lake Galena Watershed Phase I Implementation Project*

*September 30, 2012*

**PA DEP Document No. 4100053255**

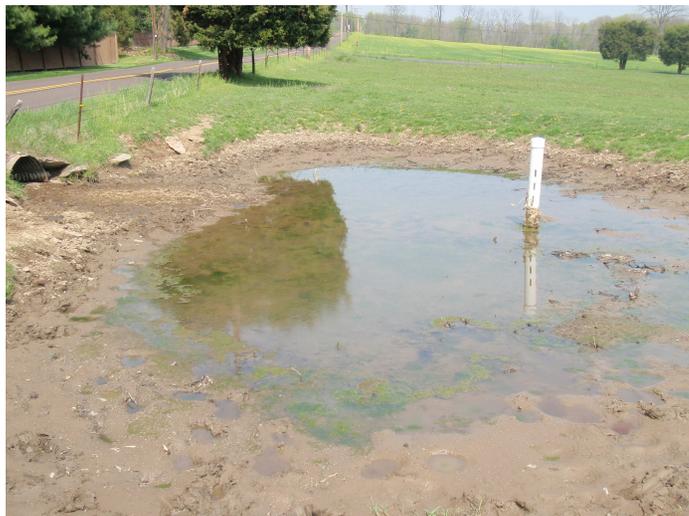
Uncontrolled stormwater runoff flows onto the Gayman Property (pasture) via a corrugated metal pipe (4 by 2.75 ft) into an archie basin. Mr. Gayman installed this basin on his property in the mid 1990's to help stop erosion that was being caused by the culvert. Over the years, this basin routinely had filled with sediment, which resulted in several failures of the auxiliary spillway of the basin itself. Stormwater from the spillway of the basin discharged onto sloping pasture resulting in severe gully erosion. Prior to implementation, approximately 900 ft. of gullies with depths up to 2.5 ft. were formed on the Gayman pasture. Based upon field reconnaissance, an NRCS engineer estimated approximately 170 tons of soil were lost from just the gullied areas.

1. Participant No. 2 – Archie Basin Prior to Implementation

- Enlarged the existing basin by 2,425 ft<sup>2</sup> to promote settling and provide additional capacity to handle incoming stormwater and installed trash rack on outlet pipe to prevent clogging
- Reinforced basin auxiliary spillway by installing a rock chute 110 ft. long, 10 ft. wide and 0.9 ft. deep
- Installed a 545 ft. long, 48 ft. wide, and 0.8 ft. deep rock-centered waterway immediately after the rock chute
- Installed a 380 ft. long, 50 ft. wide and 1 ft. deep grassed waterway immediately after the rock-centered waterway where the pasture starts to flatten out,
- Installed a 250 ft. long, 15 ft. wide, and 0.6 ft. high grassed diversion to divert stormwater when the road overtops and outlet to the rock centered waterway

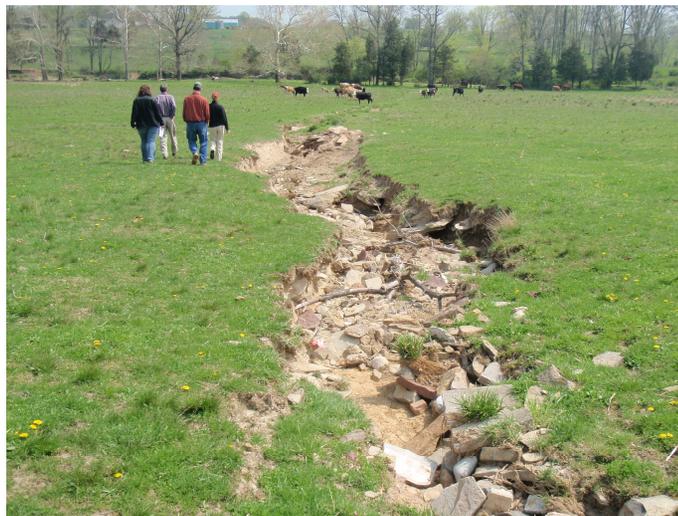
In addition, Mr. Gayman indicated that an outlet pipe from his upstream neighbor's pond outlets at the culvert's inlet resulting in periods of continuous flow during the year. The culvert is not able to carry the full flow rates and the road overtops during large storm events. One such area was approximately 230 ft. to the southwest of the culvert pipe. This area often remained saturated after storms, possibly from the road overtopping and runoff seeping through the roadbed itself. Prior to any implementation, gully erosion was observed from the saturated area to the main waterway from the archie basin.

2. Participant No. 2 – Severe Gully Erosion Prior to Implementation

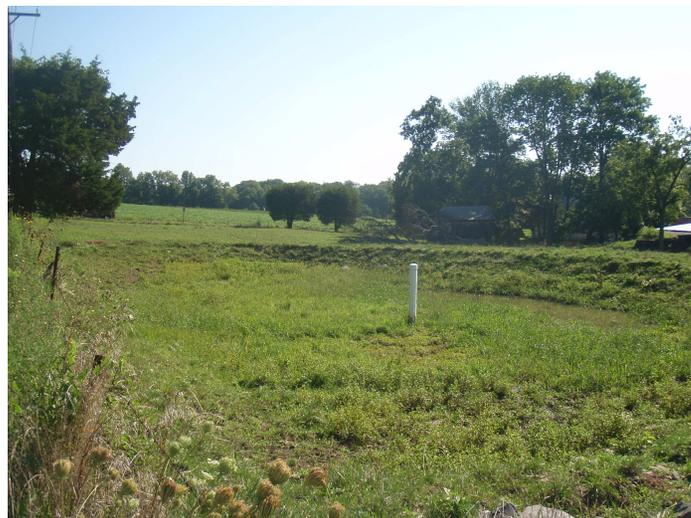
3. Participant No. 2 – Stabilized Archie Basin after Implementation

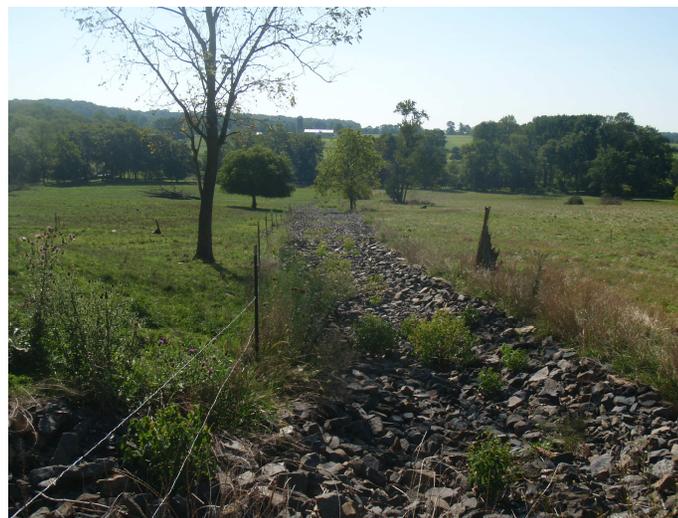
4. Participant No. 2 – Gully Stabilization after Implementation

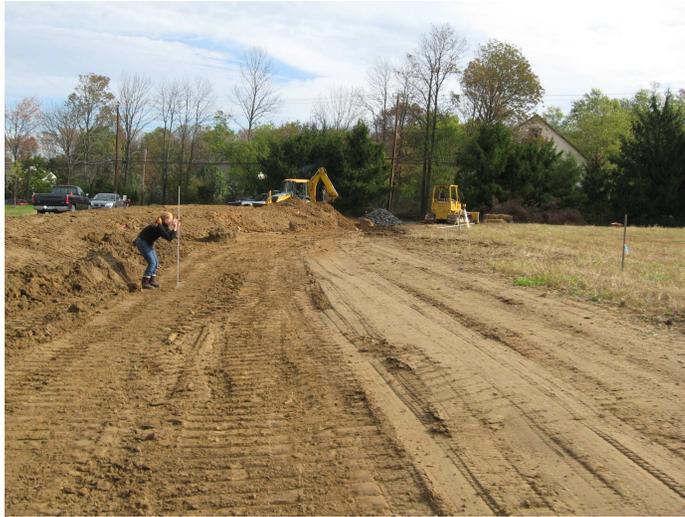
The McCauley's lease their land to a local farmer who uses no-till and mulch till and does a corn, soybean and small grain rotation. Two crop fields are separated by a driveway to the McCauley's house. Sheetflow over the driveway had caused a gully, approximately 300 ft. long by 3 ft. wide by 1 ft. deep, within the downslope cropland.

5. Participant No. 50 – Diversion during Construction

To reduce the volume of water crossing the lower crop field and reduce the potential for a gully to reform, a 600 ft. long by 20 ft. wide by 1 ft. deep grassed diversion was constructed in November 2010 along the lower end of the upslope field. A rock-lined outlet was also constructed to discharge the water to an existing road drainage way containing riprap. The gully in the down slope crop field was then plowed, shaped as a swale, and seeded to grass.

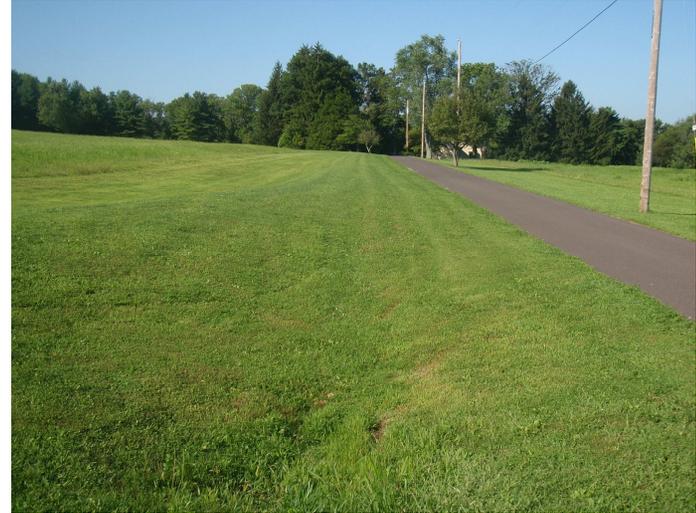
6. Participant No. 50 – Diversion after Implementation

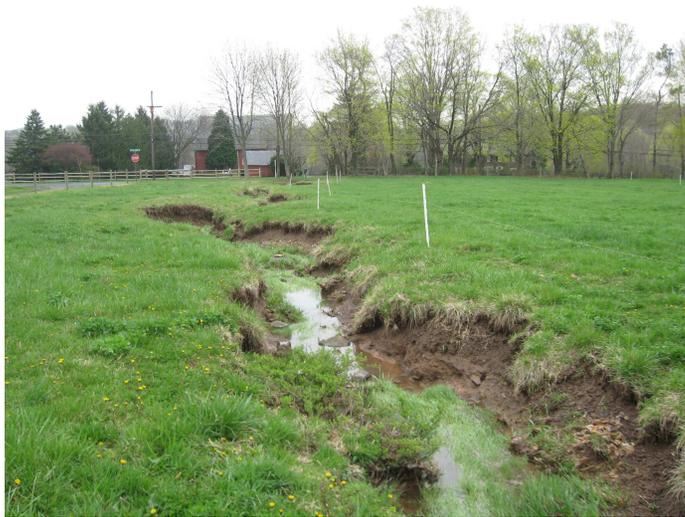
Mr. Baskin is the owner/operator of a 25-acre beef and hay farm in the watershed and had severe gully erosion in his pasture. The gully was approximately 400 ft. long by 7 ft. wide and 2 ft. deep. Based upon field reconnaissance, it was estimated that 90 tons of fertile soils had been lost due to excessive erosion. In addition, the banks of the gully were grazed to the edge by livestock.

7. Participant No. 40 – Gully Erosion prior to Implementation

- Constructed a 395 ft. long and 4ft wide meandering, trapezoidal channel and cut back the existing vertical banks to a 4:1 slope
- Reinforced the channel bottom and sides with R4 riprap stone 1.5 ft. deep across the bottom and up to a 2 yr-24 hr flow height on the banks (varied from 1.5 - 2ft. along channel length)
- Installed a vegetated buffer, overall width 35 ft.
- Installed fencing to exclude livestock from the waterway and buffer

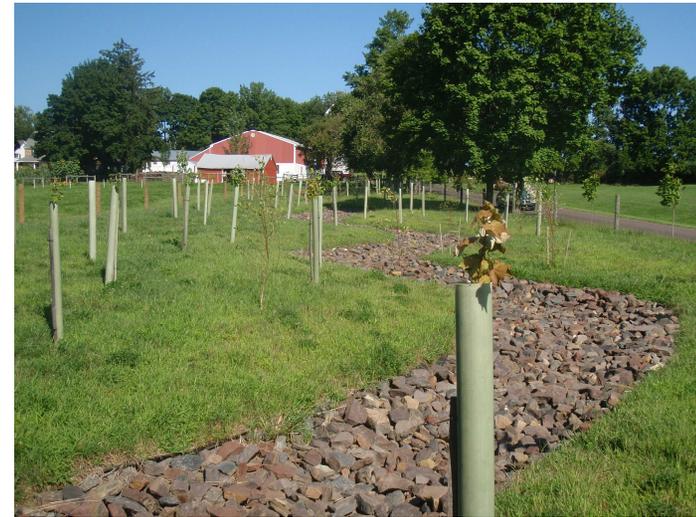
8. Participant No. 40 – Stabilized Gully after Implementation

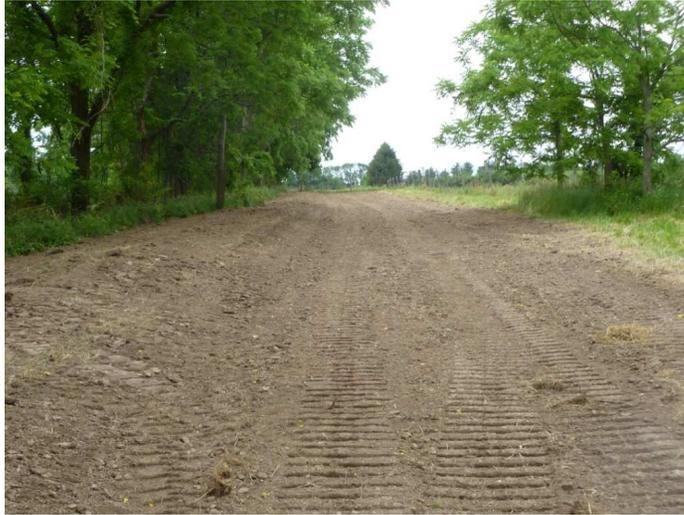
Penn View Farms is owned and operated by Paul and John Hockman. The Hockman's utilize a mulch till/minimum till system with corn, soybean and hay in the rotation on a few rented fields at 157 Upper Church Road, Chalfont, PA. Stormwater runoff from a 16-acre watershed flows over one of the fields along Old Limekiln Road. The accumulation of stormwater concentrates in an old excavated ditch along the field edge. The unstable ditch was approximately 2 ft. wide by 1 ft. deep and there was evidence of severe soil erosion to the crop field and roadside gutter.

**9.** Participant No. 37 – Diversion during Construction

To reduce the volume of water crossing the crop field and thereby reduce the potential for accelerated erosion to occur, a 460 ft. long by 16 ft. wide by 1 ft. deep grassed diversion was constructed in July 2012 above this field. In addition, a 45 ft. long by 20 ft. wide by 1 ft. deep rock chute was constructed to outlet to an existing road drainage way that contains large riprap. The eroding ditch in the down slope crop field was then plowed, shaped to match natural grade, and seeded to grass.

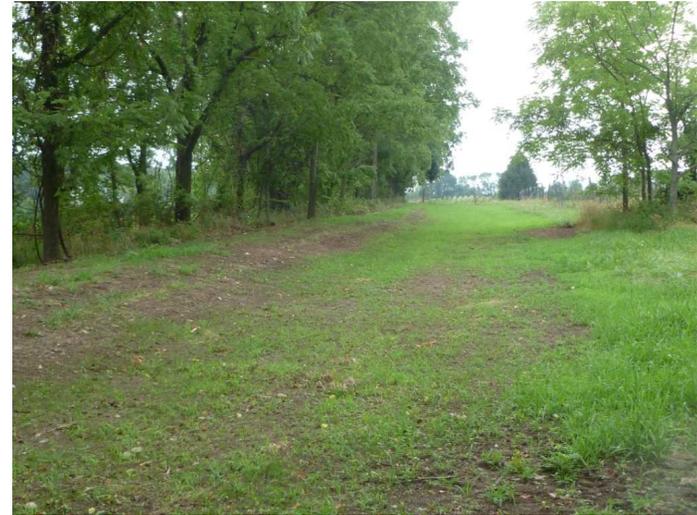
**10.** Participant No. 37 – Diversion after Implementation
