# Updated Watershed Implementation Plan for Core Creek/Lake Luxembourg Bucks County, PA

### **Princeton Hydro, LLC**

**Second Revision May 2017**

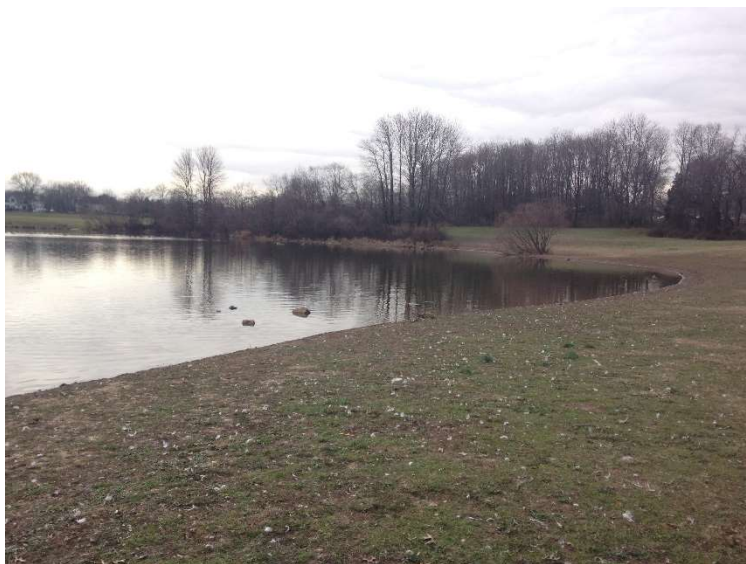
A large stretch of shoreline west of the Park boat launch could be better protected (Figure 2.1.1; noted as SS-1 on the watershed map in Appendix A). The area is currently mowed up to the water's edge and is the grazing area for a large population of geese and other birds. A vegetated buffer similar to those planted in the past along other sections of the Lake Luxembourg shoreline should be implemented to protect the shore from potential erosion as well as reduce nutrient inputs from surface runoff.

**Figure 2.1.1: Proposed shoreline stabilization and revegetation site at Lake Luxembourg.**

Recommendation: Major re-grading does not appear to be required, however, tilling of the soil may be necessary due to nearshore soil compaction. The proposed project should include multiple access points for fisherman or park visitors to avoid potential tampering that has occurred at other stabilization sites with only one access point.

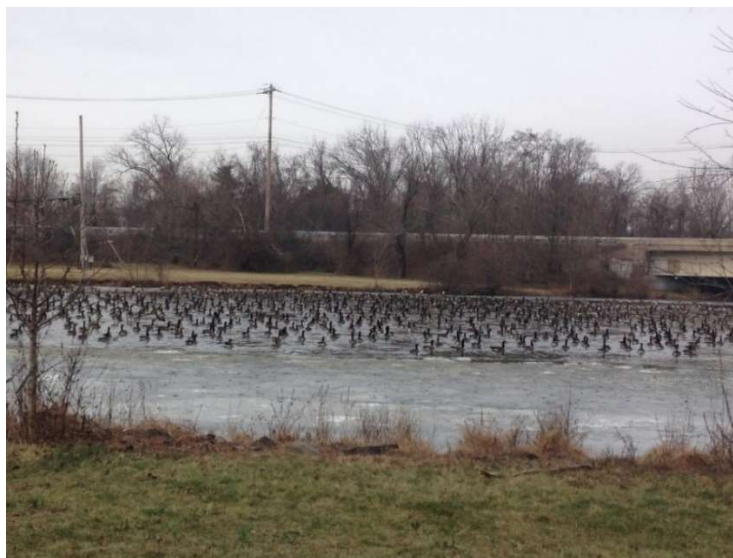
**Silver Lake (Newtown Township)** is a small waterbody located north of Lake Luxembourg and adjacent to the Newtown Bypass. This waterbody drains directly into Core Creek, less than a mile and a half upstream of Lake Luxembourg. Silver Lake contains high nutrient concentrations year around, primarily as a result of hundreds of Canada geese that inhabit this area over the winter months (Figure 2.2.1; noted as SS-2 on the watershed map in Appendix A). The lake is directly adjacent to major roads and lacks a vegetated buffer; the installation of such buffers would contribute toward reducing some of the nutrient loads from nearby impervious surfaces. The lake is located in Silver Lake Park and is adjacent to a large manicured area where people often bring their dogs. Canada geese also frequent the large open areas in the park. Since Silver Lake is hydrologically connected to Lake Luxembourg reducing the nutrient loads, particularly phosphorus, that discharge from it will contribute toward reducing the loads that enter both Core Creek and Lake Luxembourg.

**Figure 2.2.1: Conditions at Silver Lake over the winter season.**

Recommendations: A vegetative buffer should be created for a substantial portion of the shoreline of this lake. Grasses and low lying herbaceous vegetation that do not obstruct the view of the lake to visitors, with strategically placed woody vegetation is recommended. The native vegetation would also deter some of the geese from entering the lake from the shore. In-lake practices should also be considered, such as an aeration / circulation system and / or Floating Wetland Islands (FWIs). Due to the amount of Canada geese at this site, an alternative to the FWIs would be a BioDi Aerobic Digester which is designed to reduce organic material, nitrogen and other pollutants in the waterbody. Controlling the Canada geese population should be a long-term, watershed goal for reducing the nutrient concentration both in Silver Lake and its discharge.

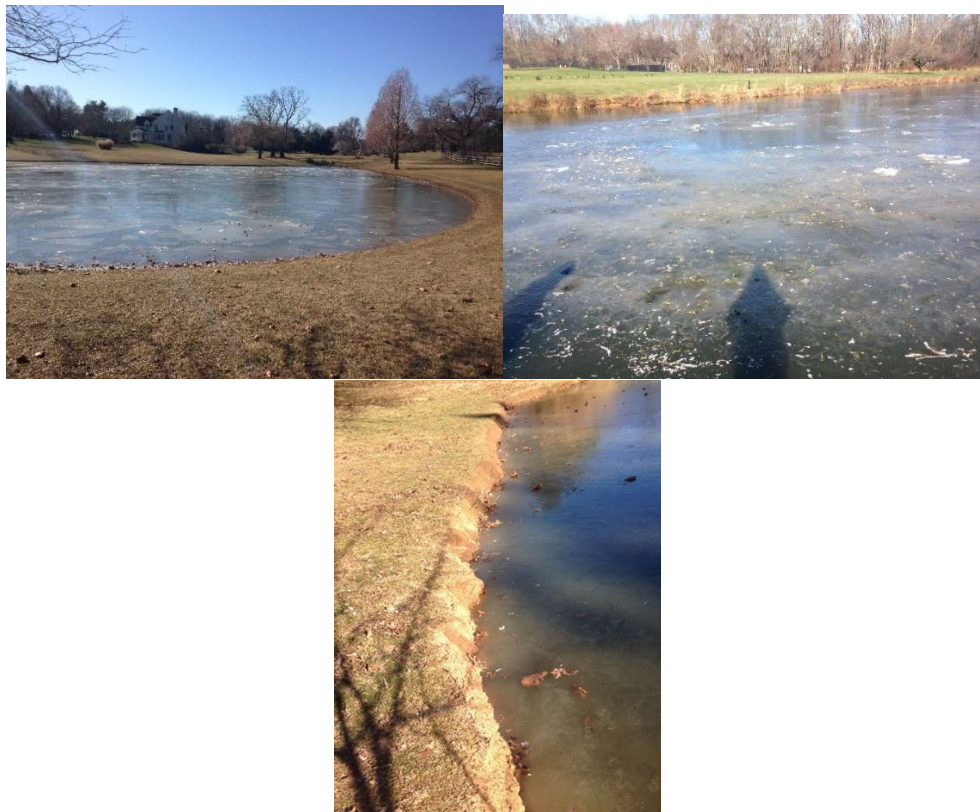
This site is located at Timber Lakes Dr and Lindenhurst Rd and includes a series of seven ponds (Figures 2.2.2 through 2.2.4; noted as SS-3 on the watershed map in Appendix A), likely owned by the community or individual residents. The ponds at the northern end of the neighborhood drain directly into Core Creek. Six of the ponds appear to be hydrologically connected. Large populations of Canada geese were present at all of the ponds and surrounding areas. Multiple ponds have no vegetated buffer with mowed lawns right to the ponds' edge and also exhibit some shoreline erosion. At least one of the ponds has an aeration system to address / improve water quality. The entrance pond has vegetation surrounding the entire lake, dominated by bamboo along the road side.

**Figures 2.2.2, 2.2.3 and 2.2.4: Conditions at multiple ponds at Timber Lakes Dr.**

Recommendations: Vegetated buffers should be considered for the pond shorelines; at a minimum, a no-mow zone should be established between 5 and 25 feet. Planted shoreline vegetation and/or a no-mow zone would reduce nutrient loads from surface runoff and also deter some of the geese from entering the ponds. In-lake practices should also be considered, such as aeration / circulation system and / or Floating Wetland Islands (FWIs). Due to the amount of Canada geese at this site, like Silver Lake, an alternative to the FWIs could be a BioDi Aerobic Digester. Geese control is absolutely necessary.

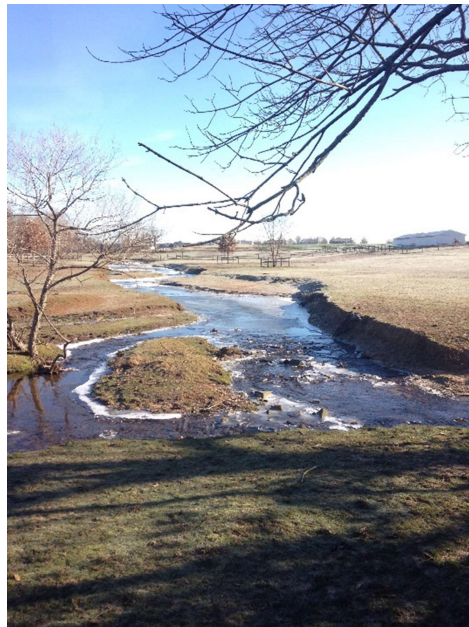
This length of exposed Core Creek is located on Lindenhurst Road in the middle of the Broad Meadows Farm property. This section of the creek lacks a vegetated buffer has some steep cuts (Figure 2.3.1; noted as SS-4 on the watershed map in Appendix A) and is surrounded by horse pastures. Along with nutrient input from the farm animals and farmland, large amounts of Canada geese also frequent the areas around the creek. The stream channel is eroded and often trampled by the large farm animals. Stormwater also enters the site from Lindenhurst Road. This long-exposed reach is directly upstream of Silver Lake, and is a source of NPS pollution for both it and Lake Luxembourg.

**Figure 2.3.1: Stretch of Core Creek located at Broad Meadows Farm.**

Recommendations: The streambanks should be re-graded and stabilized. A buffer of trees and fencing should be implemented to prevent horses from entering the stream. Various stabilized crossings should be implemented along the stream to allow for farm animals to cross safely and without harming the condition of the channel.

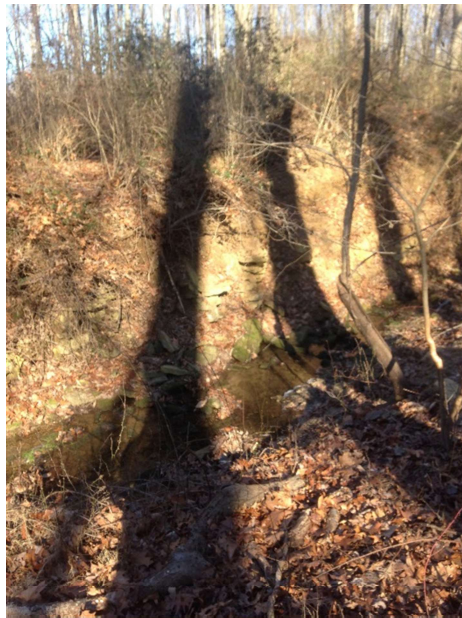
Located immediately upgradient of the most southeastern cove of Lake Luxembourg, this tributary is completely surrounded by forested lands, making it very difficult to access. A large buffer exists around this stream; however, significant erosion has been observed in some of the upstream sections (Figure 2.3.2; noted as SS-5 on the watershed map in Appendix A).

**Figure 2.3.2: Eroded banks at Tributary 1.**

Recommendations: If access allows, possibly create bankfull benches with rock and rip-rap in areas with highly eroded sides. Drawing back banks is likely difficult due to existing woody vegetation. Possible understory plantings (e.g. ferns) or plantings along the streambank to stabilize is also an option.

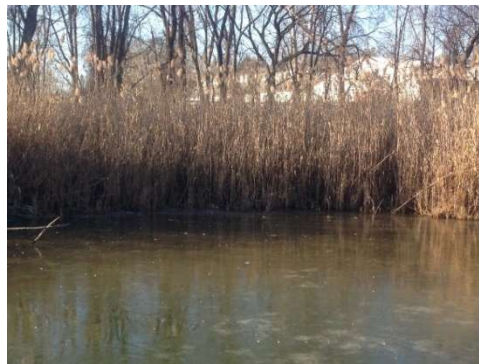
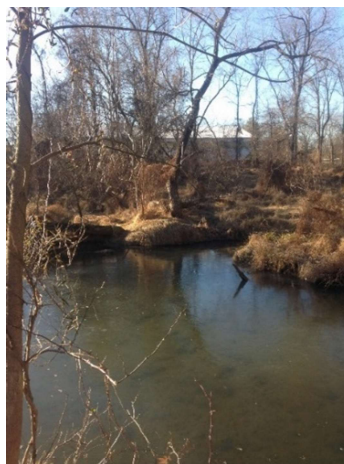
Core Creek flows directly into the Conservation pool located at the northern end of Lake Luxembourg. This creek runs adjacent to the Village Farm, which contains horse stables and pastures, with some limited riparian buffers. Access for an expansion of these buffers is limited and therefore such a project would be difficult to implement (Figures 2.3.3 and 2.3.4; noted as SS-6 on the watershed map in Appendix A). Some erosion of the shoreline can be observed in portions of this reach, contributing toward a decline in downstream water quality. *Phragmites* also dominates the farm side of the streambank. Again, due to the forested nature of the area and limited space between the streambank and farm, access is likely difficult for large equipment.

**Figures 2.3.3 and 2.3.4: Streambank conditions along Core Creek immediately upstream of the Lake Luxembourg Conservation Pool.**

Recommendations: If access allows, eliminate the *Phragmites* and stabilize shoreline with native vegetation. If possible, expand the width of the riparian buffer or thicken understory. More vegetation could be added to the meadow areas present; however, in general this project should be ranked as low due to accessibility issues.

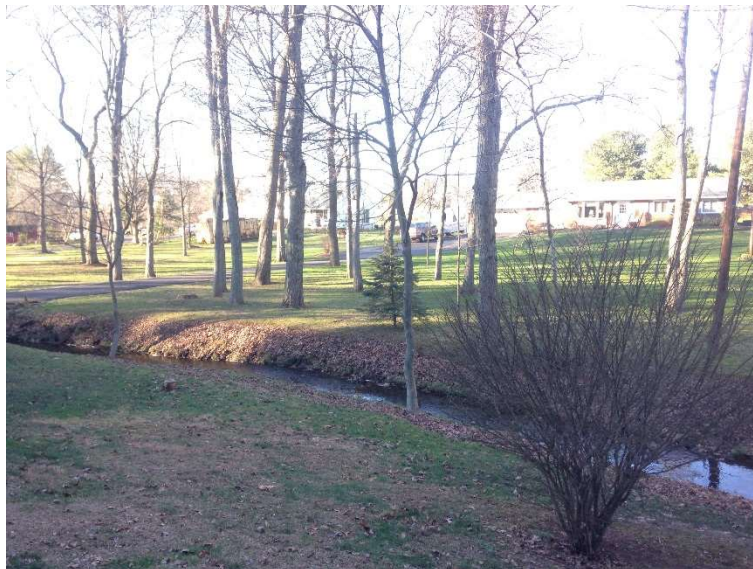
Located along Village Rd at Basil Rd, this tributary flows parallel to a road and through private properties. This section of tributary contains little to no buffer to the road (Figure 2.3.5; noted as SS-7 on the watershed map in Appendix A). The land area on the neighborhood side of the stream has scattered trees but the grass is mowed up to the streambank, where patches of slight erosion are evident. This stream passes under a road from a meadow/forested area which provides some buffering and stabilization.

**Figure 2.3.5: Conditions seen at Tributary 2.**

Recommendations: Expand / improve upon a vegetated buffer between the stream and both the road and the houses. At the forested section of the stream, add to the existing buffer. Along the exposed stretch of stream, any eroded areas should be stabilized through tree plantings. Do not mow up to the stream's edge; create a no mow zone.

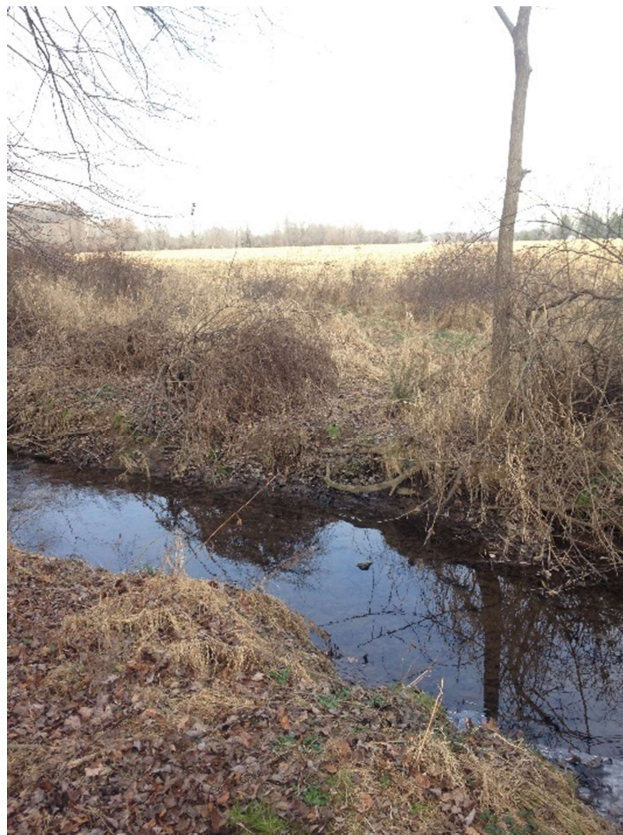
Located near the main entrance of Core Creek Park, this tributary is surrounded by farmland, which is leased by the park. The stream is located in a forested area that provides some buffers (Figure 2.3.6; noted as SS-8 on the watershed map in Appendix A). Adjacent to the road, the forested area provides a larger buffer, but farther upstream, there is minimal riparian buffer adjacent to the farmland. There is little to no erosion in the forested area near the park entrance.

**Figure 2.3.6: Buffer conditions found at Tributary 5.**

Recommendations: Increase the width of the riparian buffer along the stream to reduce the magnitude of the surface runoff pollutant load that originates from the farmland. Also, eliminate any invasive species found on site, such as multiflora rose. Since the land is probably owned by the Park, this project should be ranked high since issues associated with property ownership, easements and/or right-of-ways should be minimal.

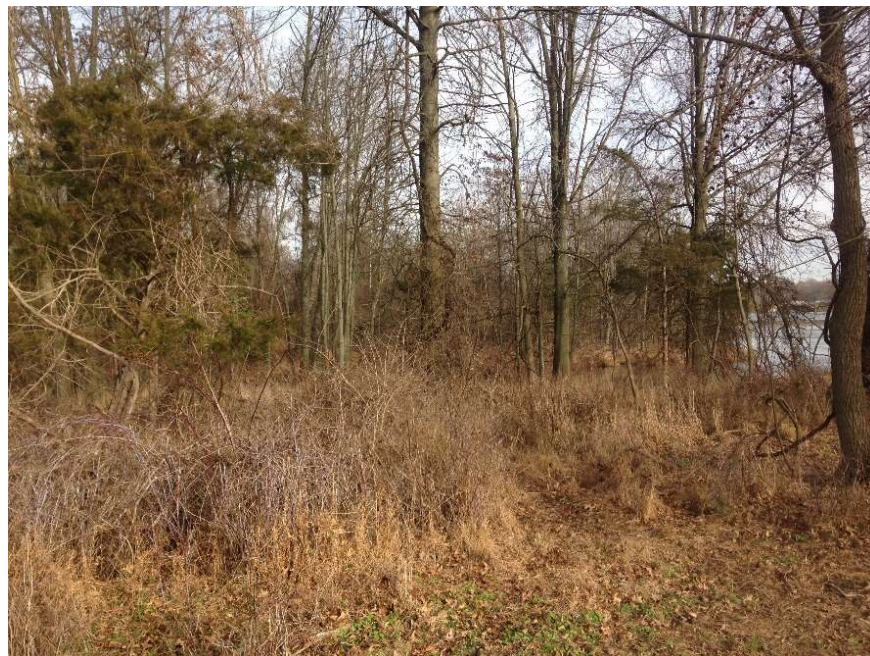
This tributary is located on Ellis Road in between two neighborhoods and adjacent to a farm, possibly leased by the Park. Some erosion is present along the streambank. The vegetation / riparian buffer along the farm (Figure 2.3.7; noted as SS-9 on the watershed map in Appendix A) could be expanded and patches of multiflora rose should be eradicated and replaced with native vegetation. However, access with large equipment to the streambank project sites may be difficult due to forested nature of the site.

**Figure 2.3.7: Buffer conditions found at Tributary 4.**

Recommendations: Increase the riparian buffer width and/or increase the density of existing vegetation. Also eliminate the invasive species found, possibly with a forest mower, and revegetate the understory. If access allows, possibly create bankfull benches to combat erosion.

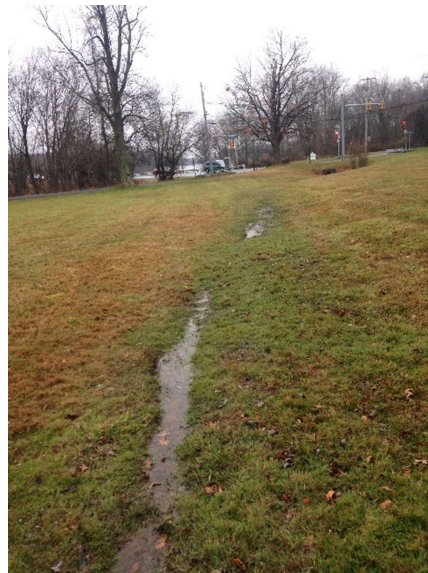
This site is located at the northeastern corner at Ellis Road and Woodbourne Road. This large mowed lawn is on Today Inc.'s property and contains an eroded, turbid channel draining directly to Lake Luxembourg (Figure 2.4.1; noted as BMP-1 on the watershed map in Appendix A). The site is also adjacent to the Village Farm, a horse farm, and a highly-developed neighborhood. The site is also frequented by Canada geese. The area is the outlet for stormwater from a large neighborhood just north. The area also lacks a buffer to the road.

**Figure 2.4.1: Channel condition at Ellis Road.**

Recommendations: A vegetated, meandering swale stretching from the forested inlet to the outlet by the road should be implemented. Another option would be to create a riprap or another stabilized channel with some buffer from forested inlet to outlet, where a vegetated basin would be located.

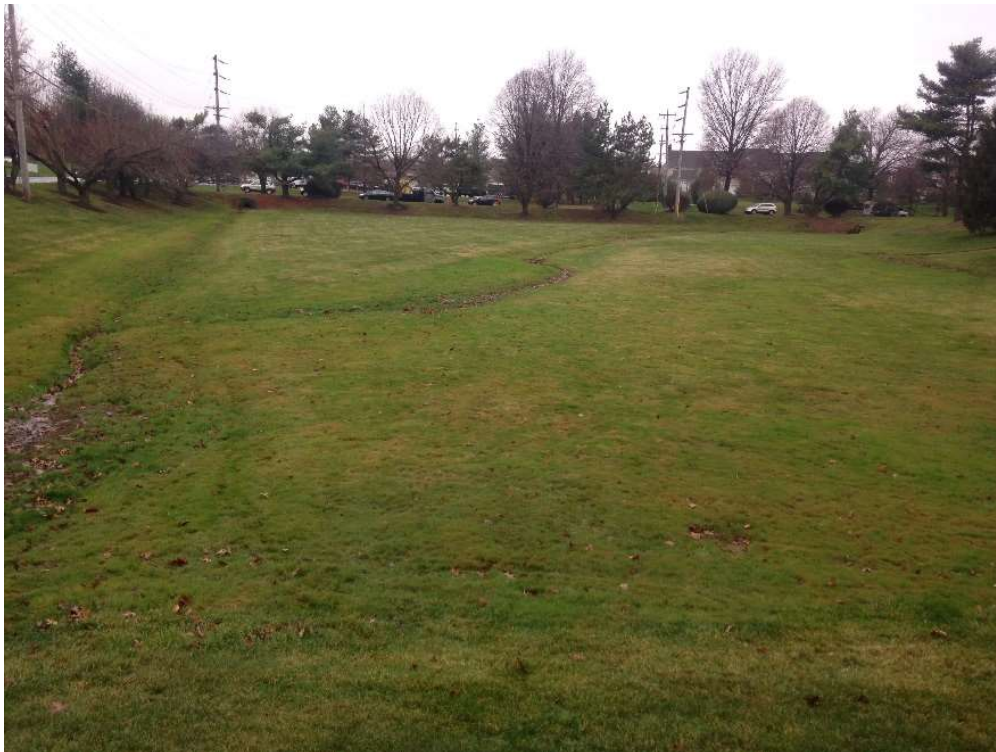
This basin is located at the northeastern corner of Lower Dolington Road and Newtown Yardley Road. It contains a large basin with eroded channels located between two busy roads and associated neighborhood. The large basin is mowed and lacks any other vegetation (Figure 2.4.2; noted as BMP-2 on the watershed map in Appendix A). There is a thin buffer to the road at the top of the sloped sides. One inlet has strategically placed rock to function as energy dissipaters.

**Figure 2.4.2: Basin condition at Dolington site.**

**Recommendations:** The existing basin should be retrofitted into a naturalized extended detention basin. This would be done by improving on the current channels, vegetating the area, and creating a no mow area surrounding the basin.

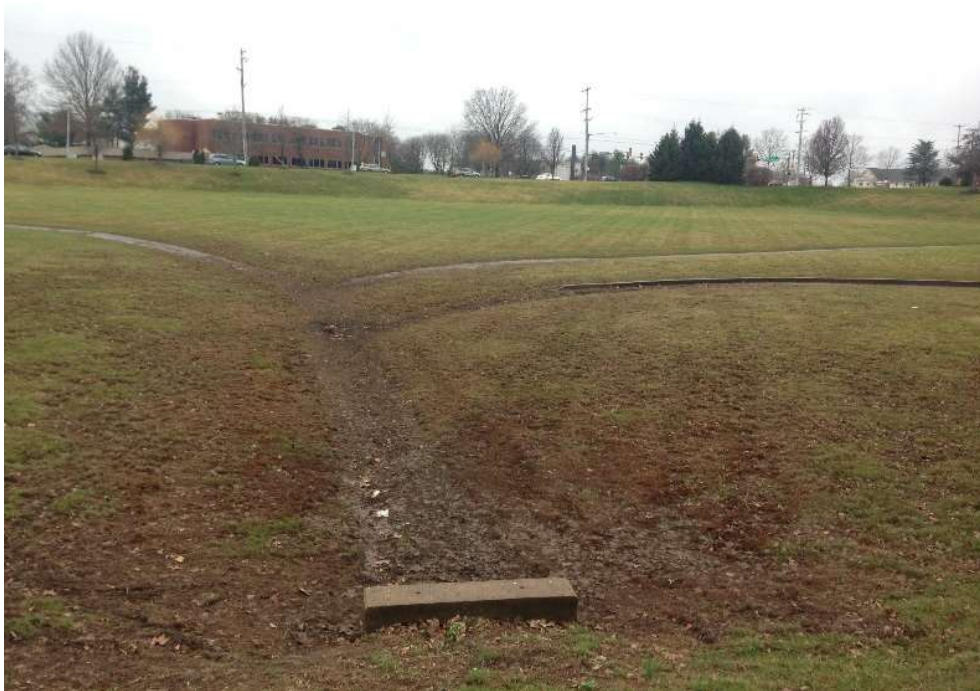
This basin is located in the northeast corner of Penns Trail N and Newtown Yardley Rd. It is adjacent to multiple roads, a neighborhood and a powerline. The basin contains three concrete channels, with a significant buildup of sediment, organic material, and gravel in front of outlet (Figure 2.4.3; noted as BMP-3 on the watershed map in Appendix A). The site is also kept mowed preventing the establishment of any other vegetation. There is no vegetated buffer adjacent the road.

**Figure 2.4.3: Conditions at Wellington site.**

Recommendations: The existing basin should be retrofitted into a naturalized extended detention basin. It should be vegetated and the channel buildup debris should be removed. The low flow channels should be replaced with a more efficient system. A no mow line should also be established.

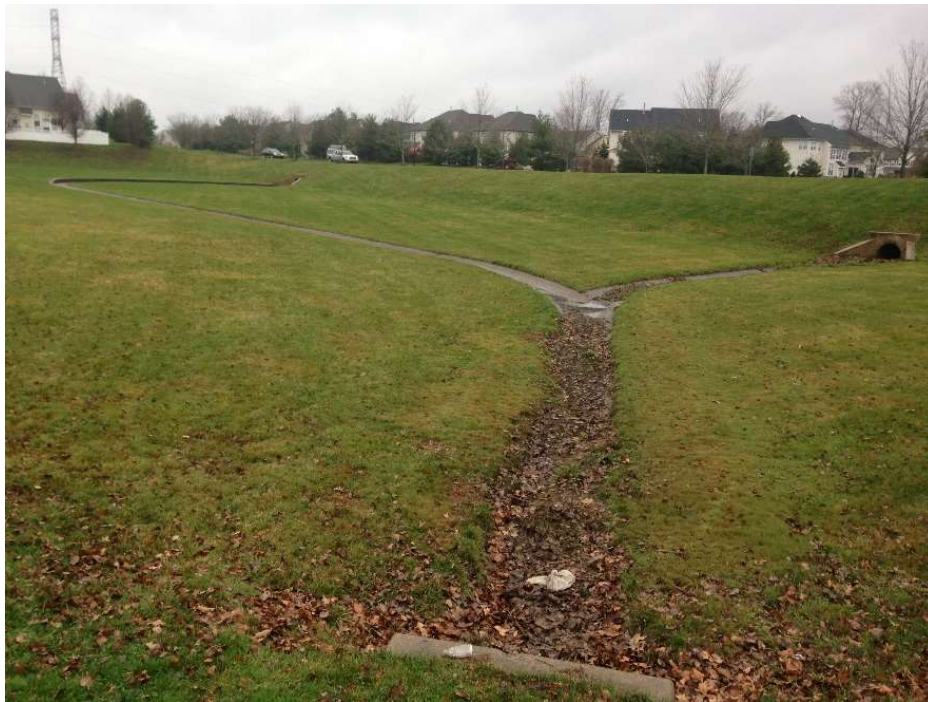
This basin is located in the southeastern corner of Penns Trail N and Hartfield Road. The site is adjacent to a small road and a neighborhood. The basin contains concrete channels with a buildup of sediments, leaves and gravel at one inlet and the outlet (Figure 2.4.4; noted as BMP-4 on the watershed map in Appendix A). The presence of Canada geese droppings in channels and adjacent areas was noted and indicates an added nutrient input. The area was kept mowed and lacks a buffer. There are energy dissipaters in the form of rocks at the inlets at this site.

**Figure 2.4.4: Site conditions at the Hartfield basin.**

Recommendations: The existing basin should be retrofitted into a naturalized extended detention basin. It should be vegetated and the accumulated material / debris should be removed from the channel. The low flow channels should be replaced with a more efficient system or preferably eliminated and replaced with a meandering, non-impervious structure. A no mow line should also be established.

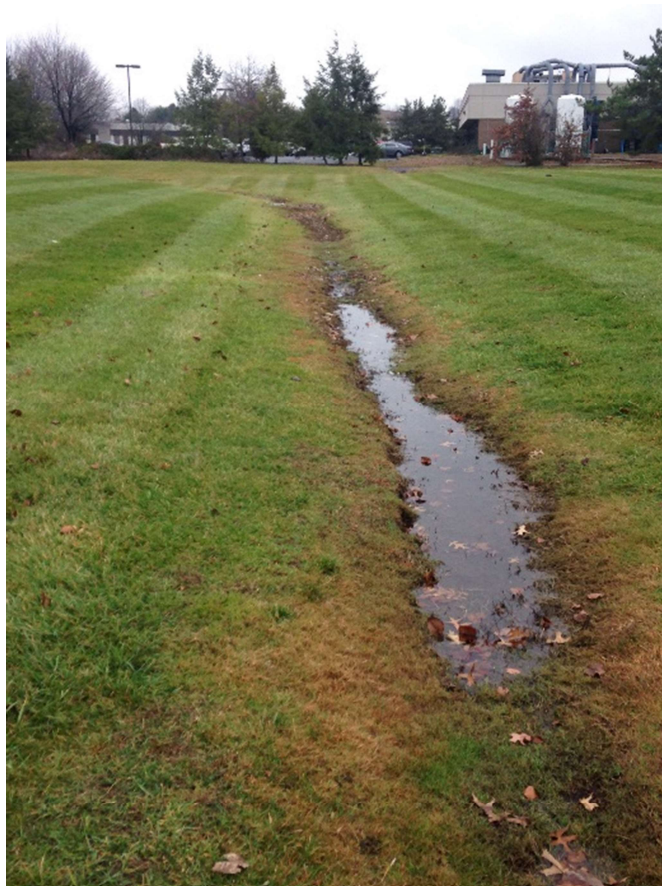
This site is located at Penn Street and Pheasant Run, across the street from the Law School Admissions Council and behind Teletronics Technology Corporation. It is adjacent to a large manicured lawn and parking lots. The current swale contains eroded channels with a buildup of leaves and a concrete channel originating from one lot (Figure 2.4.5; noted as BMP-5 on the watershed map in Appendix A). The current inlet has a riprap energy dissipater and is vegetated with cattails and some other vegetation.

**Figure 2.4.5: Swale conditions at Teletronics site.**

Recommendations: A vegetated, meandering swale should replace the existing structure. In addition, trees and vegetation should be planted between the parking lots as a slight buffer for runoff. A no mow area should also be established.

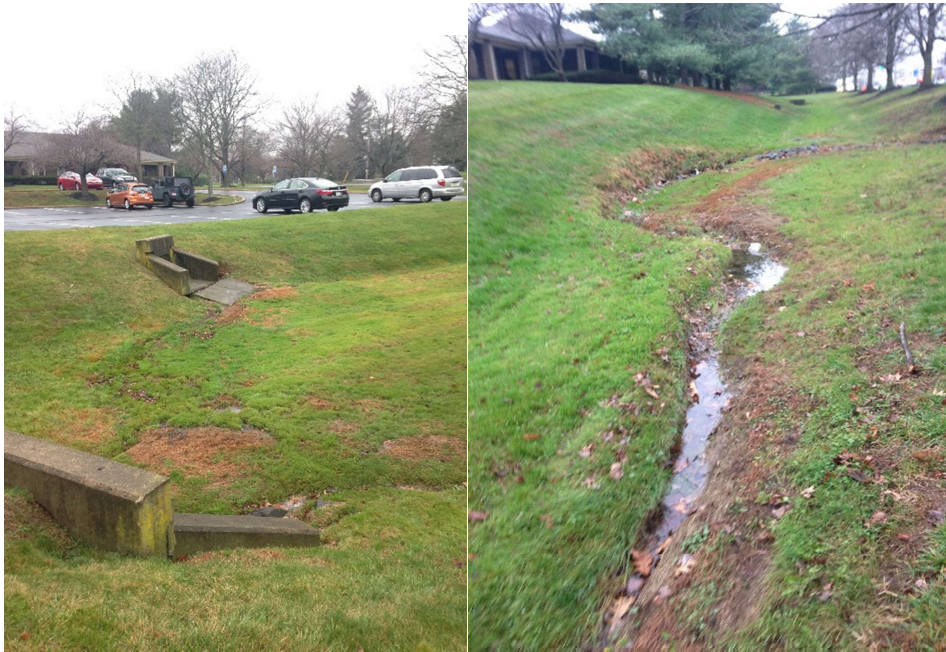
This site is located along Newtown Yardley Road at the front of the complex. The site lacks a significant buffer to the road (Figure 2.4.6) and has eroded channels and sides (Figure 2.4.7; noted as BMP-6 on the watershed map in Appendix A). The eroded channel in the basin hugs one side. The main swale channel exhibits additional erosion. Grass is mowed up to channel sides. The inlet from the road has an energy dissipater.

**Figure 2.4.6 and 2.4.7: Conditions at the Newtown-Yardley Road and Terry Drive site.**

Recommendations: The existing basin should be retrofitted into a naturalized extended detention basin. The basin should be vegetated and possibly re-graded. A vegetated swale or stabilized channel should flow into the basin in the form of a stormwater treatment train. A no mow line should also be established.

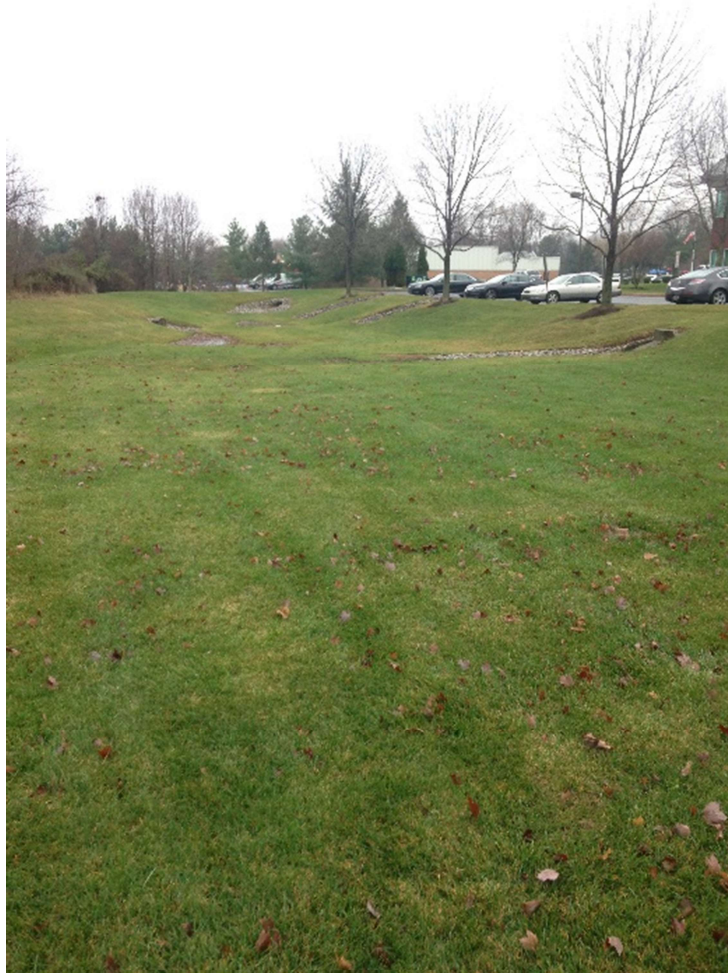
This site is located along Terry Drive behind a complex building. It is a small mowed basin with a couple of trees next to the parking lot (Figure 2.4.8; noted as BMP-7 on the watershed map in Appendix A). The basin flows into a creek that has a small forested buffer. The basin contains pre-existing BMP structures including curb cuts, inlets and an outlet with stone energy dissipaters / infiltrations. However, multiple areas contained standing water.

**Figure 2.4.8: Conditions at the Terry Drive site.**

Recommendations: The existing basin should be retrofitted into a naturalized extended detention basin. It should be vegetated and possibly re-graded to eliminate some of the standing water issues. Vegetation could be added to create a buffer adjacent to the parking lot.

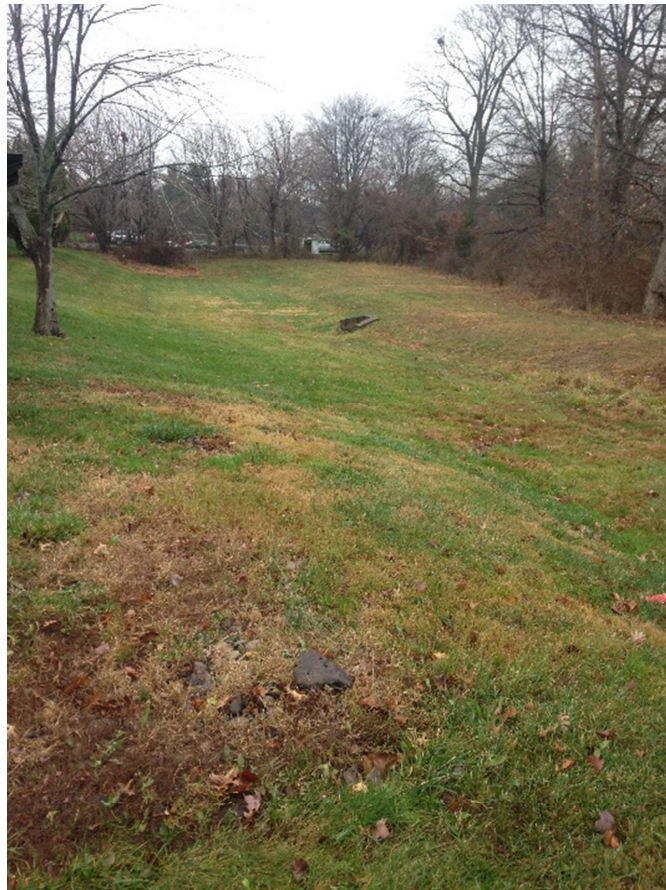
This site is located next to the Terry Drive site, behind the Just Play building. The site contains just an outlet structure with thin rock buffer between parking lot and basin. It is essentially a small mowed basin that has no plant buffer to the parking lot (Figure 2.4.9; noted as BMP-8 on the watershed map in Appendix A). The outlet discharges directly to stream with no potential treatment for stormwater / surface runoff.

**Figure 2.4.9: Conditions at the Just Play site.**

Recommendations: A potential rain garden or vegetated filter strip could be placed within the existing site to treat runoff and improve water quality before entering the creek.

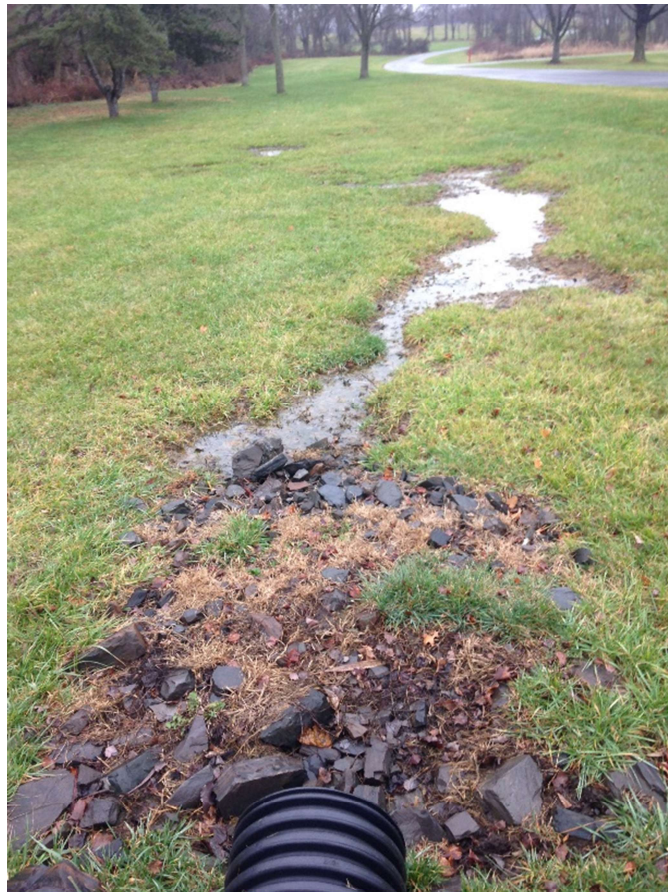
This site is located within Core Creek Park along Park road, adjacent to a hospital access road. The site contains pooling water and a pipe under the access road (Figure 2.4.10; noted as BMP-9 on the watershed map in Appendix A). There is a vegetated buffer between the site and the hospital that is overrun with feral cats. The site includes a long strip of mowed grass.

**Figure 2.4.10: Channel conditions at the Park Rd site.**

Recommendations: A vegetated swale could be created to eliminate erosion and the pooling of water. The Park should initiate a discussion on the large population of feral cats in the watershed, their impact on the health / water quality of the park and lake and what could be done to address this issue.

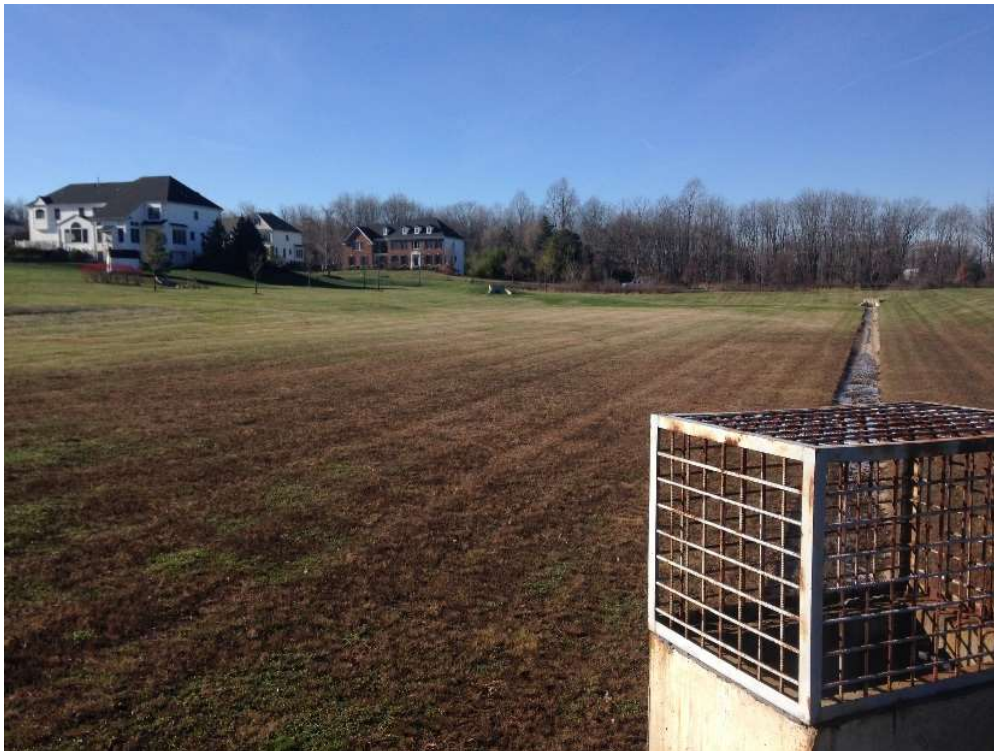
This basin is located at Foxhall Rd and Washington Crossing Rd. This mowed basin contains one concrete channel with four inlets (Figure 2.4.11; noted as BMP-10 on the watershed map in Appendix A). The channel had a buildup of sediment, gravel and leaves, which ultimately blocked the outlet. Some pooling of water was present as a result of the blockage and a fill line made of grass clippings indicated that the basin may fill up to 1-2 ft high, likely due to the blocked outlet. Existing conditions pose a potential breeding area for mosquitos.

**Figure 2.4.11: Site conditions at the Foxhall basin.**

Recommendations: The existing basin should be retrofitted into a naturalized extended detention basin. It should be vegetated and the channel buildup and outlet should be cleared. The low flow channels should be replaced with a meandering, non-impervious channel to allow for infiltration and / or evapotranspiration. A no mow line should also be established.

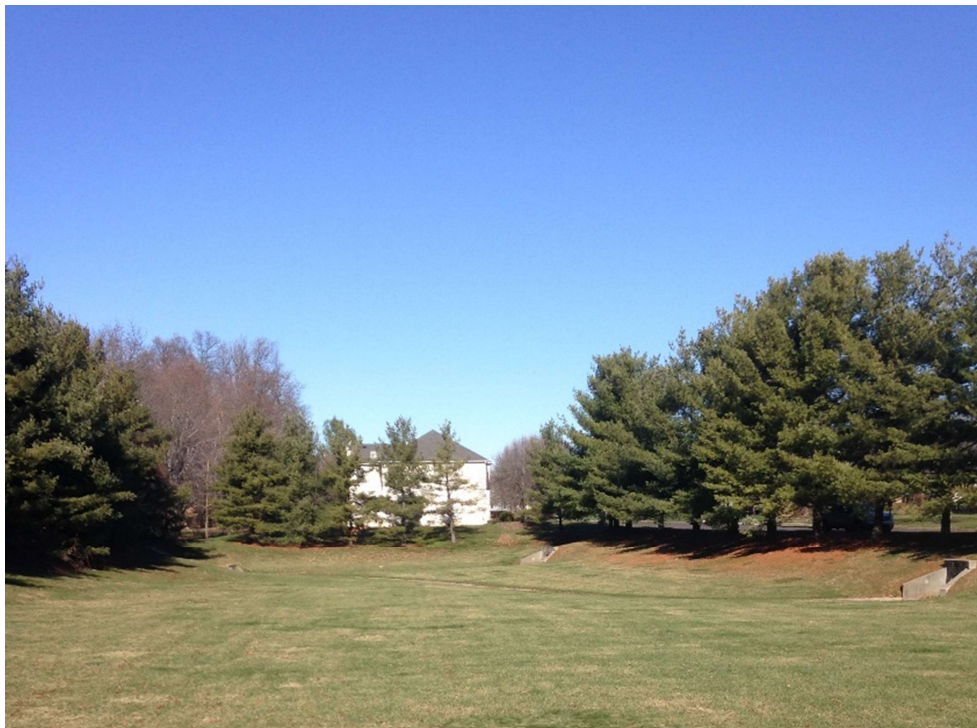
This basin is located in the southwest corner of Dorothy Dr and Brentwood Rd. It is a mowed basin containing concrete channels (Figure 2.4.12; noted as BMP-11 on the watershed map in Appendix A). There was a buildup of sediment and leaves within the channels. The western side of the basin is vegetated and buffered to the houses behind it. The eastern side has some trees lining the road, while a farm is located on the southern side of the basin.

**Figure 2.4.12: Site conditions at the Dorothy basin.**

Recommendations: The existing basin should be retrofitted into a naturalized extended detention basin. It should be vegetated with the establishment of a no mow area. The low flow channels should be replaced with a meandering, non-impervious channel to allow for infiltration and / or evapotranspiration.

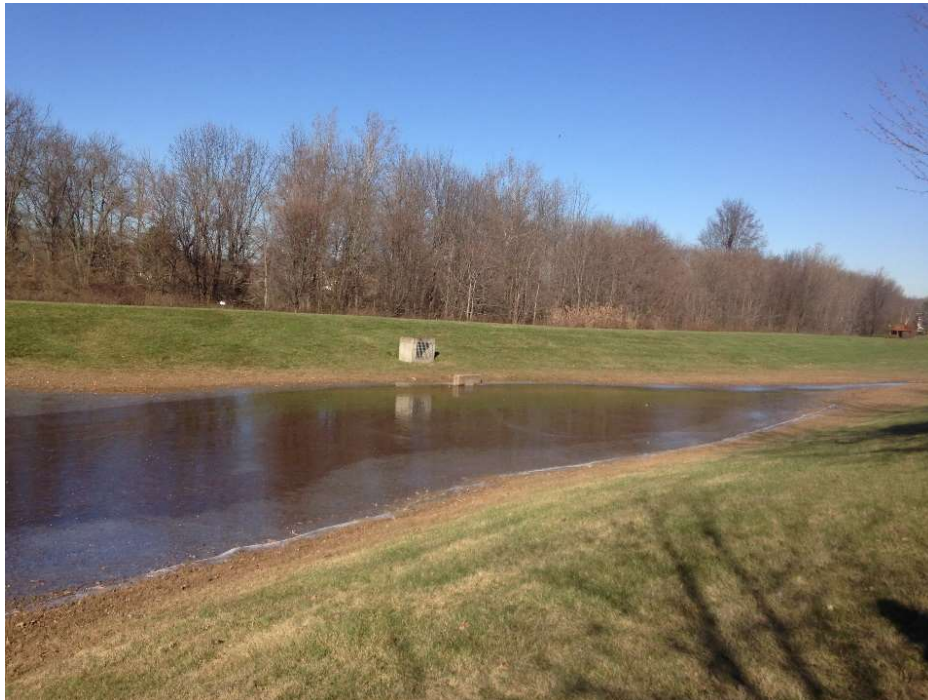
This basin is located in the southwestern corner of Bridle Estates Dr. and is mowed with concrete channels leading to the outlet. At the time of the site visit, in which it had not rained in the last few days, a large pooling of water was present, resembling a shallow pond (Figure 2.4.13; noted as BMP-12 on the watershed map in Appendix A). The low flow channels contained a buildup of sediment, leaves and grass clippings. The “pond” was iced over and the outlet appeared to be blocked at this time.

**Figure 2.4.13: Site conditions at the Bridle Estates basin.**

Recommendations. Depending on the amount of water that remains in the basin, it may be more appropriate to convert this existing detention basin into a wet pond / retention BMP. If this is not feasible, the existing basin should be retrofitted into a naturalized extended detention basin. The basin should be vegetated and the accumulated debris within the channel and outlet should be cleared. The low flow concrete channels should be replaced with meandering, non-impervious structures. A no mow line should also be established. Again, depending on the amount of water that tends to pool here, the wet pond / retention BMP may be more appropriate.

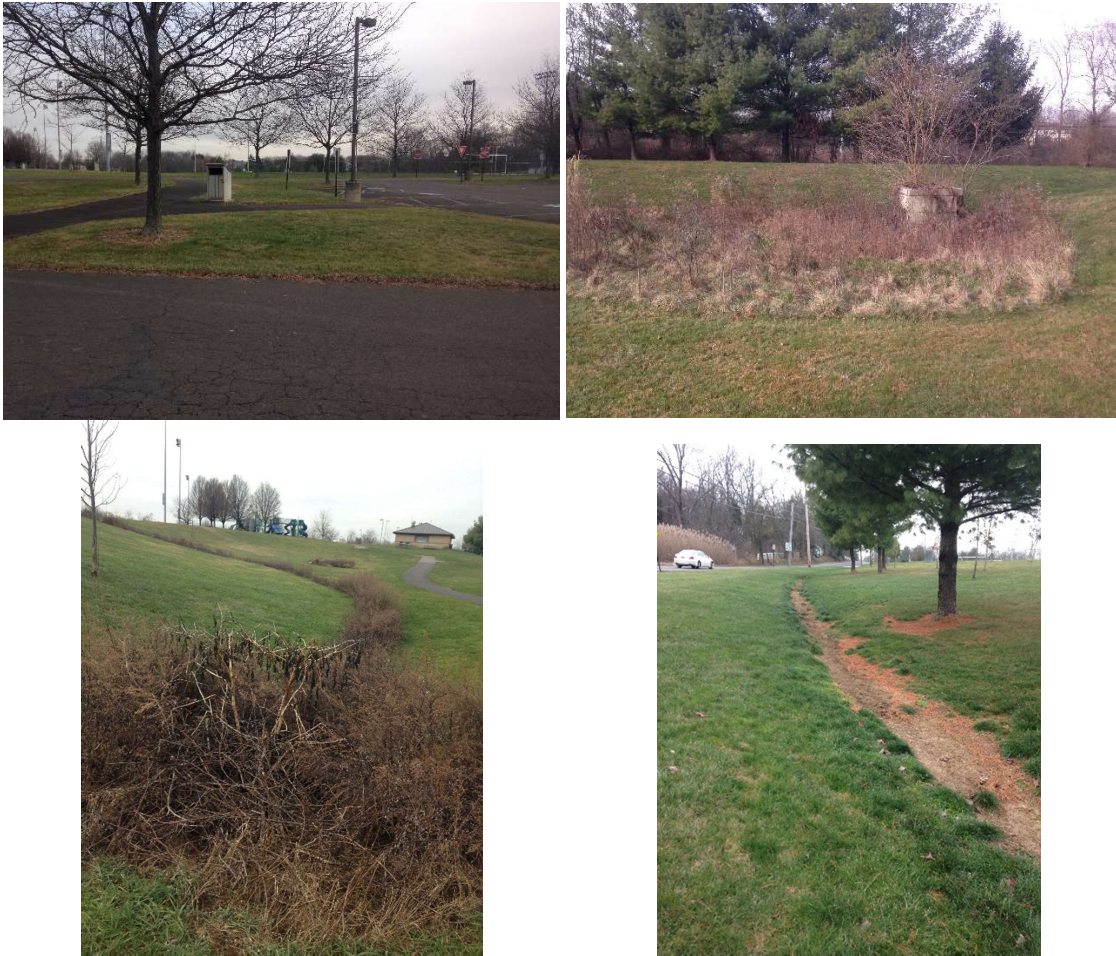
This site is located at a park along Langhorne Yardley Rd mainly used for its athletic fields. There are a number of locations within the park that could be selected for watershed improvements (Figures 2.4.14 through 2.4.17; noted as BMP-13 on the watershed map in Appendix A). First, the park contains a naturalized basin on the western edge which could potentially be expanded, and the swale leading to it could be enhanced. There is a small rock channel behind the baseball fields adjacent to the parking lot that is currently mowed. Also, there are multiple mowed areas within the parking lot that currently serve no purpose. A somewhat vegetated J hook riprap channel is located between a soccer and baseball field that leads to an overgrown eroded pit at the bottom of the hill. There is a swale adjacent to Langhorne Yardley Rd that drains into the creek that has experienced some erosion. This swale receives stormwater directly from the road as well as the park.

**Figures 2.4.14 through 2.4.17: Site conditions at Middletown Community Park.**

Recommendations: The current naturalized basin on the western edge could be expanded. A vegetated swale could replace the current swale leading to that basin. A vegetated swale could be installed behind the first set of baseball fields. The grassed areas in the parking lot could be retrofitted into rain gardens. The J hook riprap should have a vegetated buffer and the eroded pit at the bottom should be stabilized and vegetated. The roadside swale should be retrofitted to a vegetated swale to combat excess nutrients and sediments from directly entering the creek. A vegetated buffer can also be placed between the swale and the road / fields. There may be a possibility for a baffle box somewhere in the area to help reduce inputs to the creek.

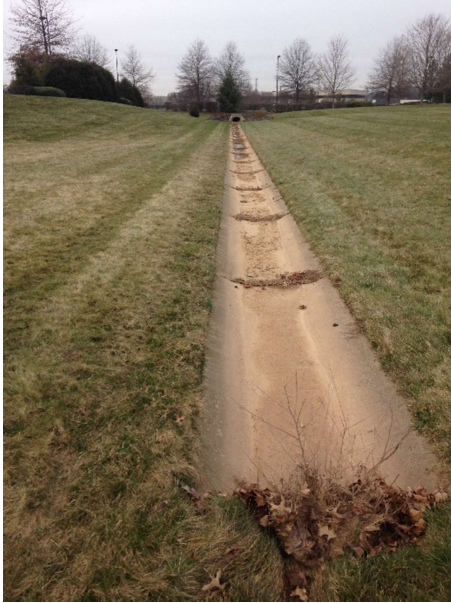
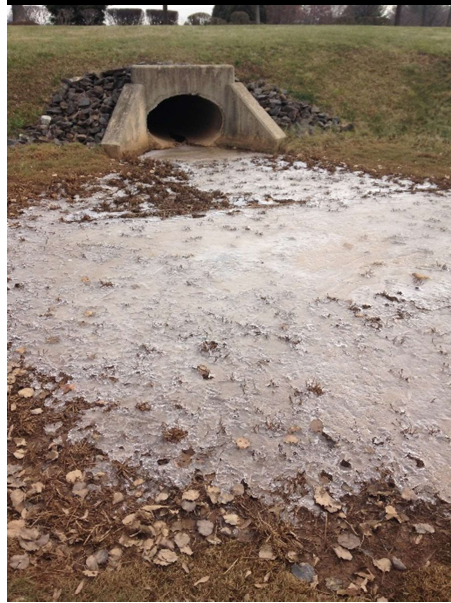
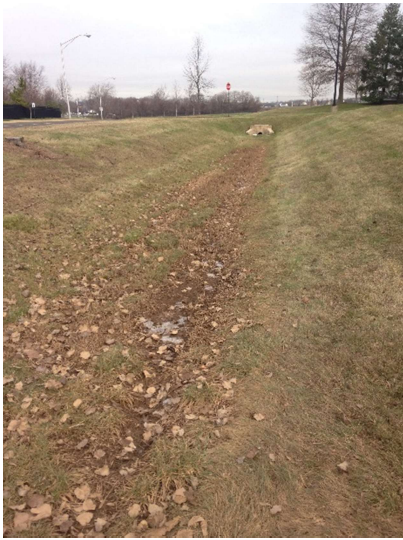
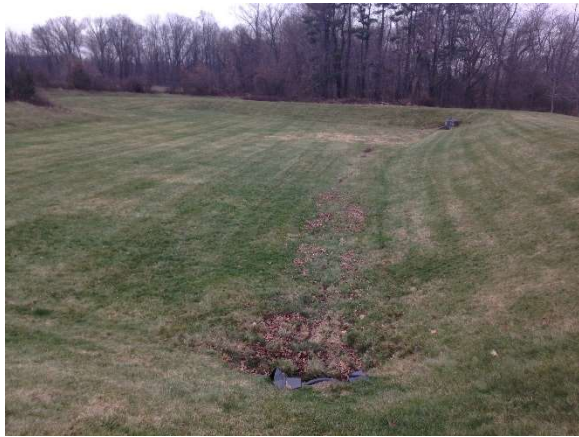
This site is located at the Newtown campus of Holy Family University. This area is also adjacent to an old Lockheed Martin facility as well as Shady Brook Farm. There were various BMPs that could be improved at this site (Figures 2.4.18 through 2.4.21; noted as BMP-14 on the watershed map in Appendix A). North of the Holy Family parking lot, there is a long stretch of concrete channel leading from the farm area. There was a buildup of sediment within the channel which leads to an outlet surrounded by riprap sides. Evidence of Canada geese was noted at this site. This outlet leads to the other side of the berm, where a large bed of rock allows for filtration. The area had large quantities of sediment, leaves and standing water. A swale runs the length of Campus Dr to the basin at the southeastern end of the property. This swale is generally acceptable with a few muddied areas and a partially blocked exit under one of the access roads. There is also a swale with a riprap bed at the end before a forested area connects with the roadside swale. The swale leads to a large, mowed basin with steep side slopes that contains eroded channels. There is a constructed spillway on the opposite side of the channel inlet which is reinforced with rock or cement blocks that leads to the forest. There was evidence of standing water in the center of the spillway.

Figures 2.4.18 through 2.4.21: Site conditions at Holy Family University at Newtown.

Recommendations: The basin in the southern portion of the site should be retrofitted into a naturalized detention basin. The channel should be enhanced and the area vegetated. A no mow area should be enforced. The spillway may be able to be enhanced. The roadside and connecting swale should be vegetated with native species and the adjacent forest could be expanded. The low flow channel in the area north of the parking lot should be replaced with a more efficient system. The bed of rock in front of the outlet could be enhanced or expanded as well as buffered with vegetation to help settle the large amount of sediment entering the area.

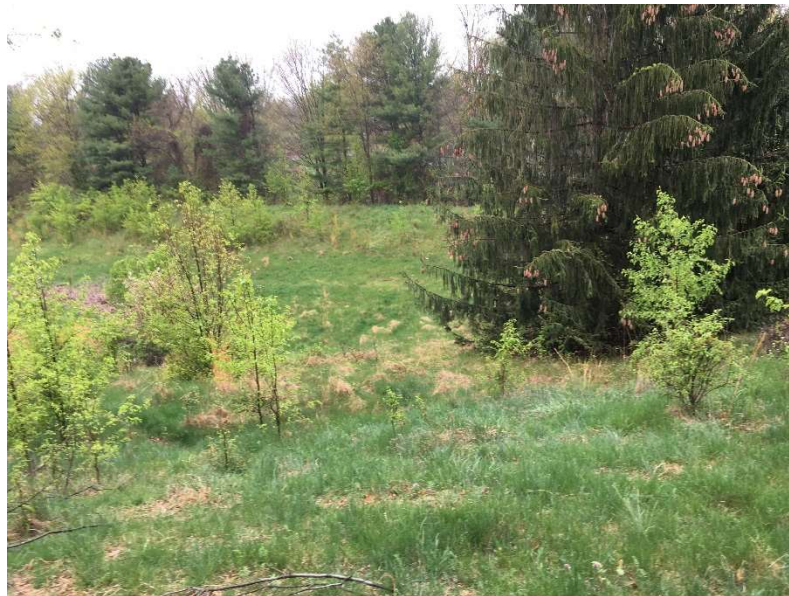
Middletown Township applied for Growing Greener 2016 funding to retrofit this basin (Figure 2.4.22; noted as BMP-15 on the watershed map in Appendix A) and several others in township. This basin has very steep sides and has been naturalized by with a mixture of native and invasive species.

**Figure 2.4.22: Site conditions at Teal Drive stormwater basin.**

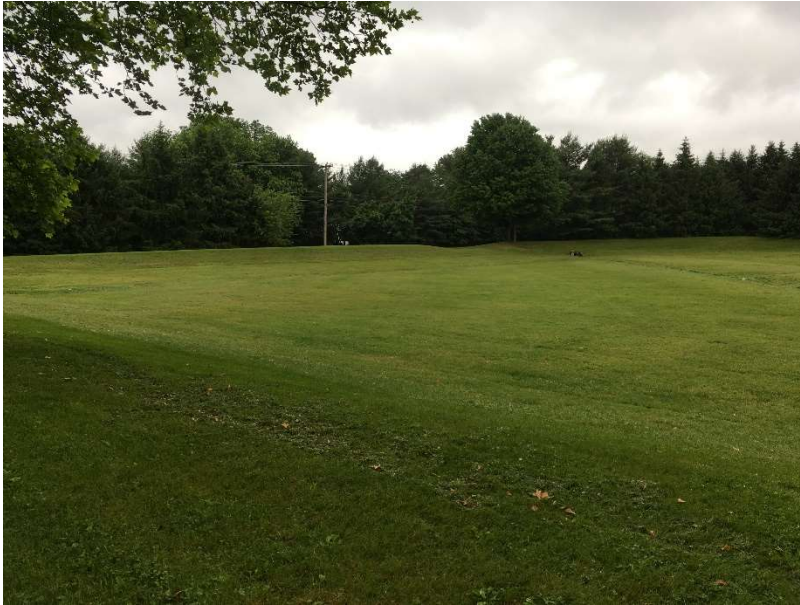
Middletown Township applied for 2016 Growing Greener funding to retrofit this basin and several others in the municipality (Figure 2.4.23; noted as BMP-16 on the watershed map in Appendix A). This is a standard large mowed basin buffered to most of the adjacent houses by a large hedgerow.

**Figure 2.4.23: Site conditions at Swan Pointe stormwater basin.**
