# Updated Watershed Implementation Plan for Core Creek/Lake Luxembourg Bucks County, PA

### **Princeton Hydro, LLC**

**Second Revision May 2017**

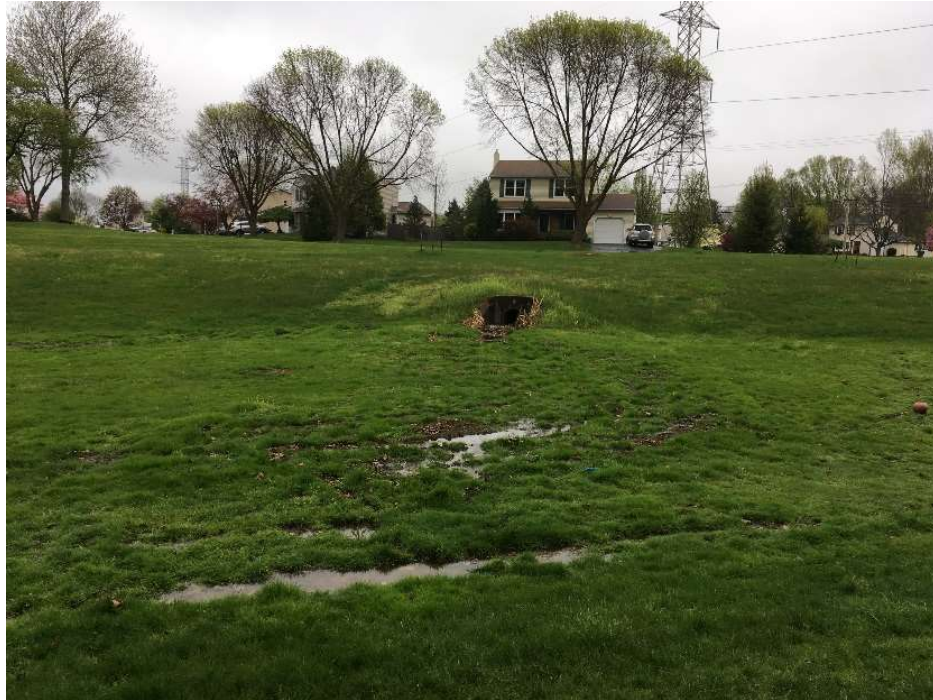
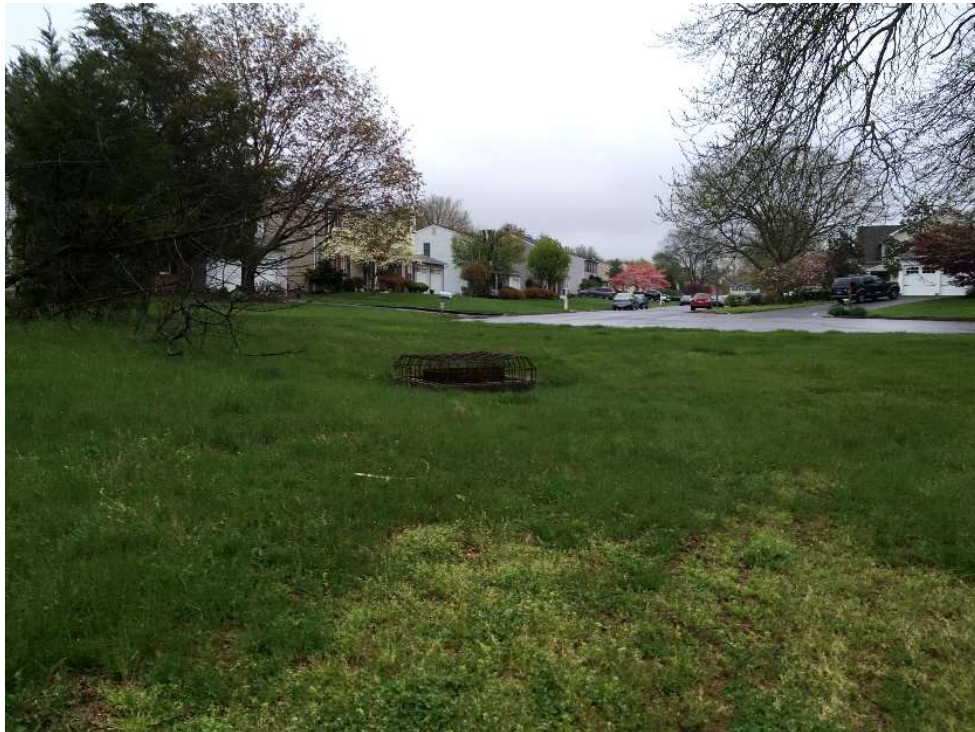
Large regional basin for this neighborhood (Figures 2.4.24 and 2.4.25; noted as BMP-17 on the watershed map in Appendix A). Does not appear to be well maintained and/or functioning as was intended. Per Bucks County parcel data, this basin is owned by Middletown Township.

**Figure 2.4.24 – 2.4.25: Site conditions at Adeline Place and Barnsbury Road stormwater basin.**

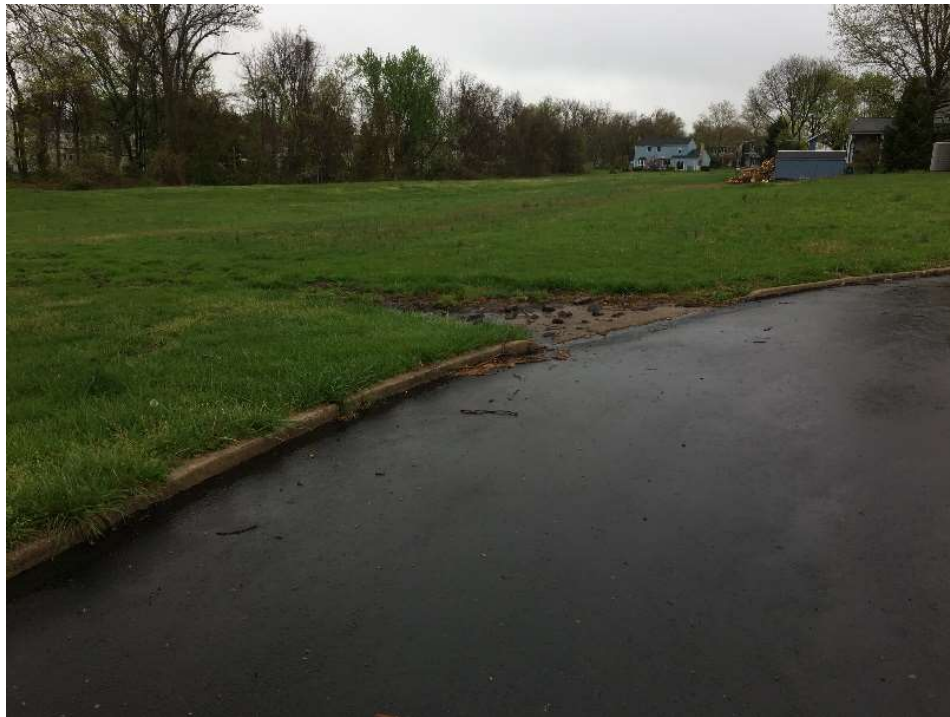
At the end of this road is a shallow basin receiving curb cuts from 2 dead end streets: Argyle Road and Barley Court (Figure 2.4.26; noted as BMP-18 on the watershed map in Appendix A). Stormwater runoff from the streets is eroding the area at the curb cuts that appear to serve as the only basin inlets.

**Figure 2.4.26: Site conditions at Argyle Road stormwater basin.**

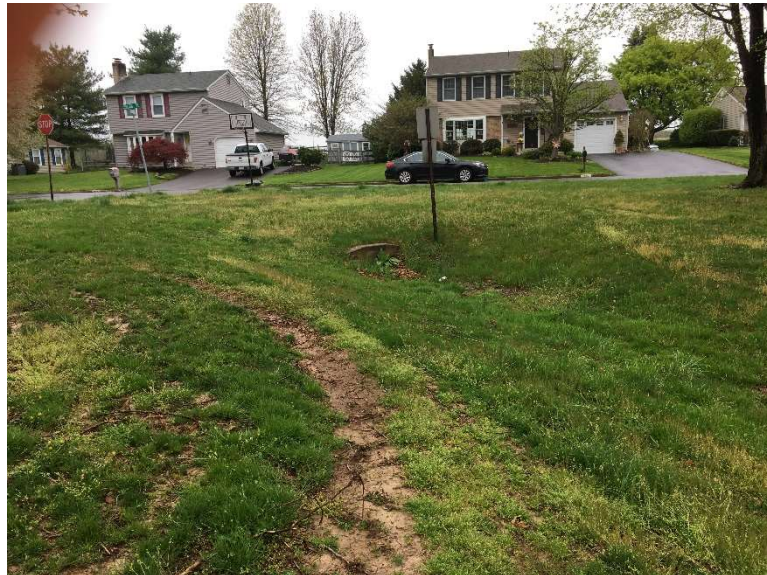
Tributary crossing at this location. Corner captured in photos is owned by Middletown Twp. (Figure 2.4.27; noted as BMP-19 on the watershed map in Appendix A). This site may be appropriate for a bioretention feature here and expansion of a limited riparian buffer. The site contains an outlet structure that captures drainage from the adjacent residential streets. The outlet discharges directly to a small tributary with no potential treatment for stormwater / surface runoff currently.

**Figure 2.4.27: Site conditions at Chilton Place discharge area.**

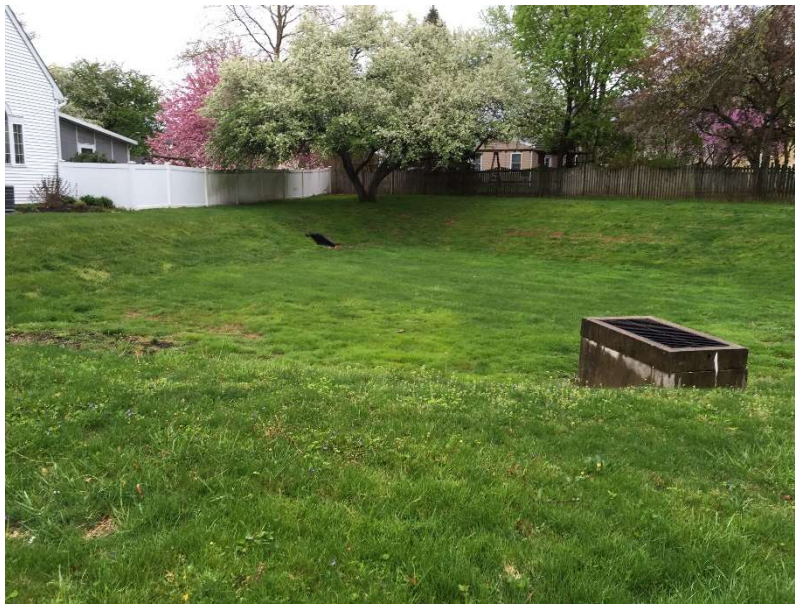
This site contains a small basin that is mowed (Figure 2.4.28; noted as BMP-20 on the watershed map in Appendix A). Unlike most of the other sites listed in this report, the Bucks County parcel info basin indicates that this basin is owned by the Home Owners Association.

**Figure 2.4.28: Site conditions at Stonebridge Court basin.**
