# FINAL REPORT

## *Lake Galena & North Branch Neshaminy Creek Watershed Implementation Plan*

*September 24, 2010*

**Aqua Link, Inc.**  
Pond, Lake & Stream Management & Supplies

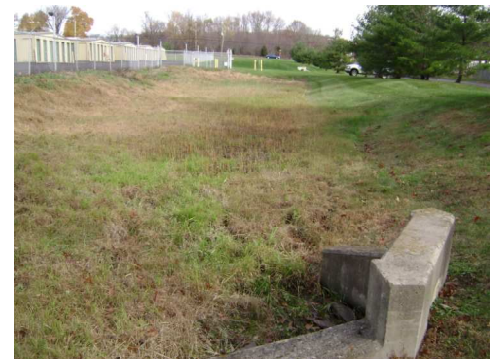
No. 6 - Photograph 2  
AA Self-Storage – West of Entrance Drive

evidence of erosion along a low flow channel that has developed over time. The area to the west of the drive is not mowed as often and is more of a meadow, which is more stable. Although the west facility is acceptable, the east basin should be modified to address the erosion issue and possibly establish a wet-meadow condition, which would improve water quality.

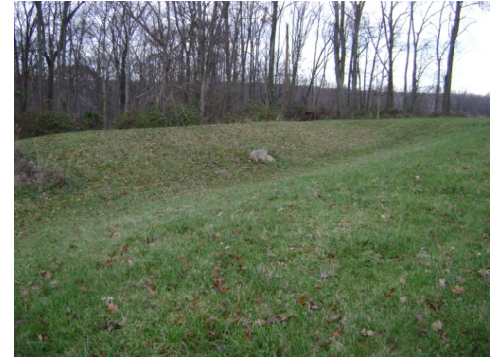
No. 9 - Photograph 1  
Czestochowa Shrine Cemetery – Basin 2

These two basins are installed below the cemetery at the Shrine. Unfortunately, there was no design information available for these basins. Basin 1 appears to be installed as a sediment control structure, while basin 2 has been completed and stabilized as lawn. Both facilities are intended as dry detention facilities. During our site visit, Basin 1 has been allowed to support a naturalized meadow appearance, while Basin 2 has been maintained as manicured lawn. Unless the sediment control structure is still needed, it should be removed and replaced with appropriate “permanent” controls and trash racks. Additional vegetation should be considered for Basin 2 to enhance water quality.

The sediment control structure on the one basin should be removed if all active earthmoving work has been completed. Native plants around this structure should be allowed to remain to improve water quality.
