# PHASE I FINAL REPORT

## Cooks Run Watershed Assessment

**CZM PROJECT NUMBER: 2002-PD.14**

*March 31, 2004*

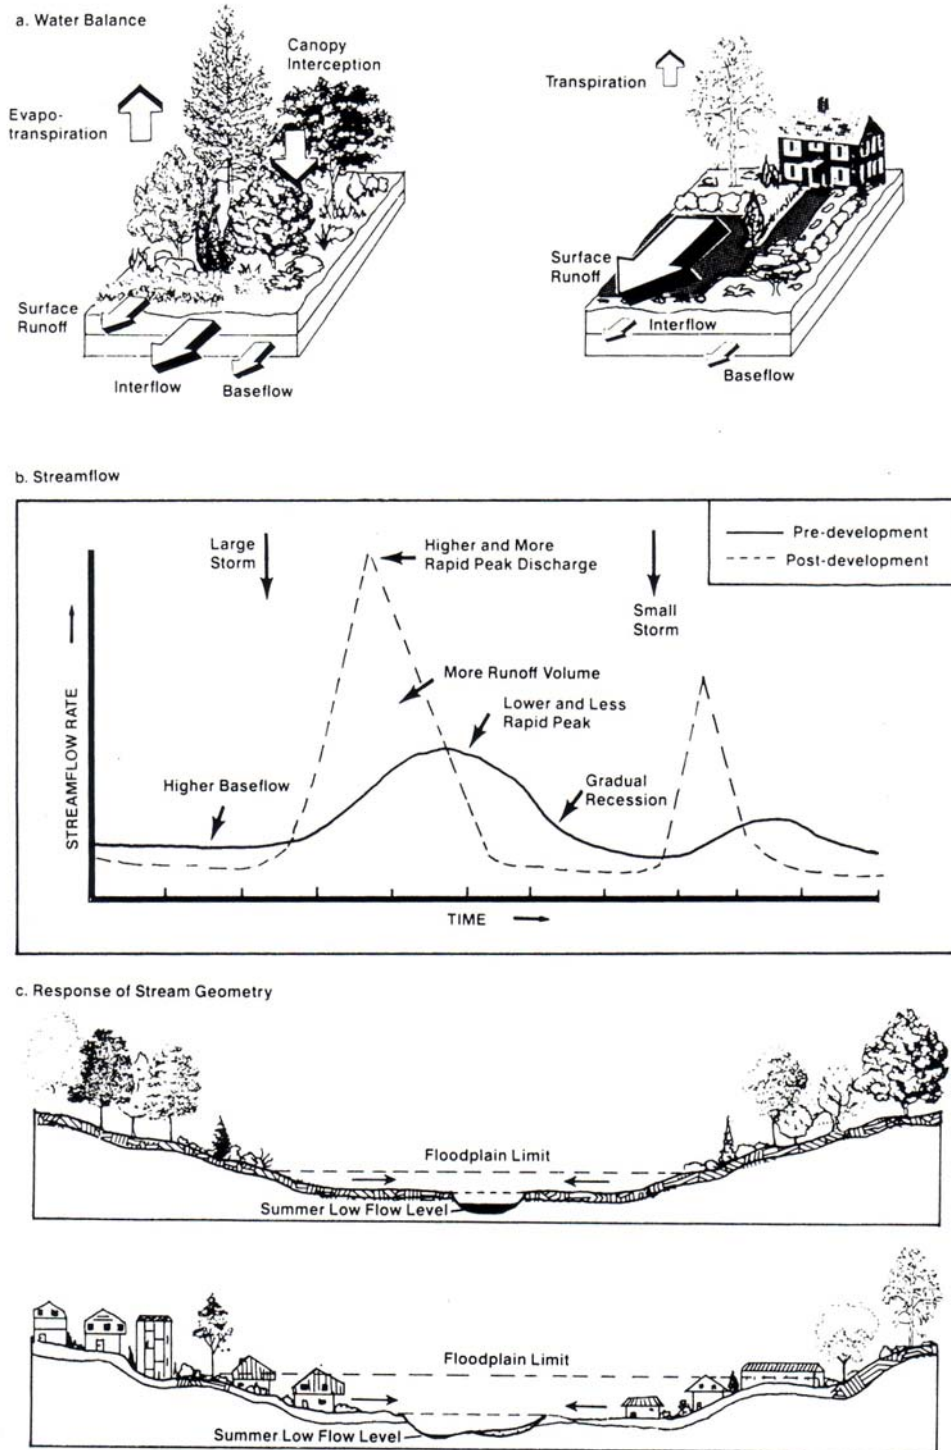
Figure 3.1 Changes in Watershed Hydrology as a Result of Urbanization

In a typical, moderately developed watershed, the net effect of development is a series of changes to stream hydrology (Figure 3.1 b) including:

- Increased peak discharges about two to five times higher than pre-development levels.
- Increased volume of storm runoff produced by each storm, in comparison to pre-development conditions. A moderately developed watershed may produce 50% more runoff volume than a forested watershed during the same storm.

- Decreased time needed for runoff to reach the stream (termed the time concentration) by as much as 50%, particularly if extensive drainage improvements are made.

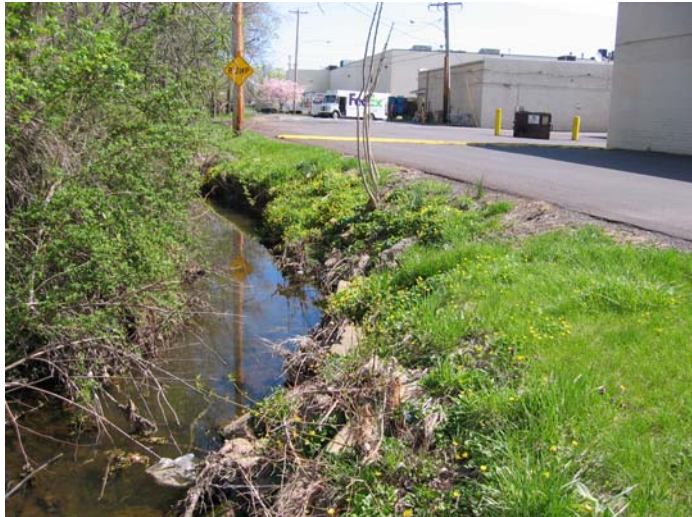
NPS 3

**NPS Problem No. 3**

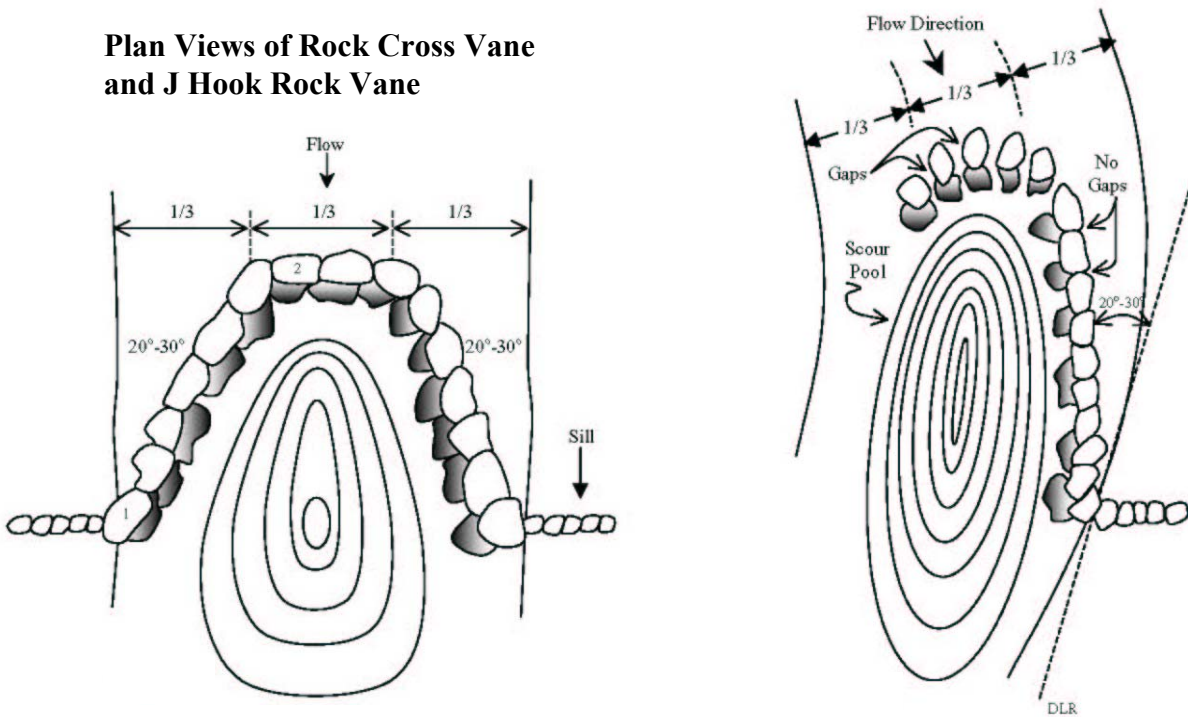
**Plan Views of Rock Cross Vane and J Hook Rock Vane**

bend or across stream channels. Common NSCD structures used in Pennsylvania are J hook rock vanes (J hooks), log vanes, rock vanes or rock cross vanes. These NSCD structures are commonly to deflect flow away from eroding stream banks, concentrate the flow in the center of the channel or enhance pool and riffle habitats.

Prior to implementation, it will be necessary to obtain the proper permits from the Pennsylvania Department of Environmental Protection (PA DEP) for these projects. Under normal circumstances, a general permit (GP-3) is commonly issued for projects that are less than 500 linear feet and an Individual Permit for Small Projects is issued for projects greater than 500 linear feet. The proposed installation of any NSCD structures will likely require an individual permit regardless of the size of the project area.

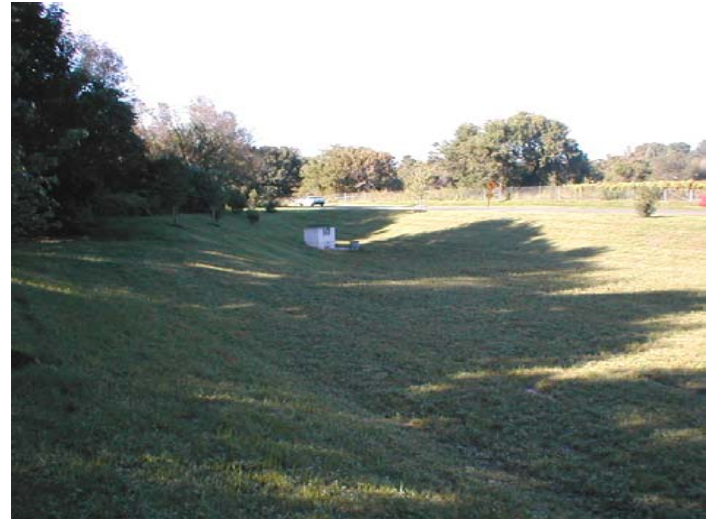
SWM 2

#### **SWM-2 Lenape Valley Foundation**

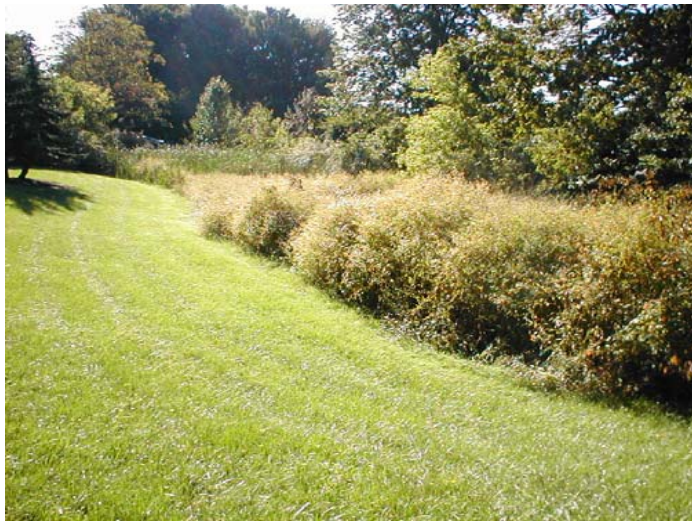
SWM 3

**SWM-3 Westwyck Community**

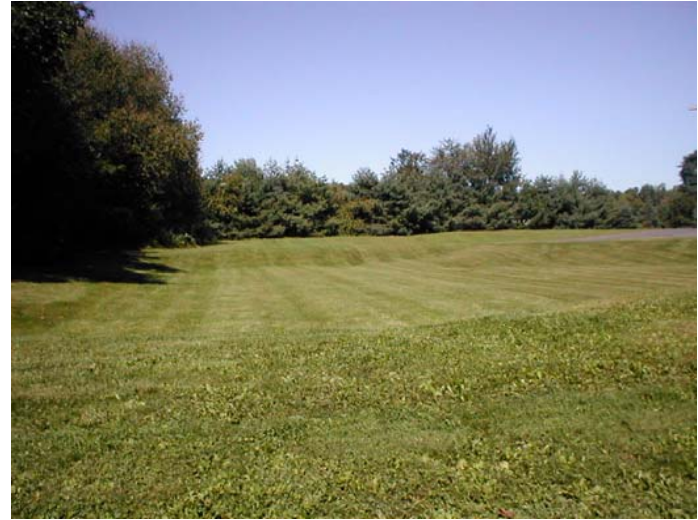
SWM 9

The Georgetown Commons detention basin is a wet pond with various wetland plantings. The pond is in very good condition with little to no erosion on the banks. Water quality is affected by lawn fertilization. The inlet and outlet structures are in good condition.

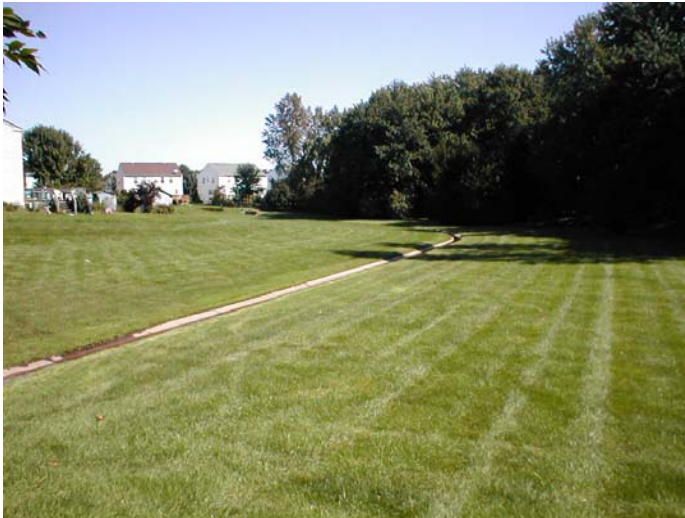
SWM 10

The Central Bucks Senior Citizens retention basin is in good condition. The basin collects runoff from parking lots and buildings, thereby making it vulnerable to nonpoint source pollution. The basin abuts to the parking lot. The inlet and outlet structures are in good condition. The entire basin is manicured lawn.
