Dimple Creek Watershed Water Chestnut Management Project Final Report

Bucks County Conservation District

Jan 10, 2022

Bucks County Conservation District
Lake Towhee Aquatic Macrophyte Treatment Report for 2019-2020 February 9, 2021

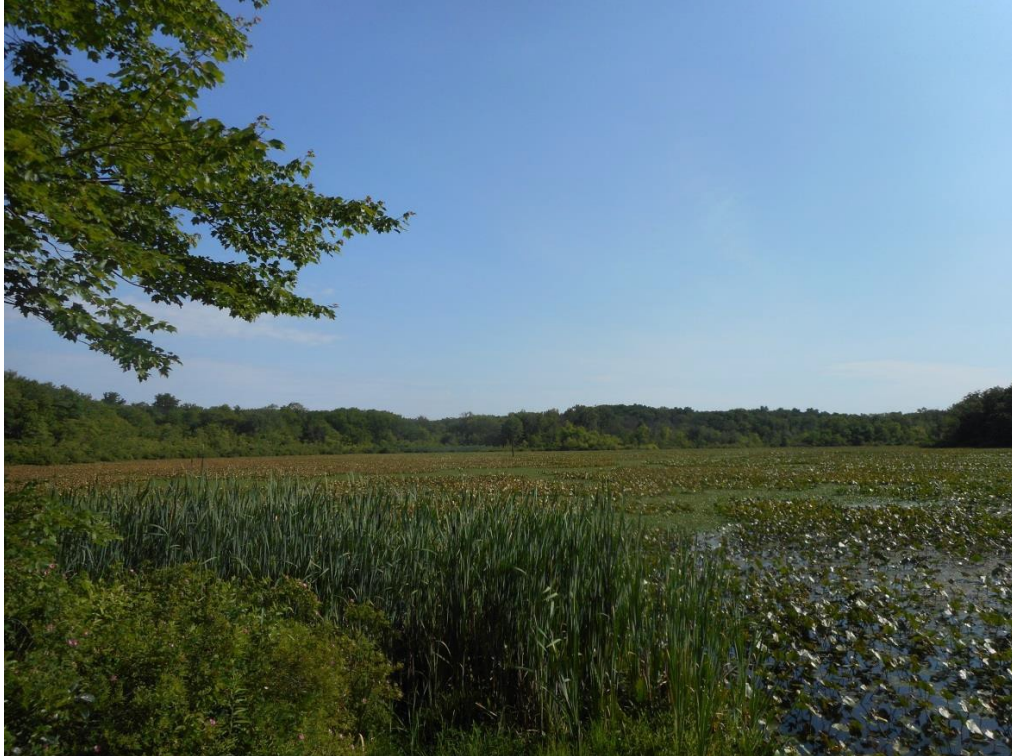
Photo 1A - Upper End of Lake - Early Summer 2019 (Date: 7/2/19)

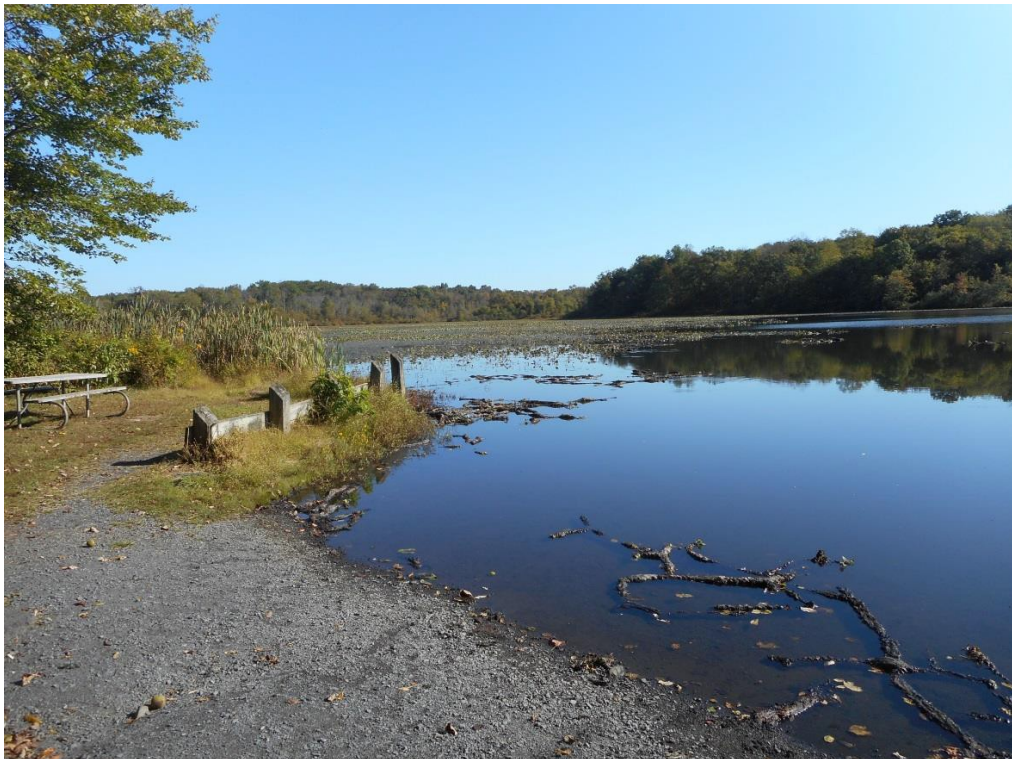
Photo 1B - Upper End of Lake – Early Fall 2019 (Date: 9/25/19)

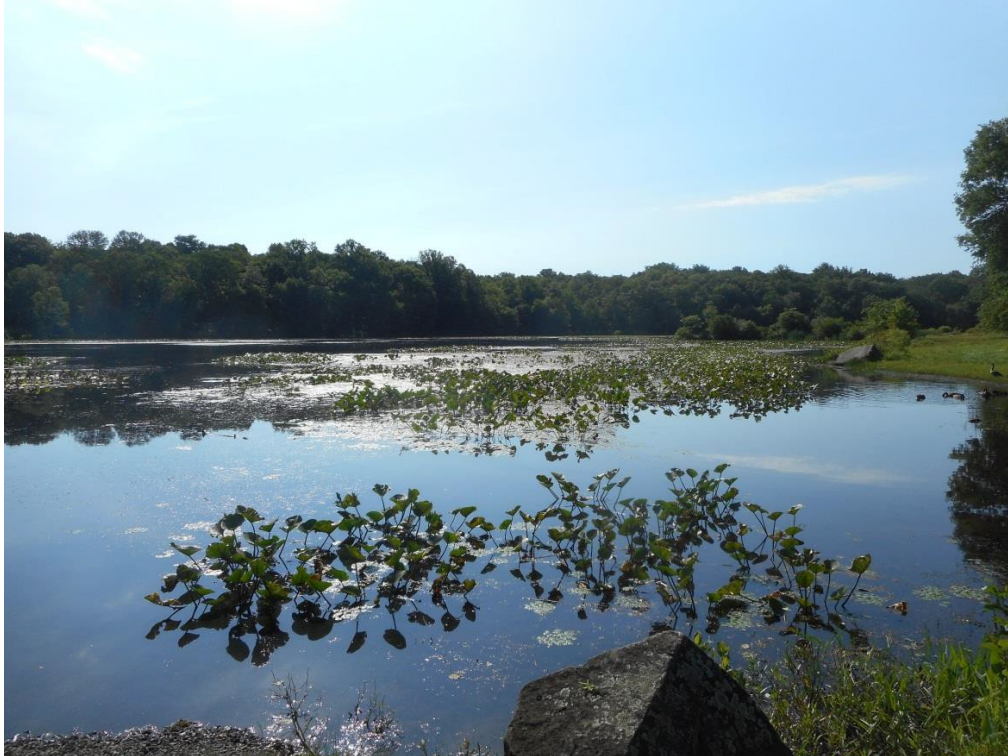
Photo 2A - Lower End of Lake – Early Summer 2019 (Date: 7/2/19)

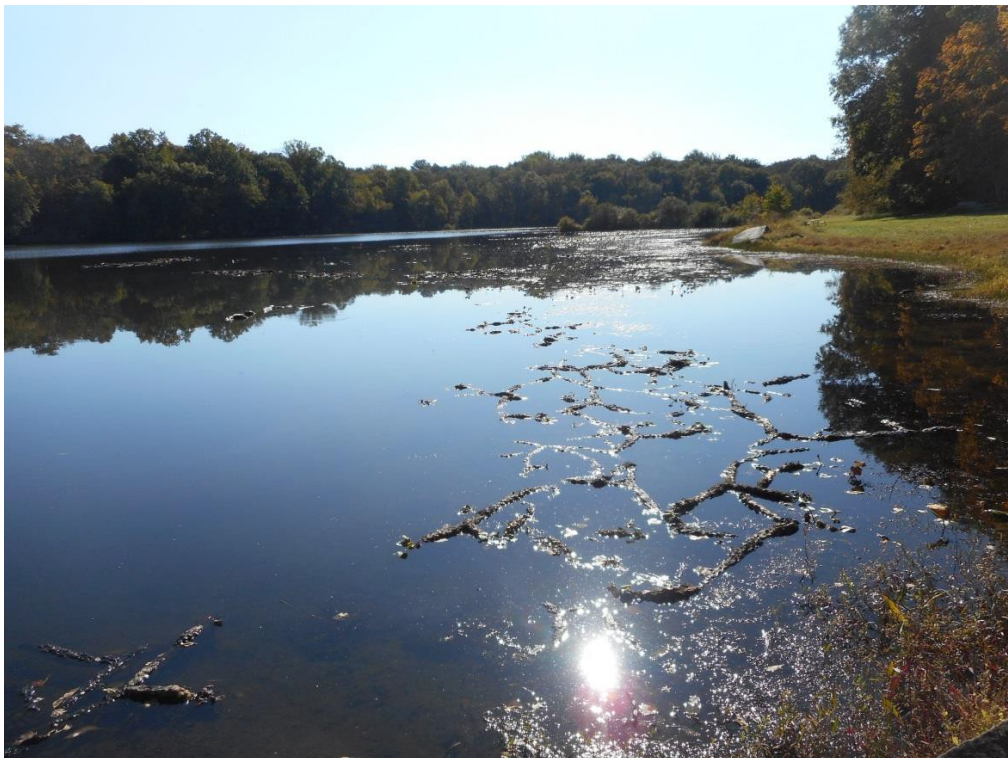
Photo 2B - Lower End of Lake – Early Fall 2019 (Date: 9/25/19)

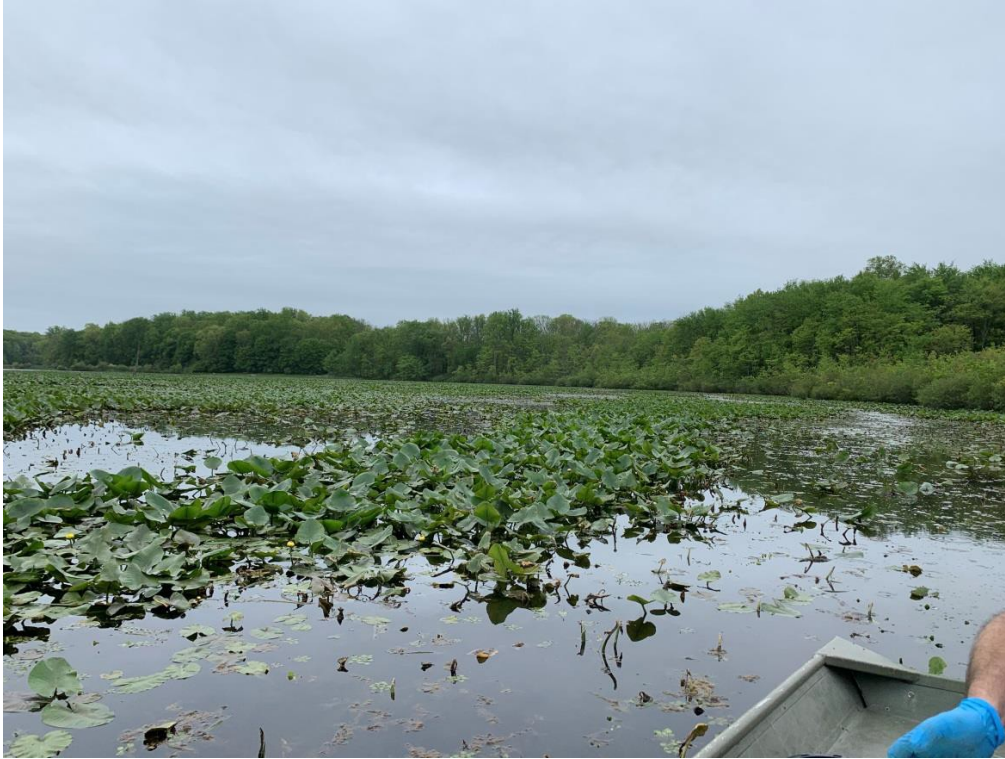
Photo 3A - Upper End of Lake – Late Spring 2020 (Date: 5/22/20)

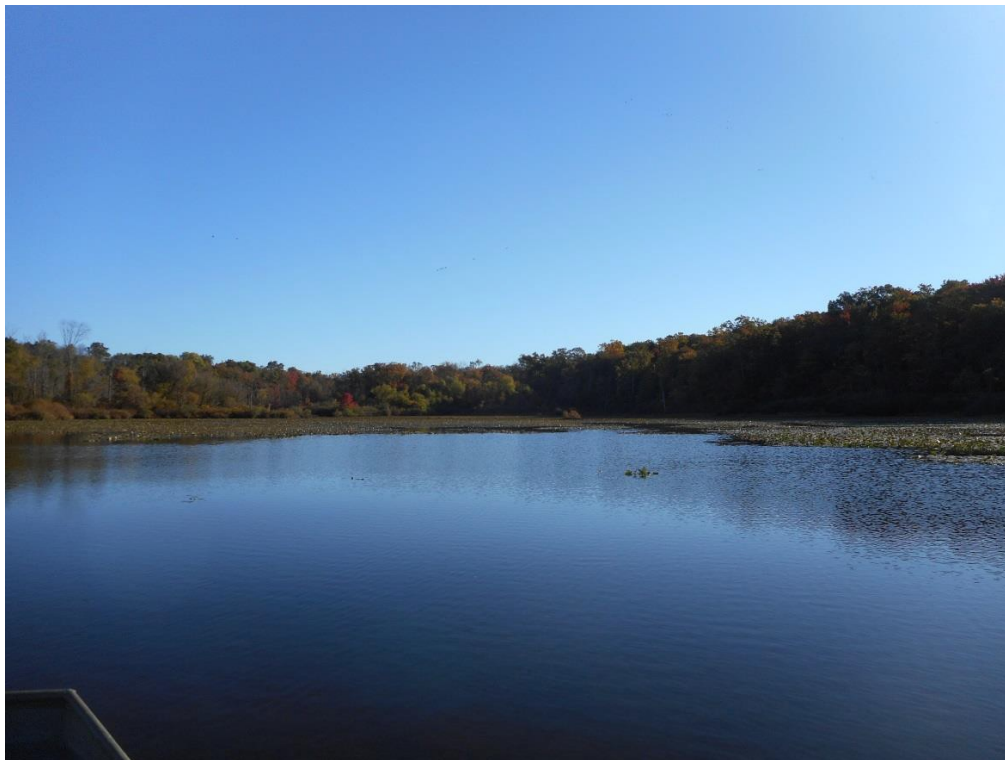
Photo 3B - Upper End of Lake – Fall 2020 (Date: 10/8/20)

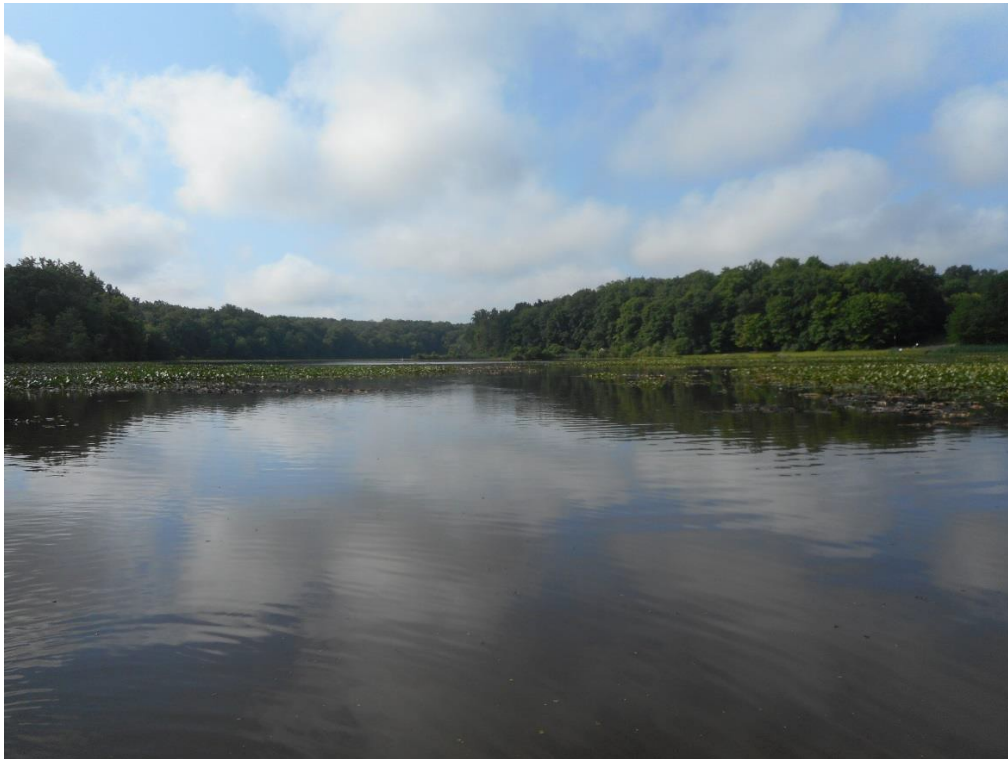
Photo 4A - Lower End of Lake – Late Spring 2020 (Date: 7/7/20)

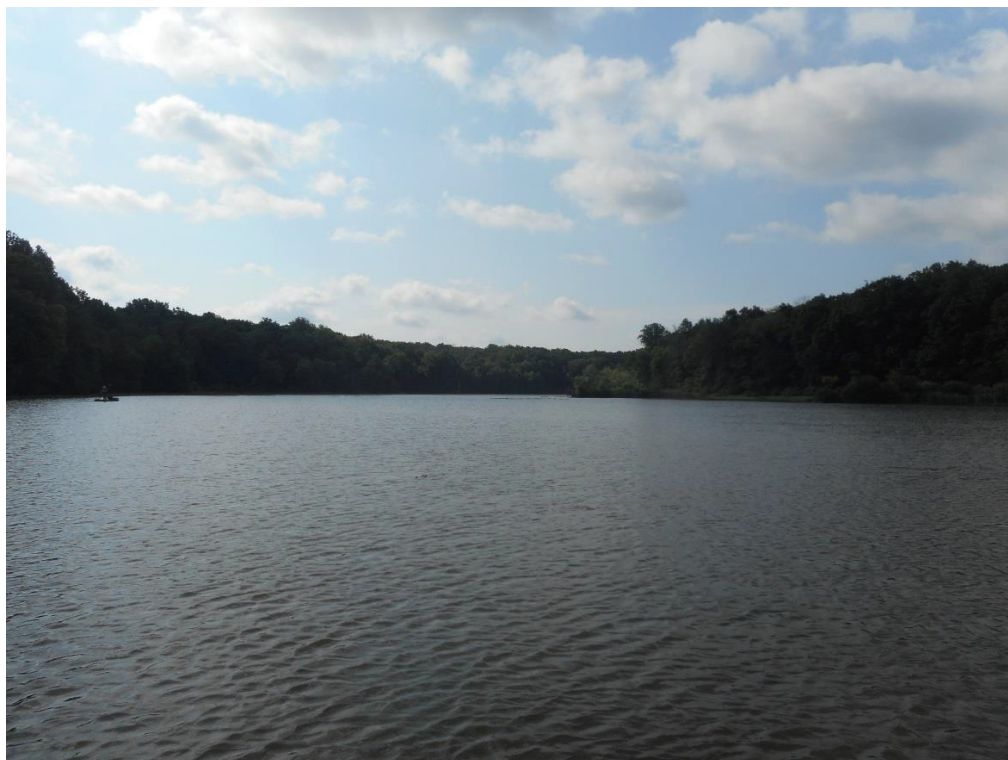
Photo 4B - Lower End of Lake – Late Summer 2020 (Date: 8/28/20)

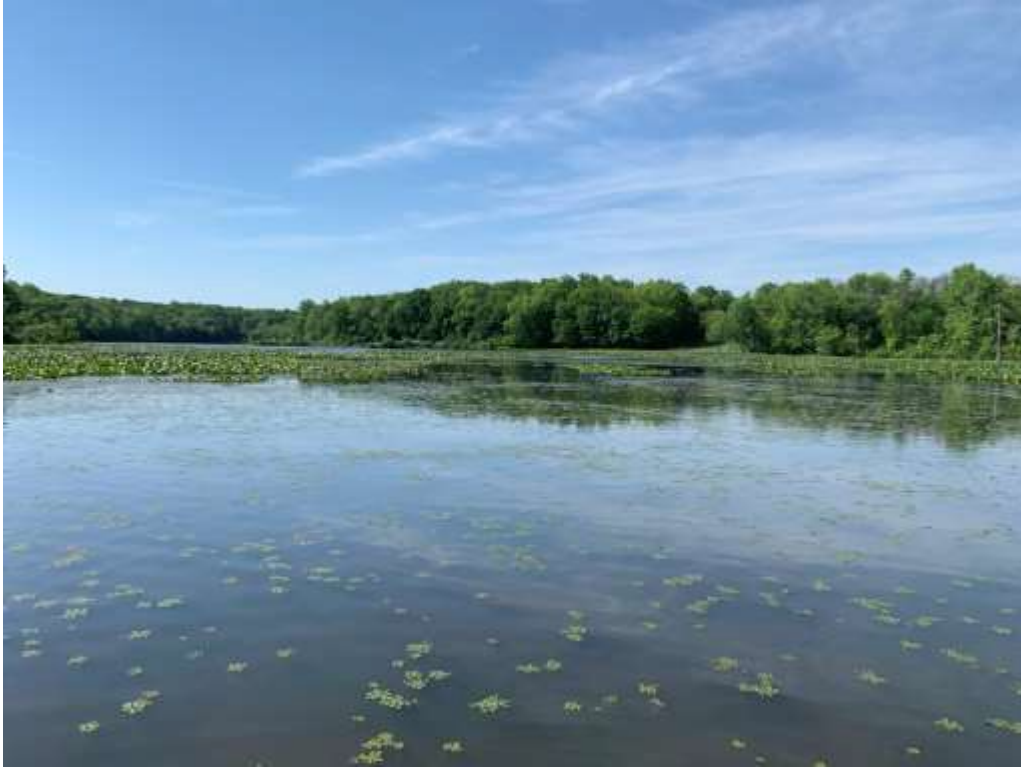
Photo 1A - Upper End of Lake – Spring of 2021 (Date: 5/20/21)

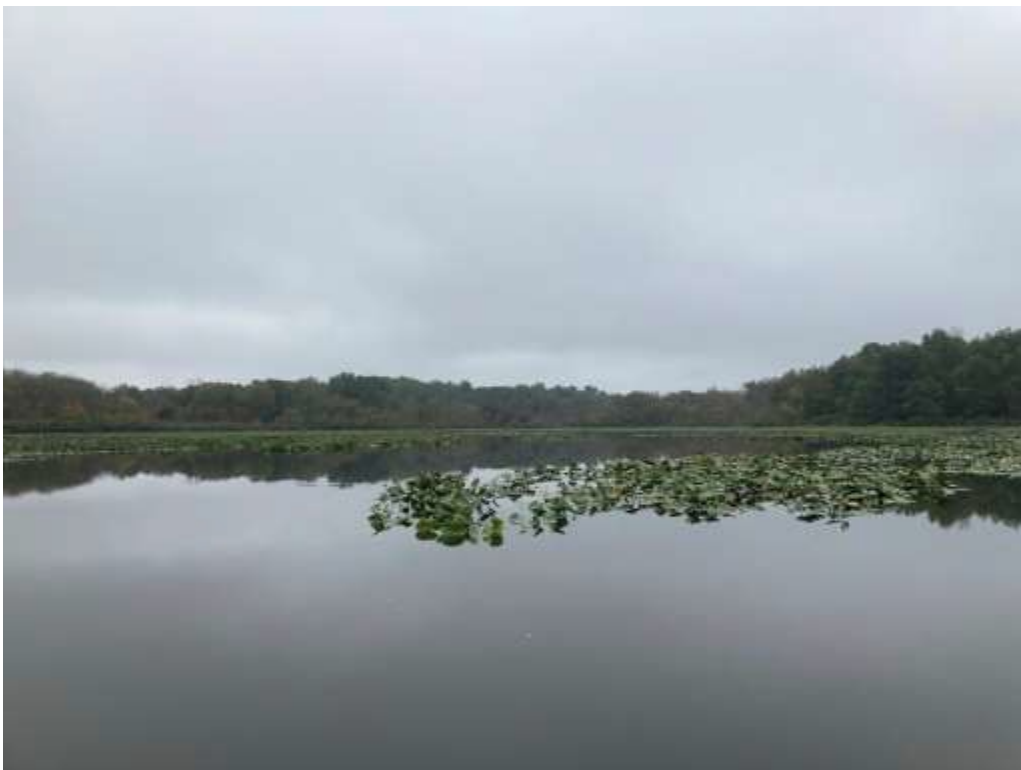
Photo 1B - Upper End of Lake – Fall of 2021 (Date: 10/6/21)

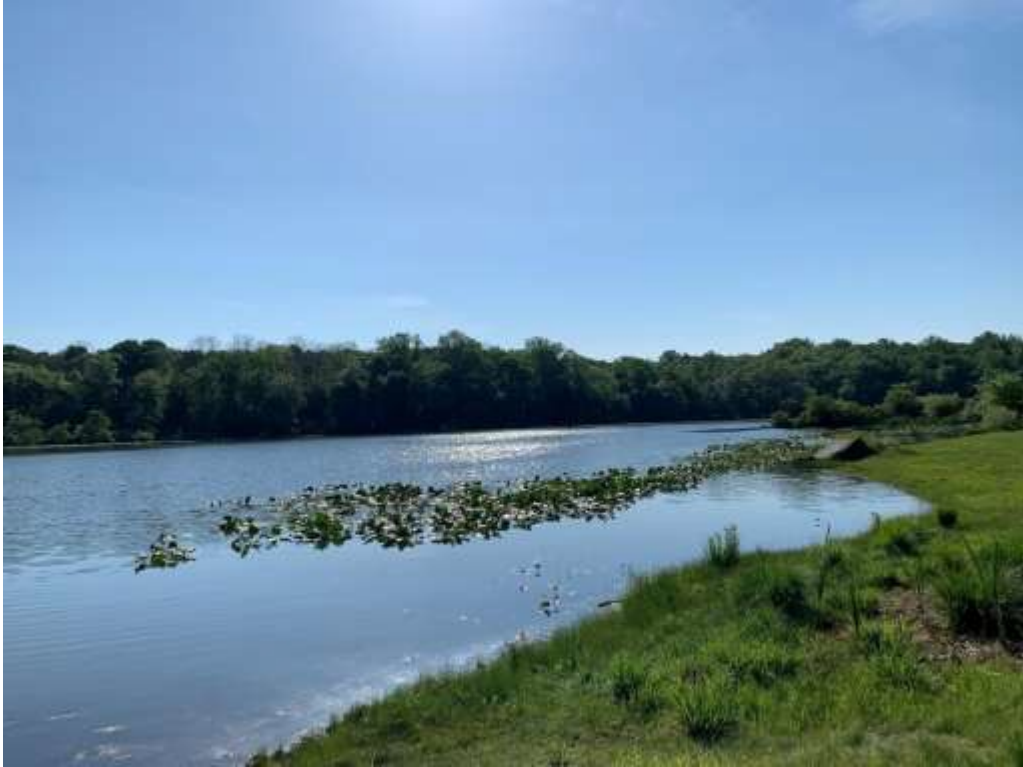
Photo 2A - Lower End of Lake – Spring of 2021 (Date: 5/20/21)

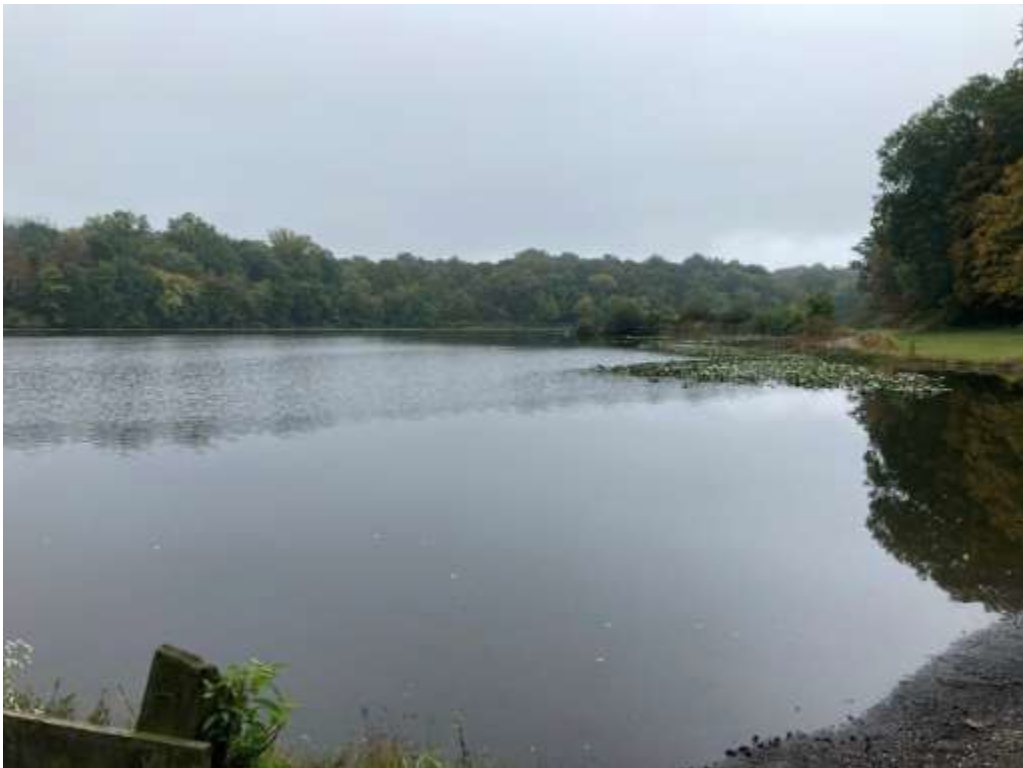
Photo 2B - Lower End of Lake – Fall of 2021 (Date: 10/6/21)

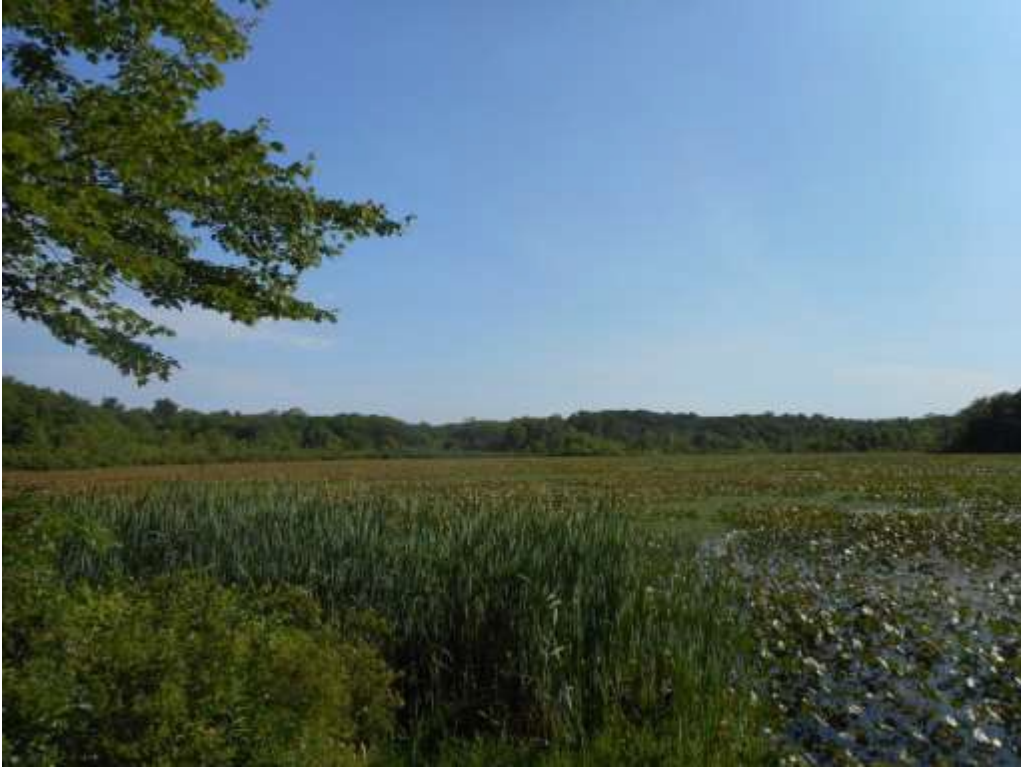
Photo 3A - Upper End of Lake - Early Summer 2019 (Date: 7/2/19)

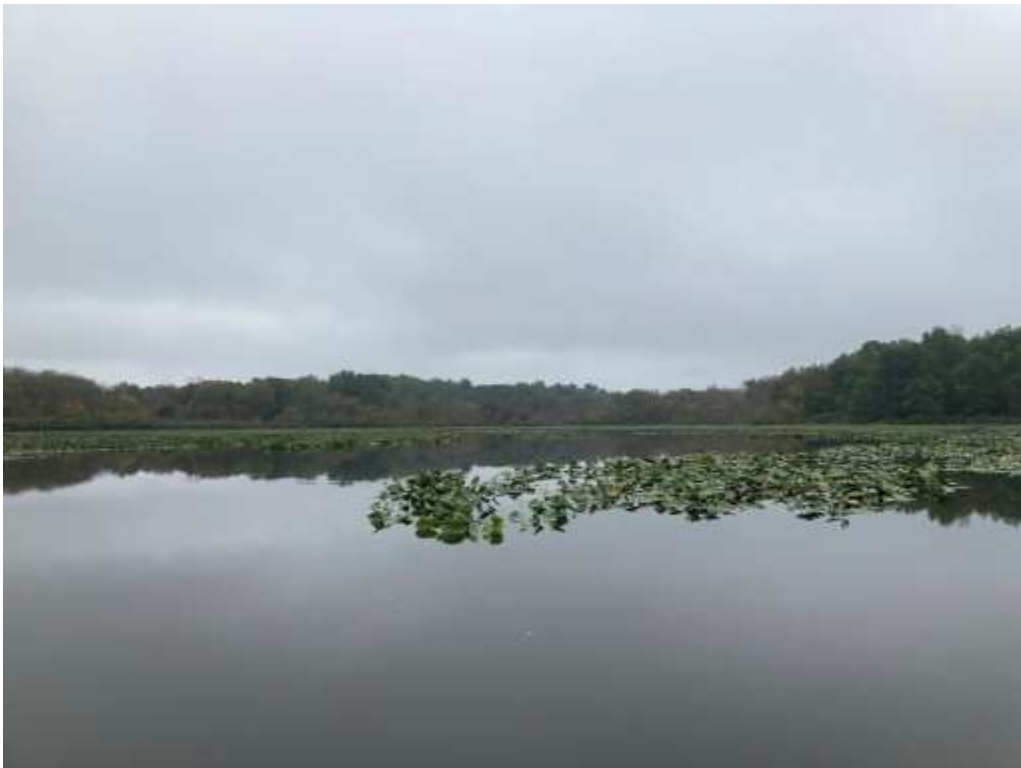
Photo 3B - Upper End of Lake – Fall of 2021 (Date: 10/6/21)

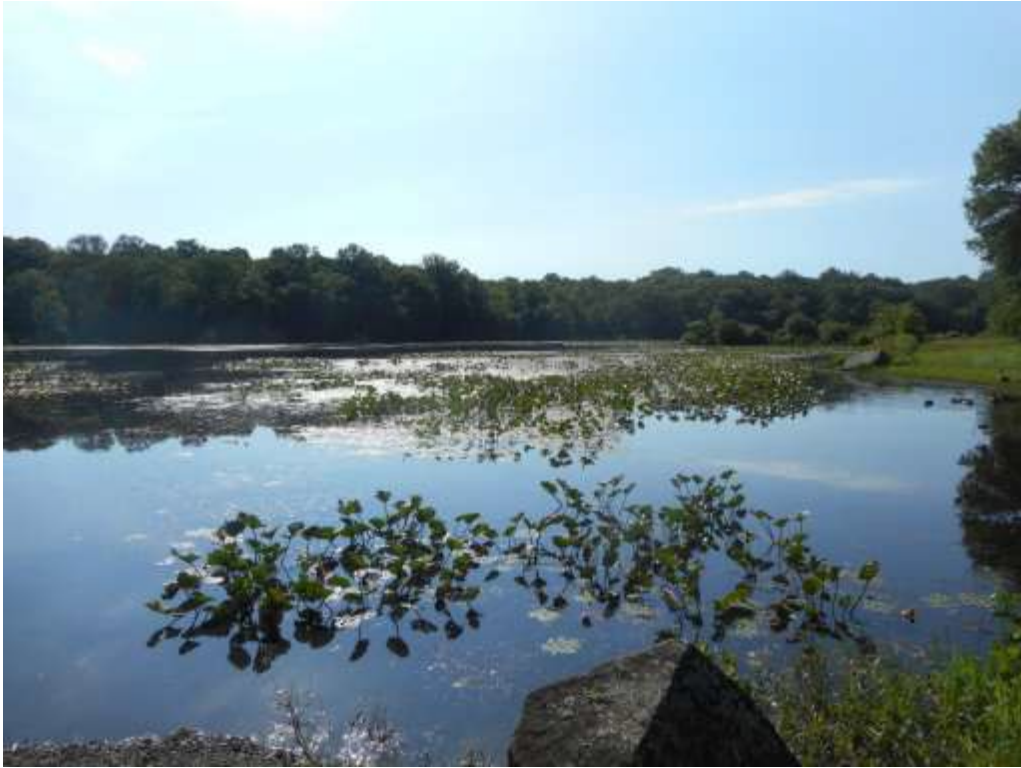
Photo 4A - Lower End of Lake – Early Summer 2019 (Date: 7/2/19)

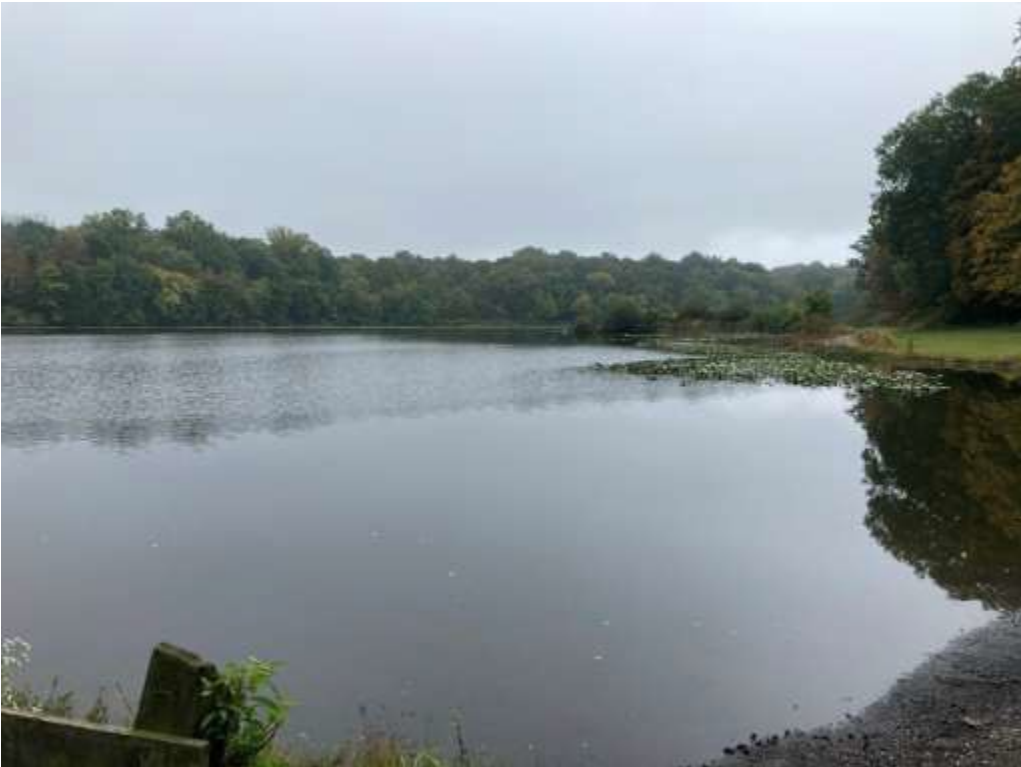
Photo 4B - Lower End of Lake – Fall of 2021 (Date: 10/6/21)

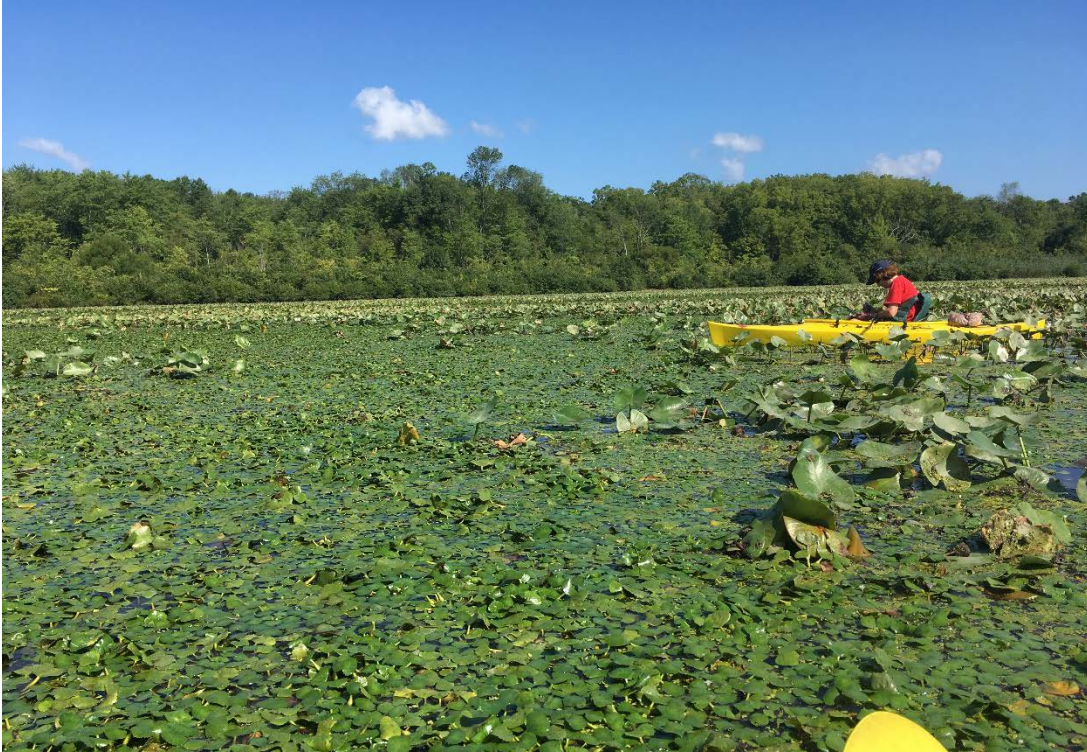
Photo 2. A 2018 volunteer, Joyse Wobensmith assesses a dense stand of water chestnut in upper reach of Lake Towhee

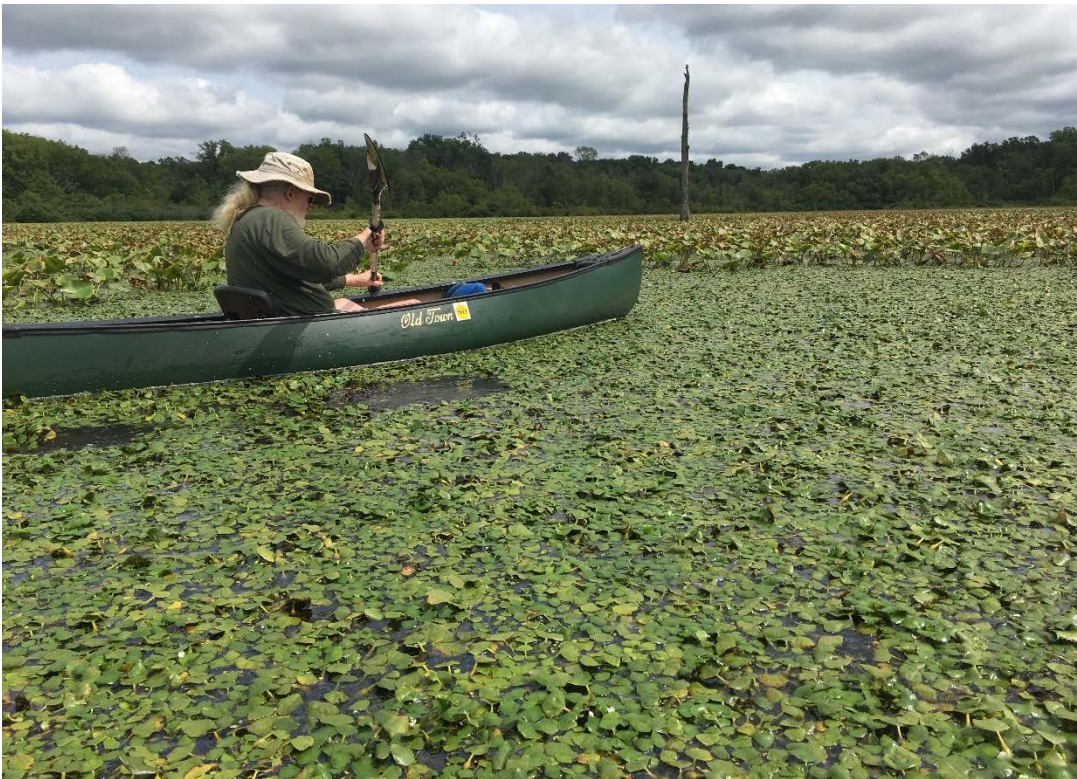
Photo 3. 2018 volunteer, Mike McCann assesses another dense stand of water chestnut in upper reach of Lake Towhee in 2018.

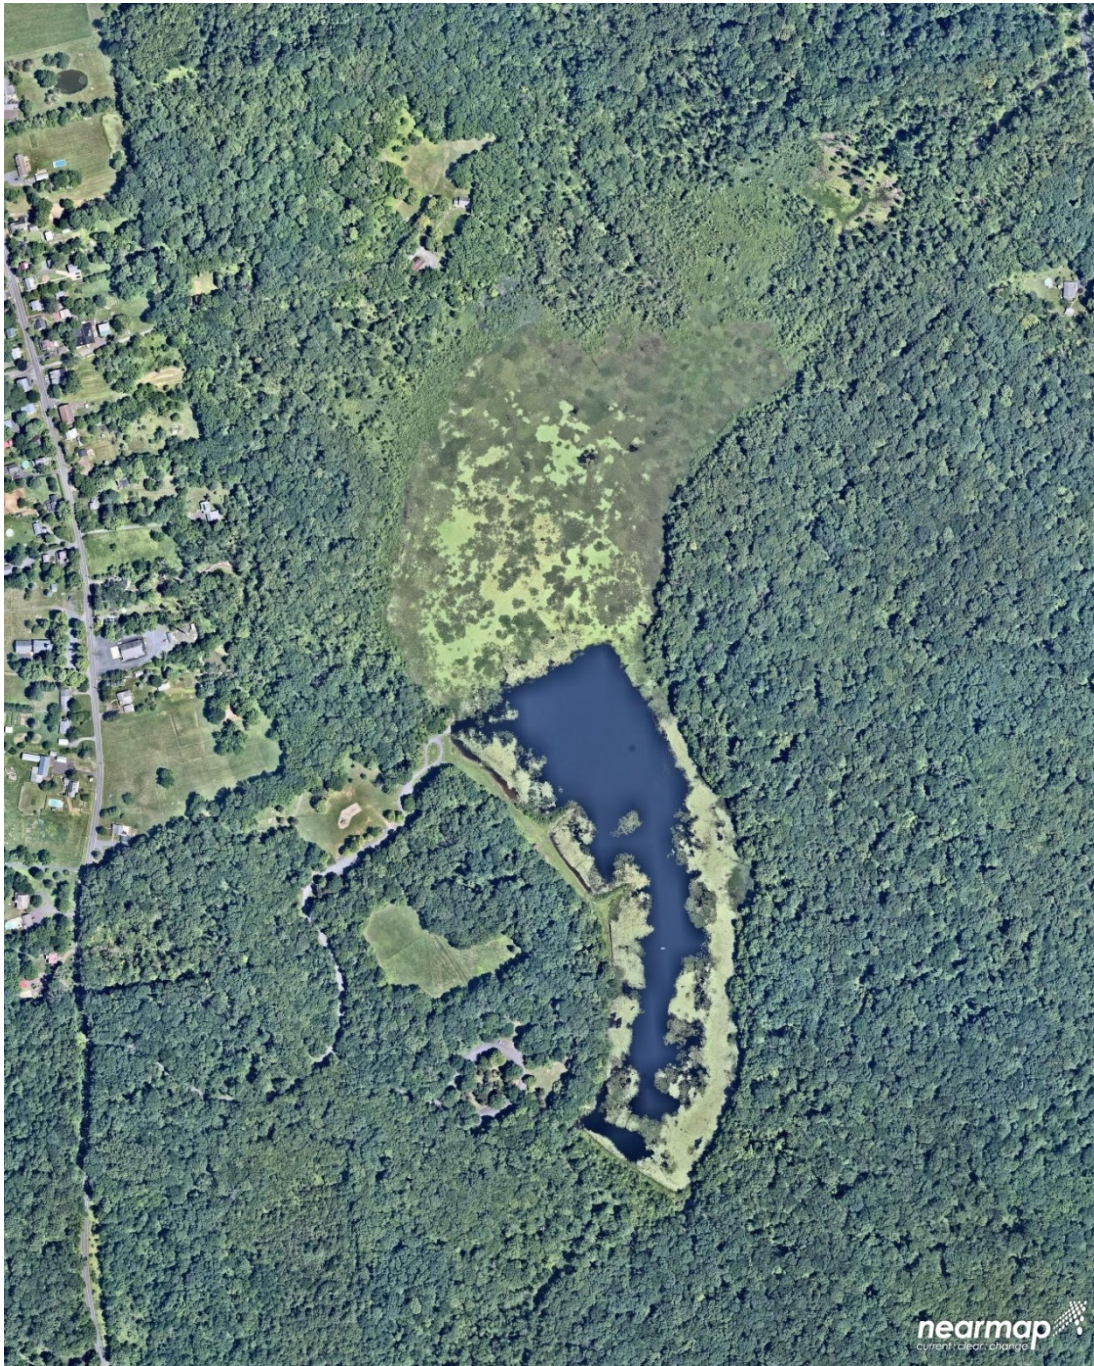
Image 2: Satellite imagery of Lake Towhee dated June 15, 2018

It was determined that the restoration of open water as a result of treatment would best be documented using overhead imagery. In 2020, BCCD received approval to utilize drones to capture surface vegetation conditions and the extent of open water habitat on Lake Towhee. Orthomosaic imagery for 2020 and 2021 are included (along the satellite imagery from 2018 as comparison) in Appendix C.

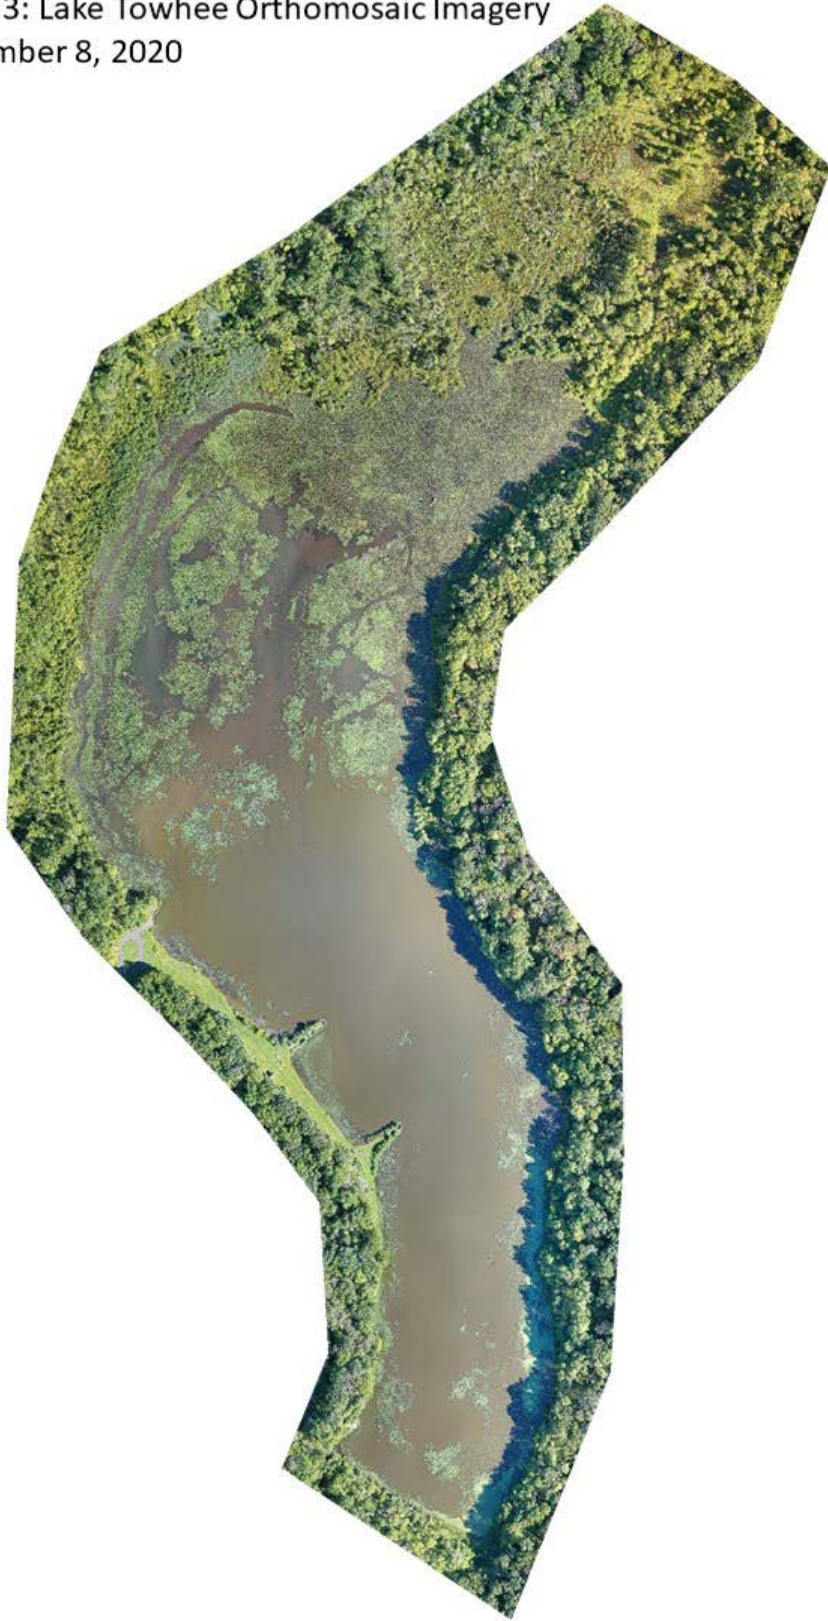
Image 3: Lake Towhee Orthomosaic Imagery
September 8, 2020

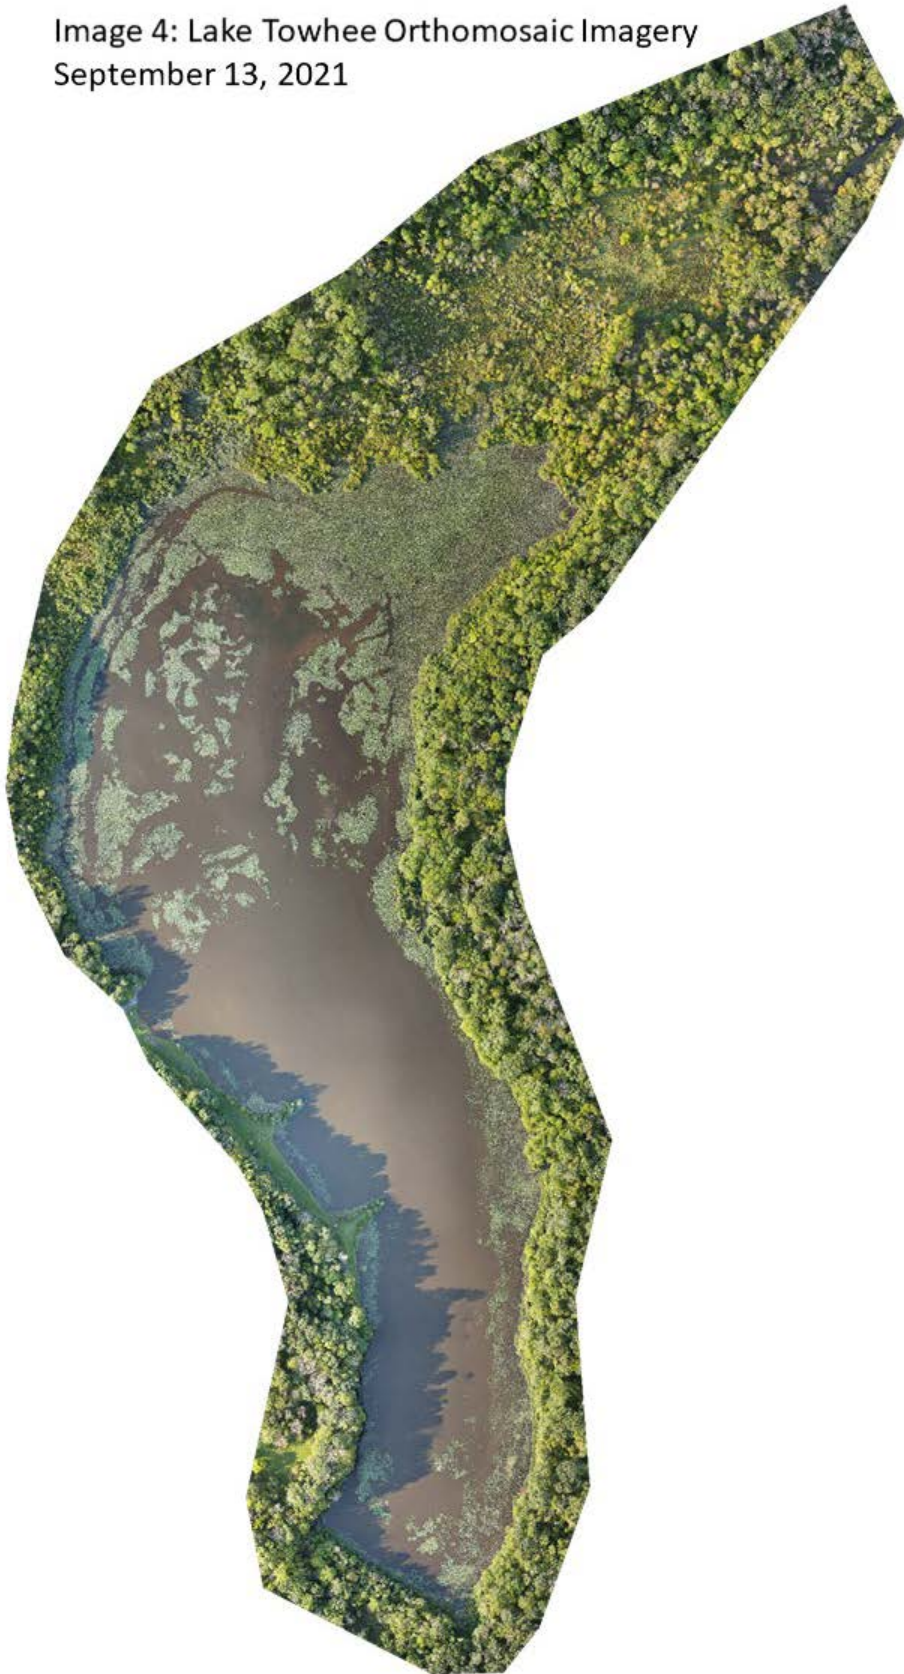
Image 4: Lake Towhee Orthomosaic Imagery
September 13, 2021
