Phase II Final Report

Cooks Run Watershed Assessment

June 30, 2008

**Aqua Link, Inc.**

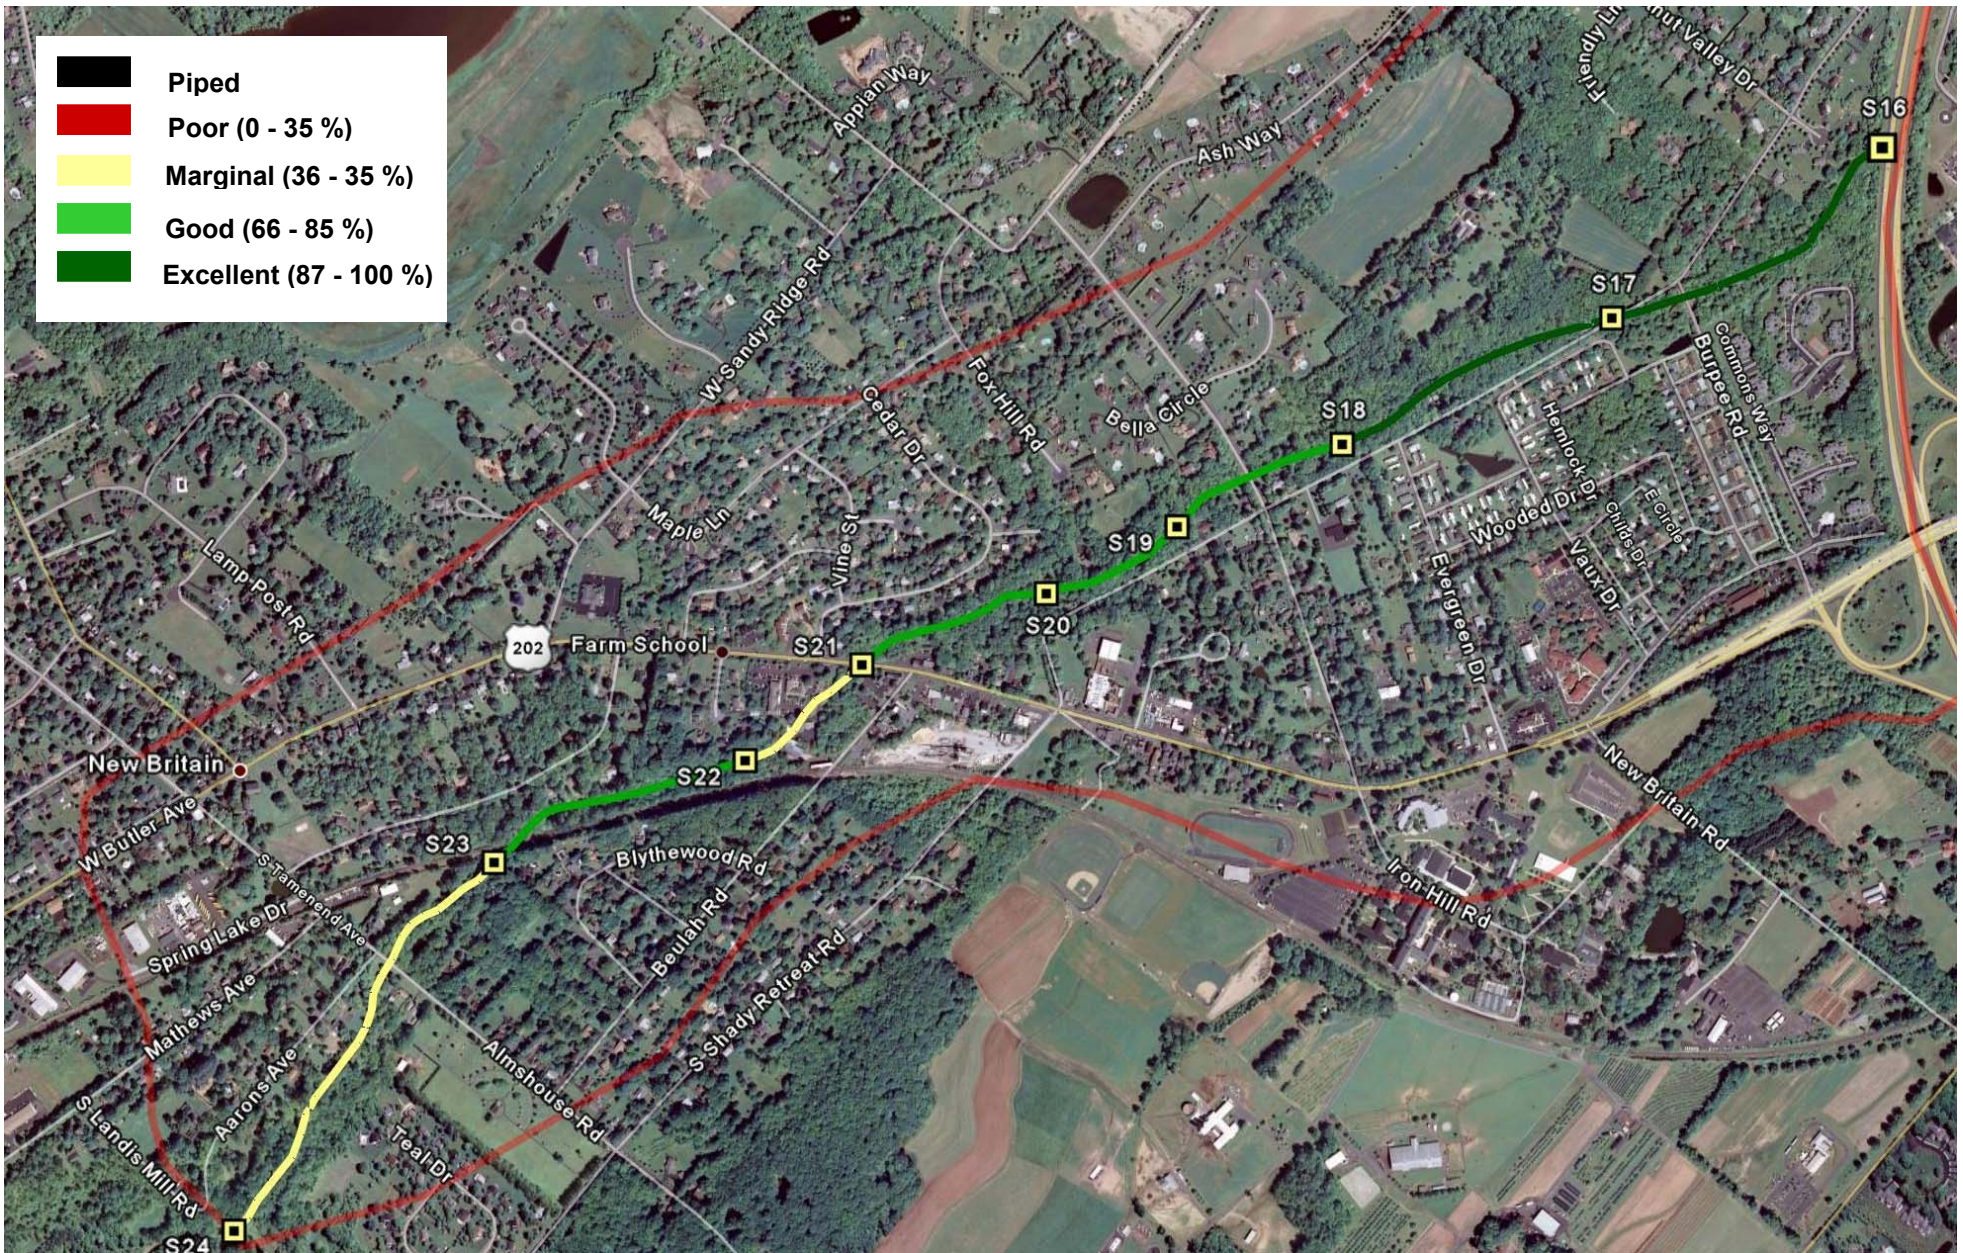
Figure 3.1

Based upon the stream and riparian visual assessment, the scores of the eight stream segments ranged from 56 to 86 percent (marginal to very good) as shown in Table 3.1. The highest scores were recorded for Segments 16-17 and 17-18 as shown in Figures 3.1 and 3.2. It should be noted that the scores for these two segments were the highest for all segments throughout the entire Cooks Run watershed (upper and lower subwatersheds). Conversely, the lowest scores were noted for Segments 21-22 and 23-24, which lie in the southern end of the Cooks Run lower subwatershed. The major problems in these two segments are localized areas of stream bank erosion.

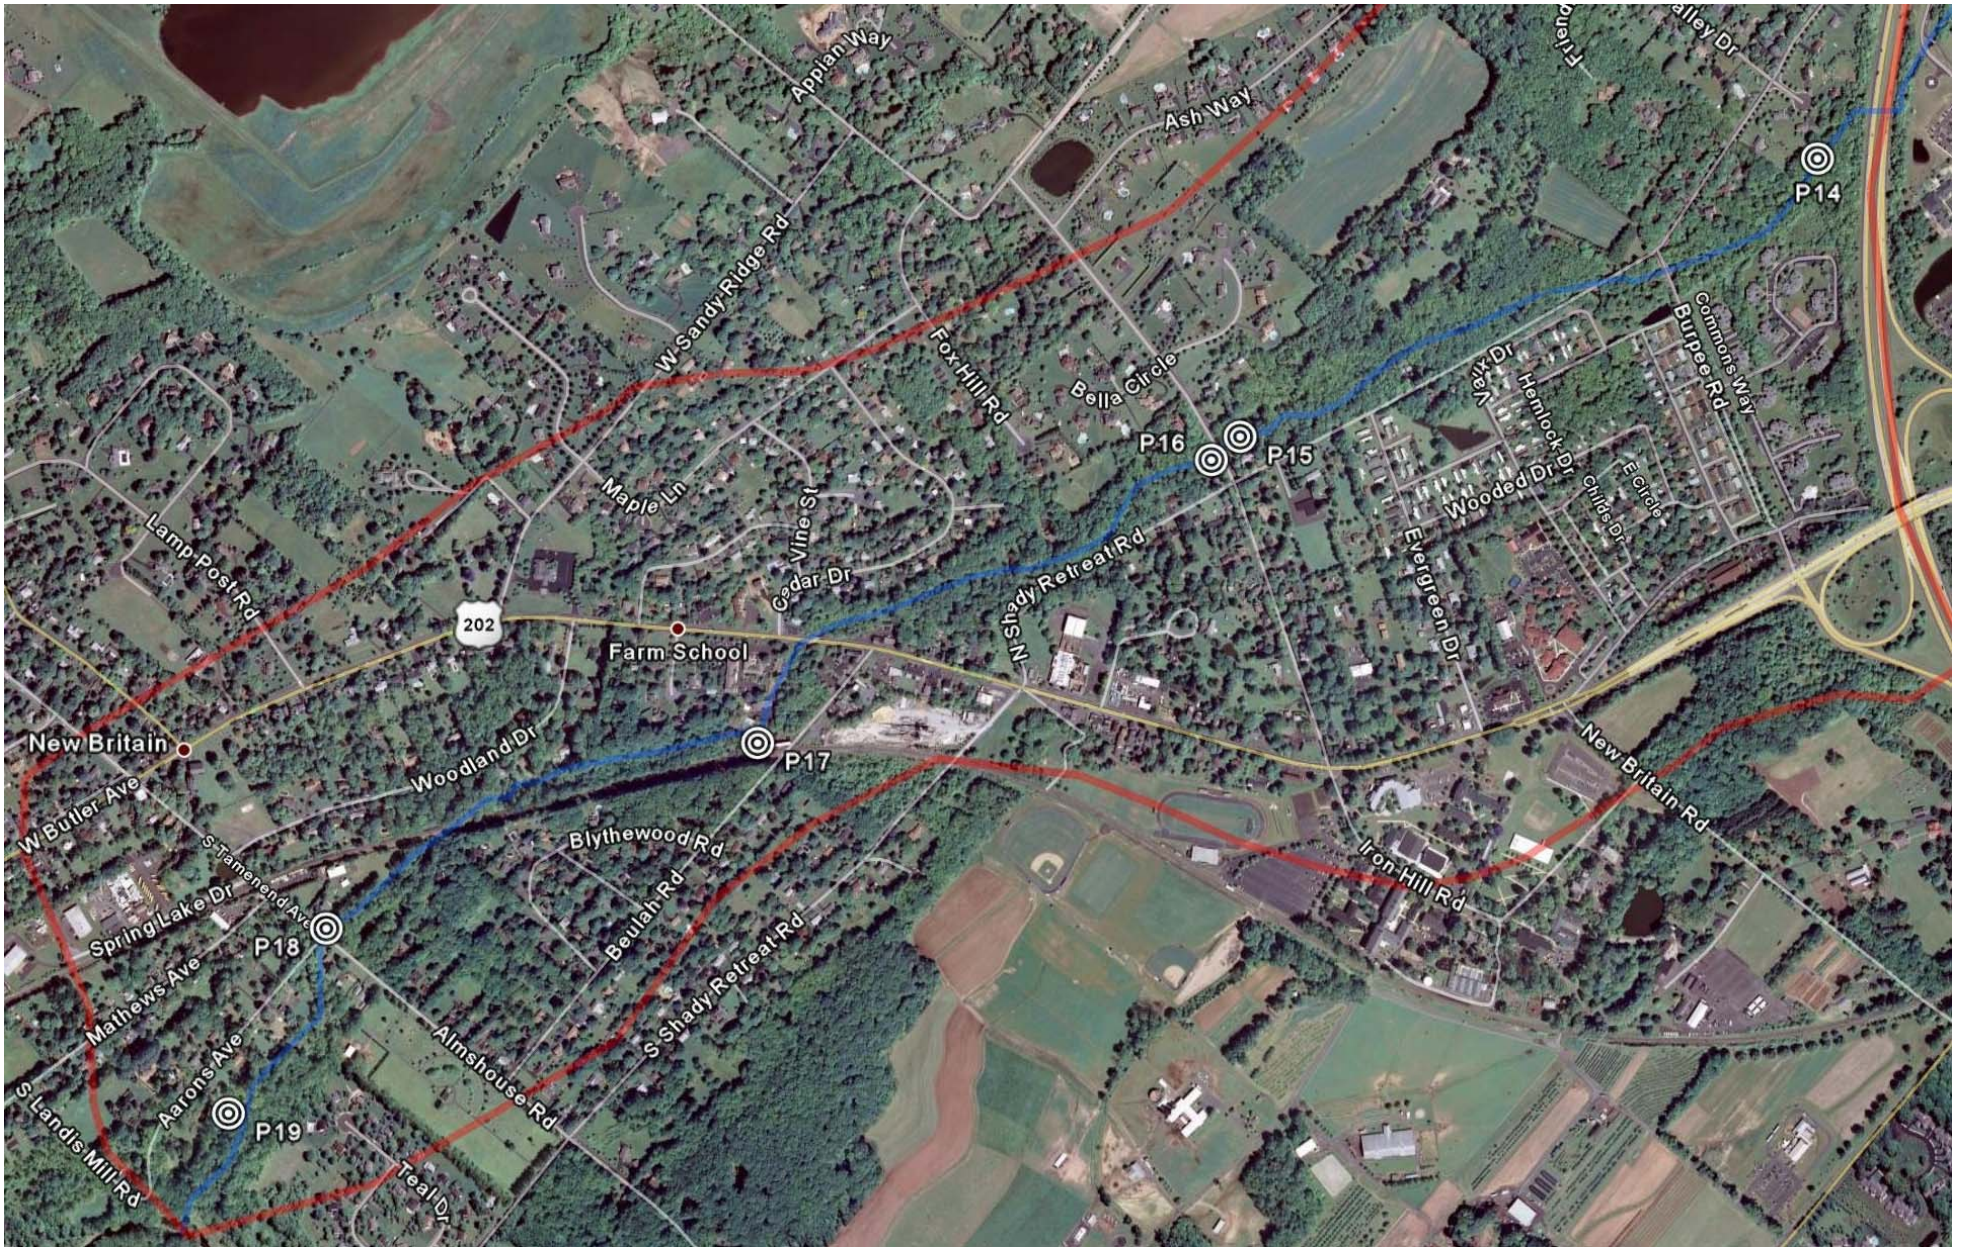
Figure 4.1

Aqua Link identified a total of 6 major nonpoint source (NPS) problems within the lower Cooks Run subwatershed. These NPS problems are discussed below in detail. In addition, the locations and photographs of these NPS problems are shown in Figures 4.1 and 4.2, respectively. All NPS problems were assigned a score ranging from 1 to 5 (low to high) based upon its overall level of impairment.
