# FINAL REPORT

## *Lake Galena & North Branch Neshaminy Creek Watershed Implementation Plan*

*September 24, 2010*

**Aqua Link, Inc.**  
Pond, Lake & Stream Management & Supplies

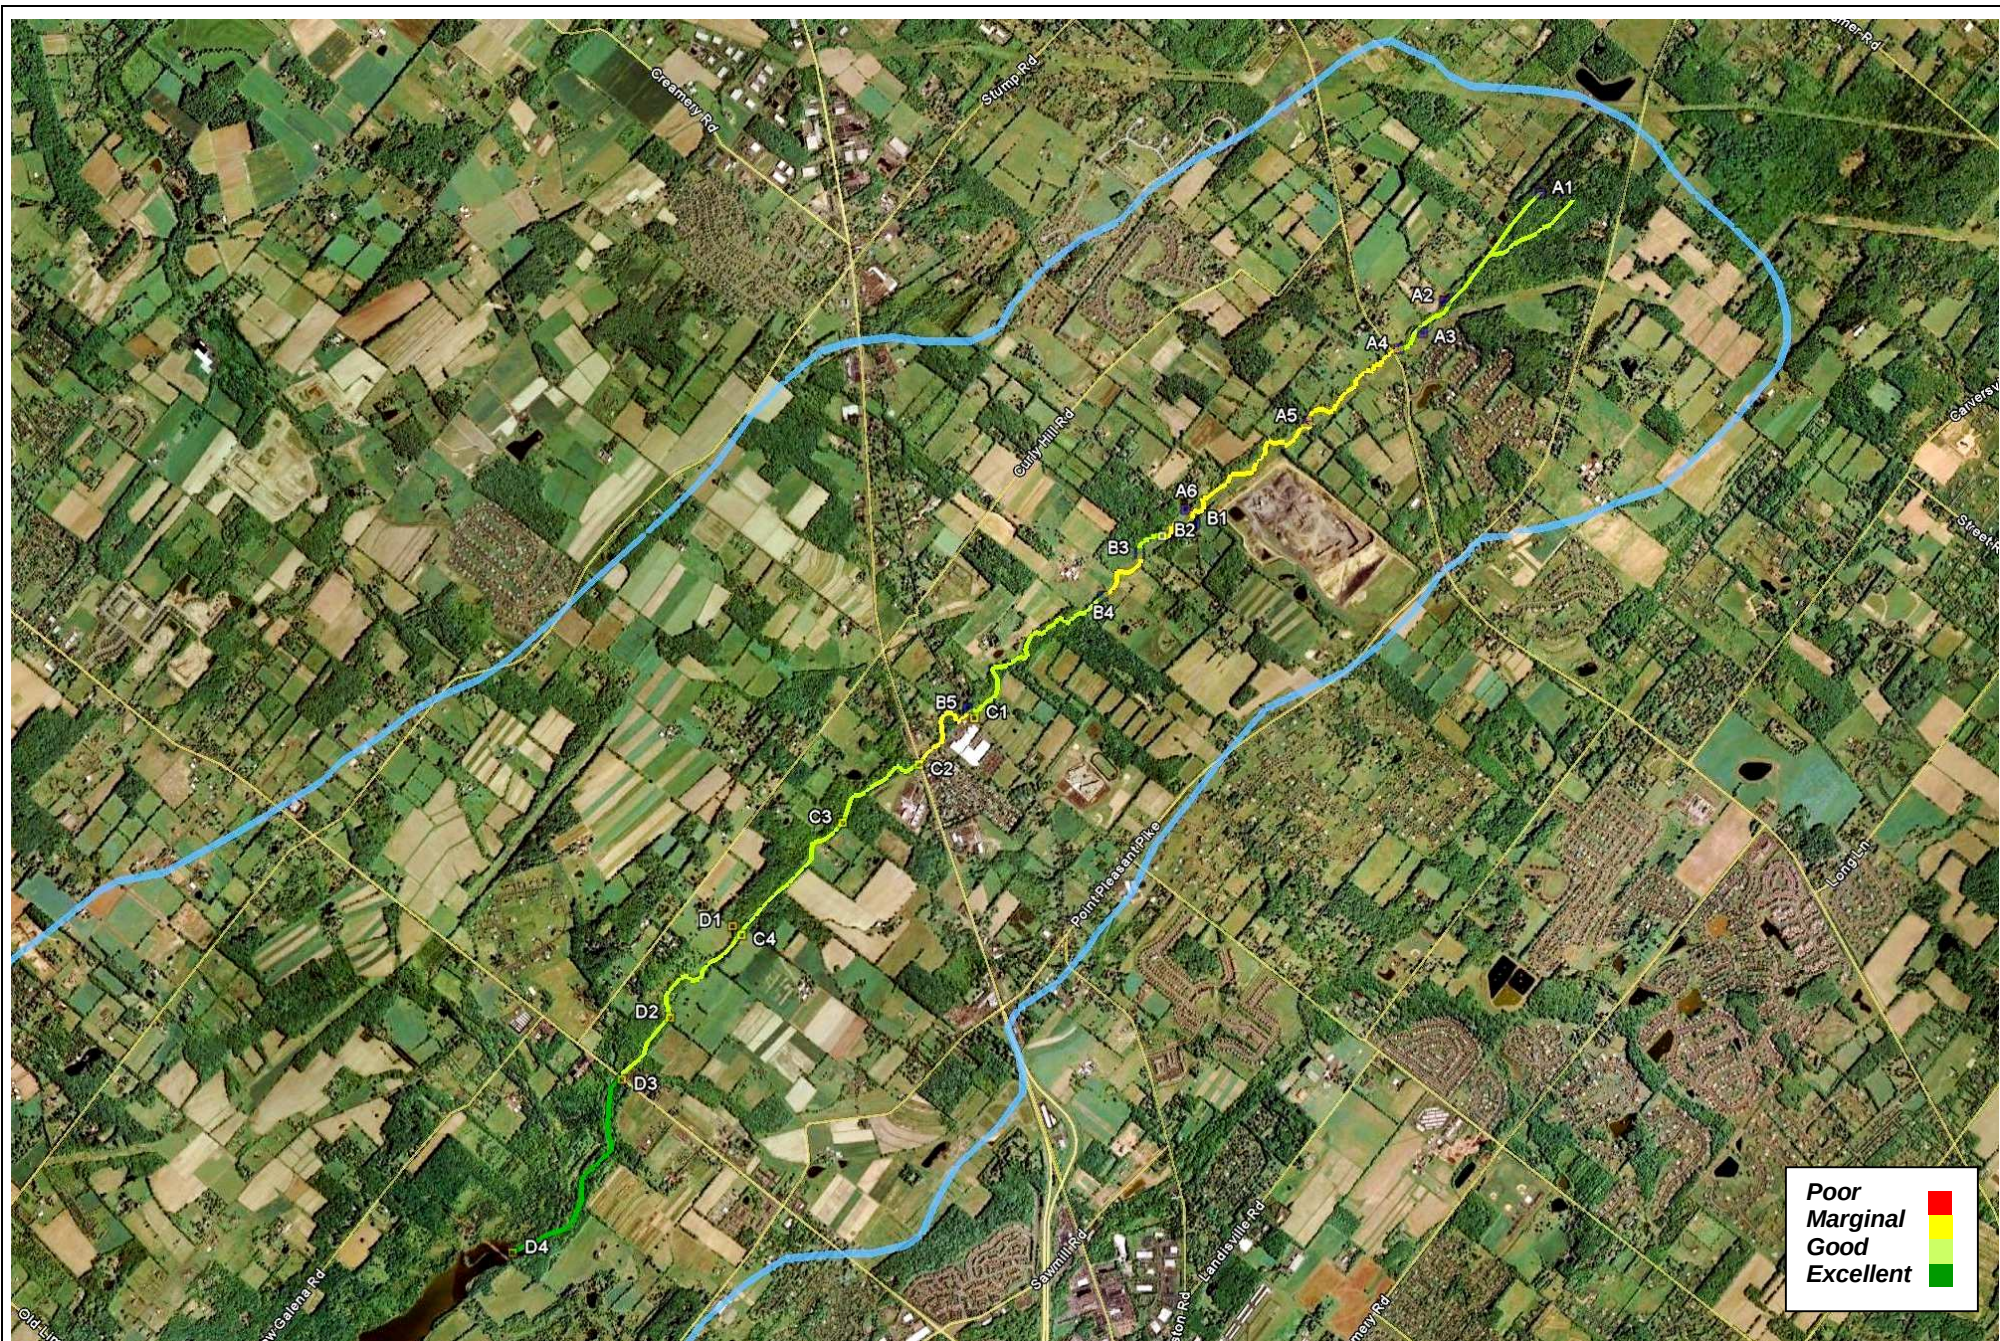
**Figure 5.4 Condition of Stream & Riparian Corridors  
Lake Galena Watershed**

The results of the stream and riparian visual assessment are presented in Tables 5.2 and 5.3 and Figures 5.4 through 5.6. Overall, five of the fifteen stream segments only obtained a “marginal” score (Table 5.2 and Figure 5.4). Based upon our field reconnaissance, Stream Segments A4-A5, A5-A6, B1-B2 and B3-B4 are greatly impacted by the PECO (Philadelphia Electric Company) electric power transmission line right-of-way. Unfortunately, this right-of-way encompasses about 1.75 stream miles along the North Branch in the upper, most northern portion of the Lake Galena watershed. Within this right-of-way, the streambanks are virtually devoid of woody vegetation, which are necessary to stabilize streambank soils (Table 5.2 and Figure 5.4). Consequently, severe streambank erosion was

observed throughout the right- of-way and thereby resulting in massive bank failures. In turn, eroded soils are adversely impacting downstream aquatic habitats and inevitably the water quality of the North Branch and Lake Galena.

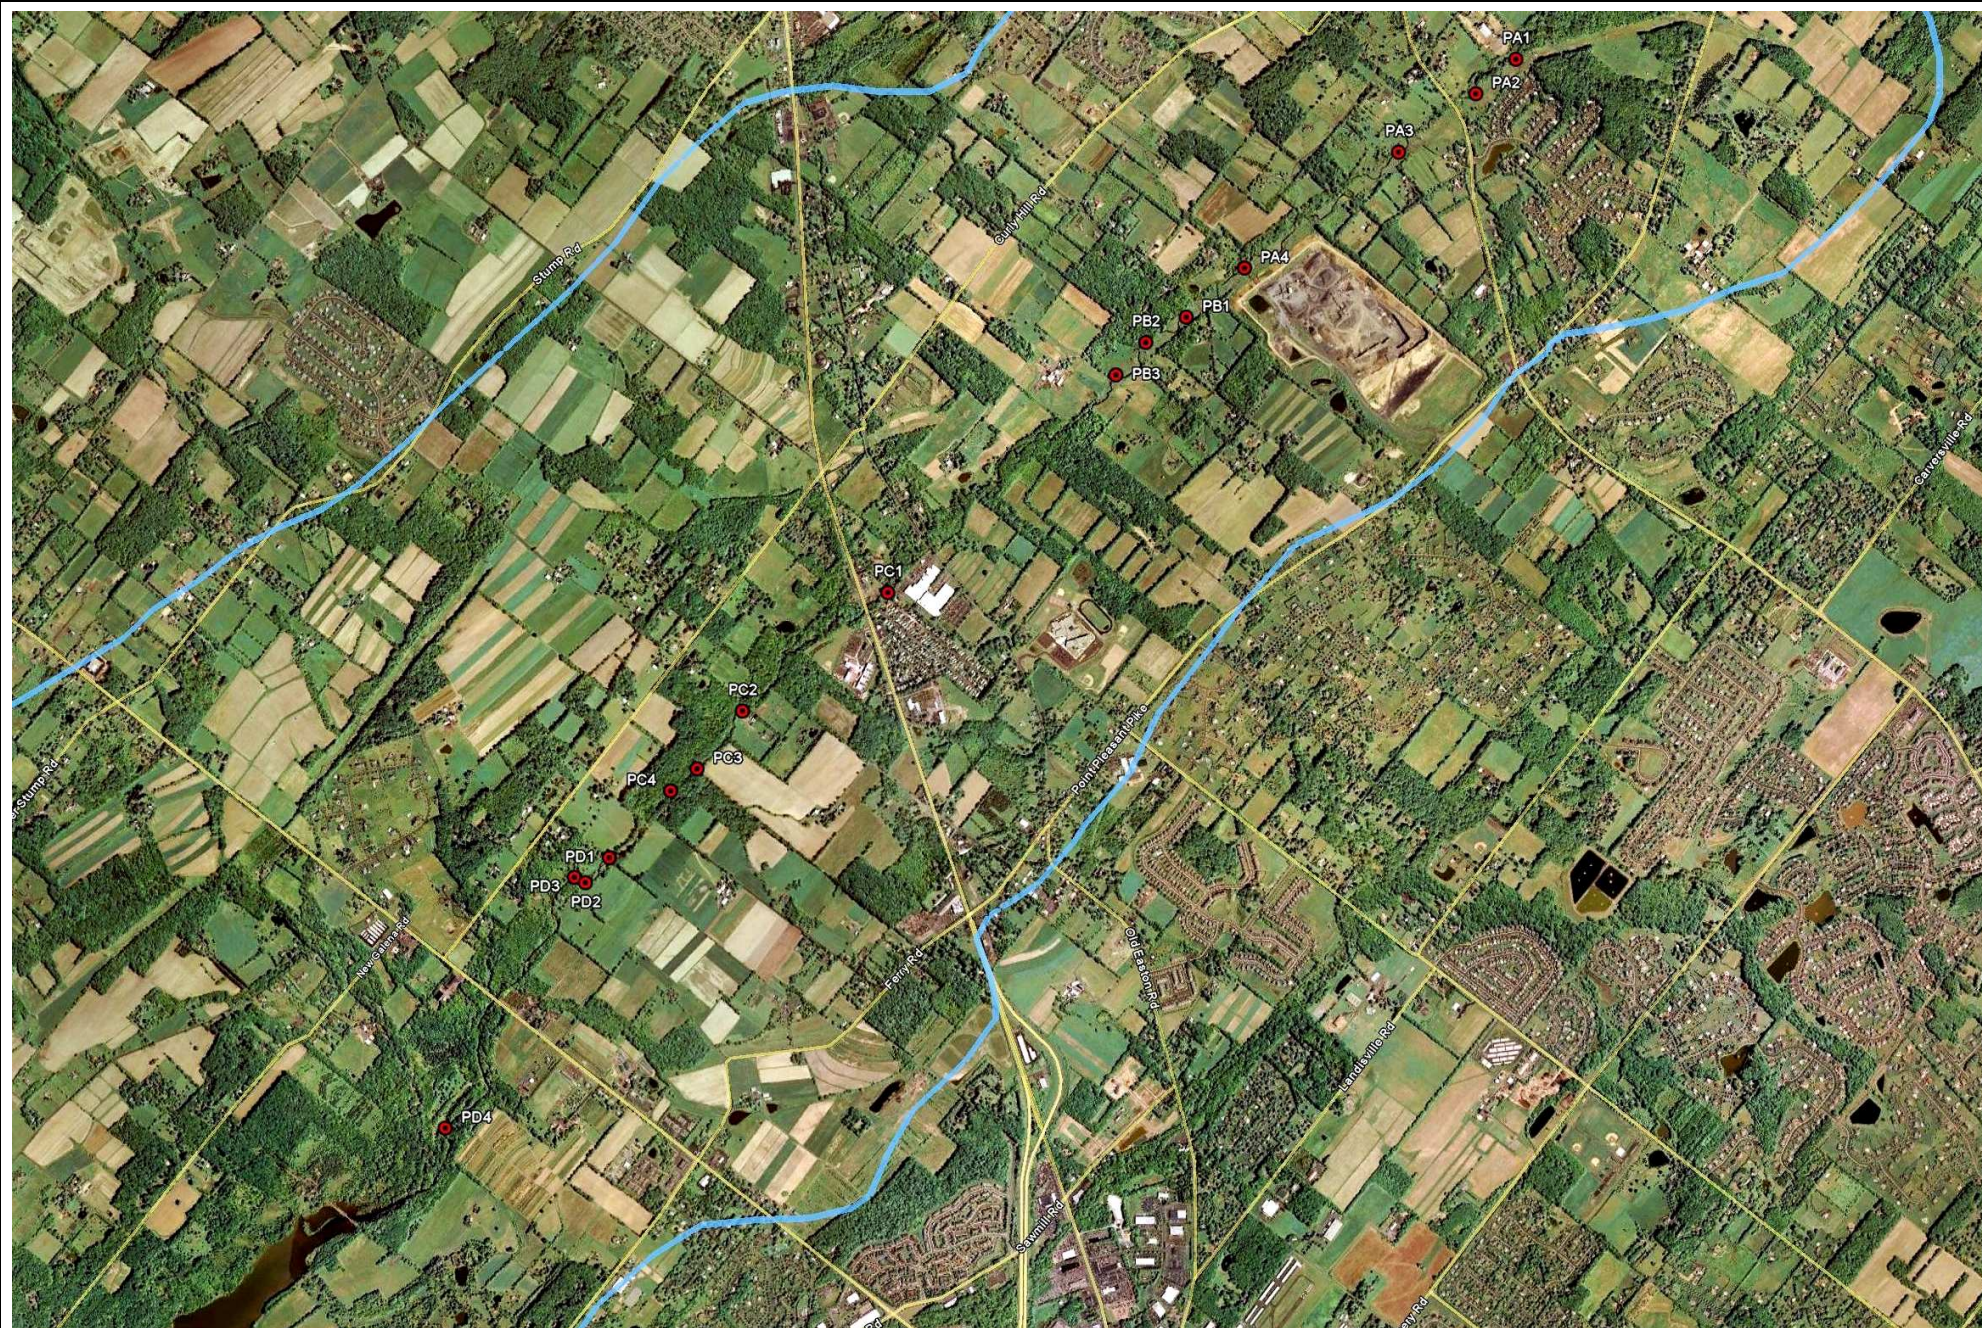
**Figure 5.5** Location of Major Stream & Riparian Problems  
Lake Galena Watershed

Lastly, all of the major stream and riparian problems that were identified during the assessment portion of this project are presented in Table 3.3. The locations and photographs of these problems are shown in Figures 5.5 and 5.6, respectively. With the exception of PC3 and PC4, all of the problem areas are related to streambank erosion. The total estimated amount of severely eroding streambanks along the North Branch Neshaminy Creek is nearly 18,000 feet. This estimate includes both streambanks with stream segments if applicable. As discussed previously, most of the streambank erosion is located in the upper portion of the watershed along the PECO right-of-way.

For more information, refer to Appendix G of this report, which provides a list of recommendations to rehabilitate/restore all of the identified stream problems areas. Overall, many of the recommendations focus on maximizing the use of vegetative and bioengineering restoration measures, thereby creating a more natural appearance.
