FINAL REPORT

PALMS Lake BMP Mini-Grant Program – 2022 Lake Towhee Invasive Plant Management Project

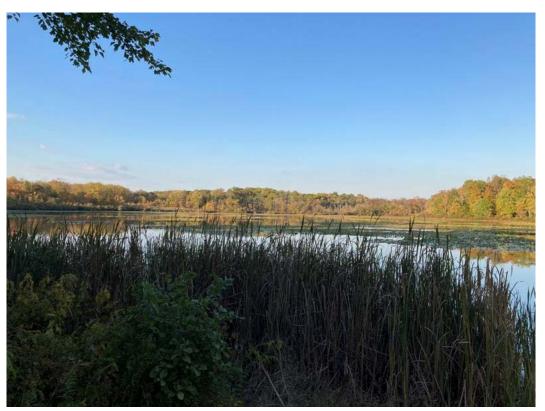
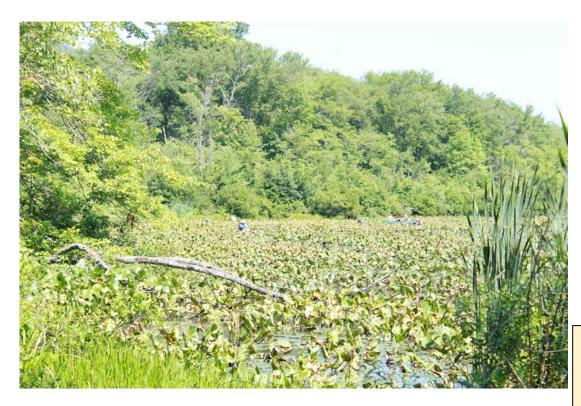
Upper Lake 7/2/19

This project restored an estimated 2 to 3 acres of open water habitat. This area, as depicted in 2021 aerial imagery, was infested by water chestnut. Looking back to initiation of chemical treatment of Lake Towhee, the area restored to open water approaches 18 acres – more than doubling since 2019.

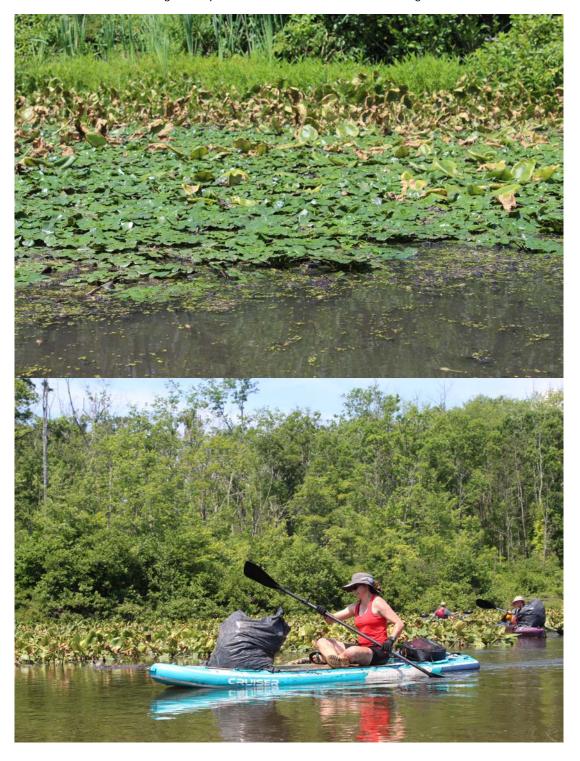
7/20/2022 Infested area showing evidence of prior herbicide application.

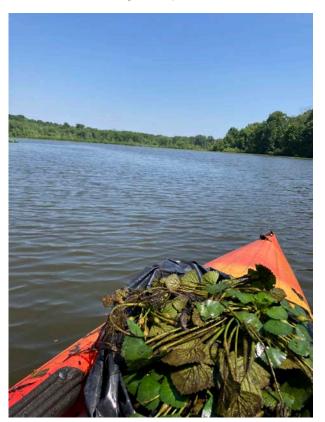
7/20/2022
HandpullingWater
chestnut
amidst native
spatterdock

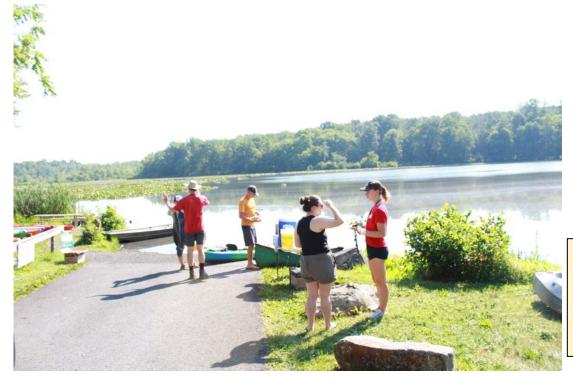
7/20/2022 Open water at boat launch.
